## Cambridgeshire Guided Busway

### Advisory Report on Guideway Investigations, Defects and Corrective Measures

Advisory Report on Guideway Investigations, Defects and  
Corrective Measures

| Date | : | 1 November 2016 |

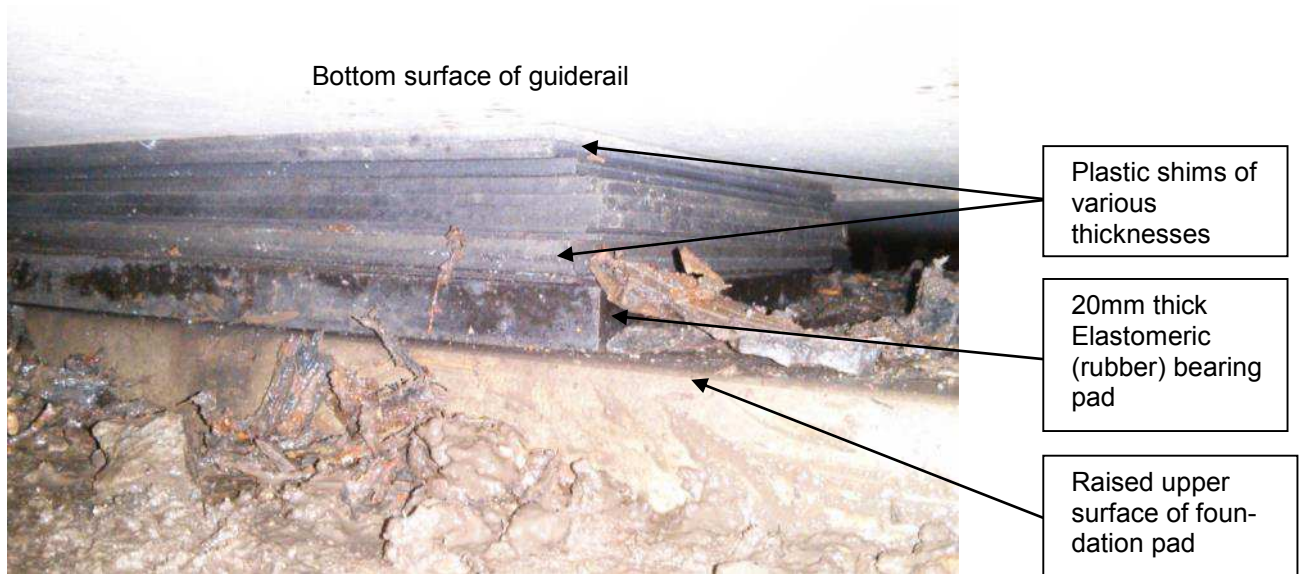
14. BNL's design included for there to be 10mm of shims in place on construction and permitted a maximum of a further 25mm to be placed if necessary. Limited exploratory excavations to examine the bearings and shims along the site, where no previous adjustments have been made, have shown that the depth of shims present is variable where shallow foundations are present. We believe this reflects corrections to the level of the guideway undertaken by BNL prior to handover to the Council. There appears to be no correlation between depth of shims and shallow foundations or ground conditions, the overall shim thicknesses probably being a function of how accurately in level the foundations were installed. The depth of shims occasionally exceeds BNL's design limit of 35mm as can be seen in the photograph below.

**Figure 3. Photograph of a foundation pad upon which there are more than 35mm of shims.**

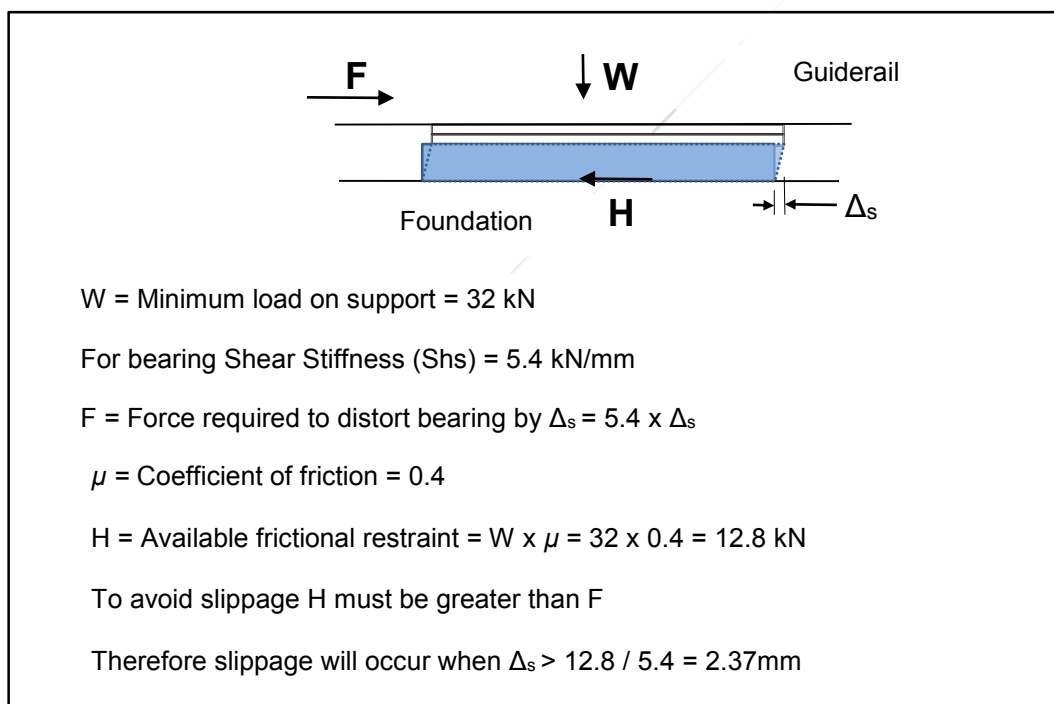
38. Notwithstanding the requirements of BS5400 Part 9.1, we have calculated that for an ‘in-plane’ ladder, with end bearing reactions of approximately 32kN (see paragraph 35 above), with coefficient of friction of 0.4, and with bearing pad shear stiffness of 5.4kN/mm (given by Ekspan in its bearing schedule), slippage of a bearing pad/shims can occur for thermal expansion/contraction of a guideway ladders only 2.37mm (see Figure 6 below). Given that thermal expansion/contraction is frequently greater than 2.5mm, the bearing design is flawed irrespective of the stiffness of the guideway superstructure because there is insufficient friction to retain the bearing pads in place even for an ‘in-plane’ guideway ladder undergoing thermal changes without trafficking of the guideway.

**Figure 6. Calculation for Slippage of Bearing Pad and/or Shims.**

39. Acceptance of inadequate friction for fixity of the bearings and shims in our opinion constituted a failure to act with the reasonable skill and care to be expected from an ordinarily competent and experienced design engineer.

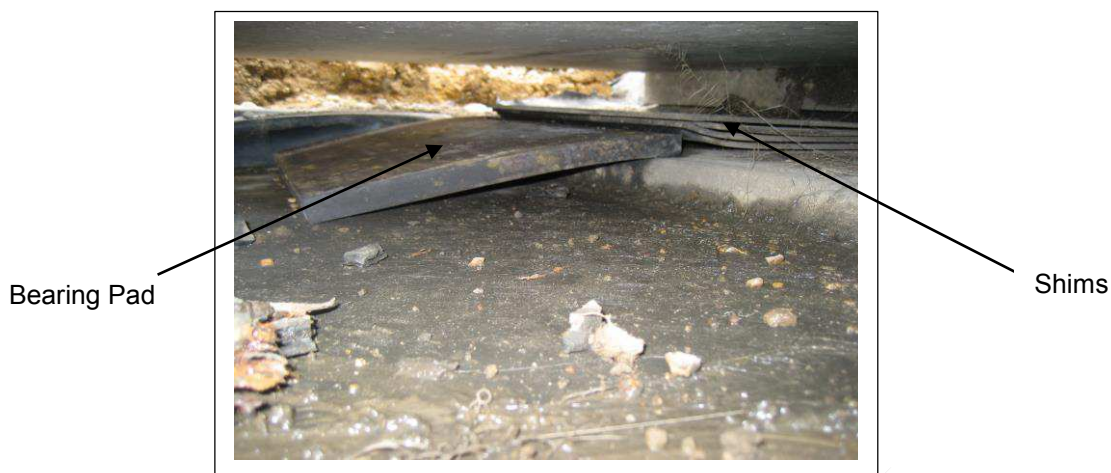
73. Our analysis shows that even a coefficient of friction as high as 0.35 is significant in contributing to loss of bearings and/or shims and thus the recorded coefficients of friction show a significant contribution to the losses.

**Figure 11. Bearing pad has 'walked out' from beneath the shims.**

74. What is clear from Investigation G is that the risk of bearings and/or shims moving out is further increased because of lower coefficients of friction that are often less than 0.4.

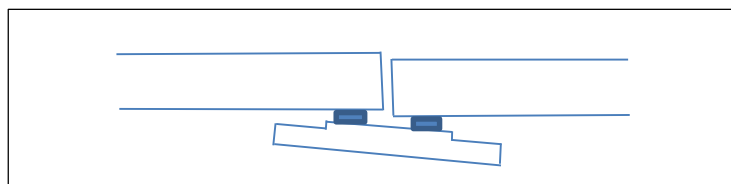
80. Investigation C shows that some 3.9% of joints have vertical steps that exceed 2.0mm (which is greater than the permitted construction and handback tolerance of 1mm in DDG Rev 6). In our view vertical steps are the result of bearing/shim loss and/or possible tilting of foundations about a transverse axis.

**Figure 12. Diagram (exaggerated for clarity) showing how tilting of foundation can result in a step at a joint.**

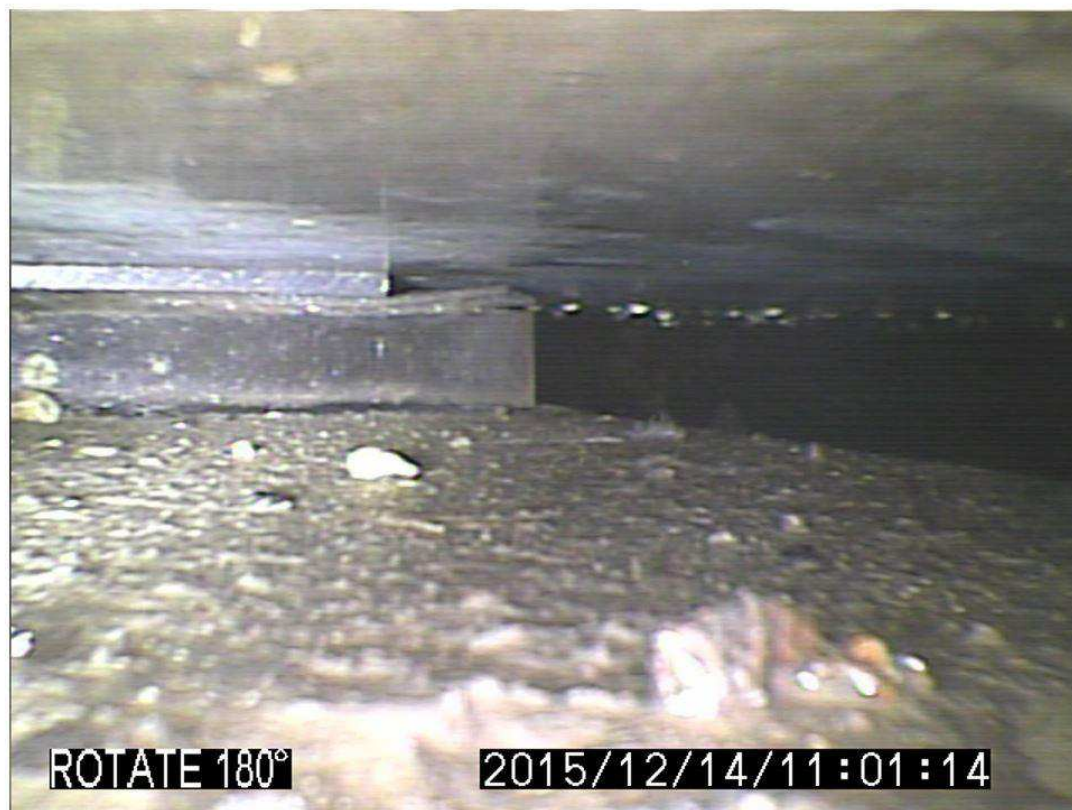
**Figure 16. Uneven compression of Elastomeric Bearing Pad.**

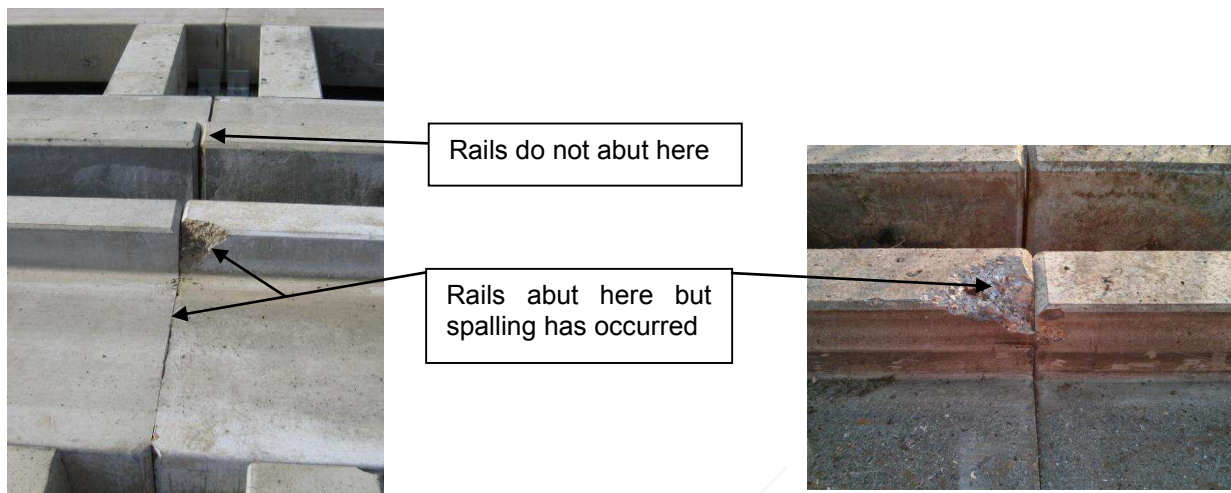
122. Investigation C shows that the vast majority of the (so-called) fixed joints do not have abutting joints as designed. This means that the guideway is not properly restrained in the longitudinal direction. Where the joints are abutting, there have been instances of spalling, possibly due to rotation of the beams as a result of foundation movement:

**Figure 17. Photograph of guiderails not abutting, and spalling in locations where they do abut.**

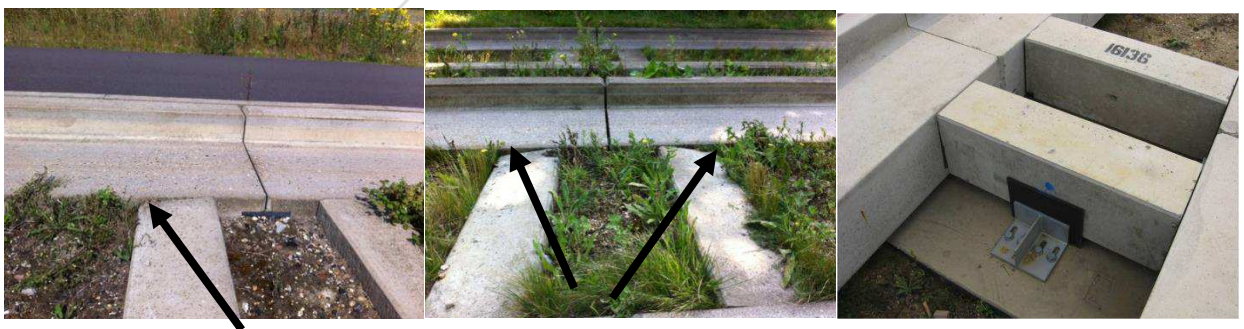
123. Notwithstanding the above, we have concerns about the stability of the guideway under the current operation of the guideway and normal bus traffic. Investigation C has also recorded many instances where the spacer beams have rotated which is also an indication of lack of longitudinal restraint. This indicates that the guideway ladders are not adequately restrained for normal busway operations (Investigation I was for an abnormal emergency braking circumstance using a fully-loaded double decker bus).

**Figure 18. Photographs of rotated spacer beams. The marked sloping surfaces in the two photographs to the left were originally level with the guiderail as shown in the far right photograph.**

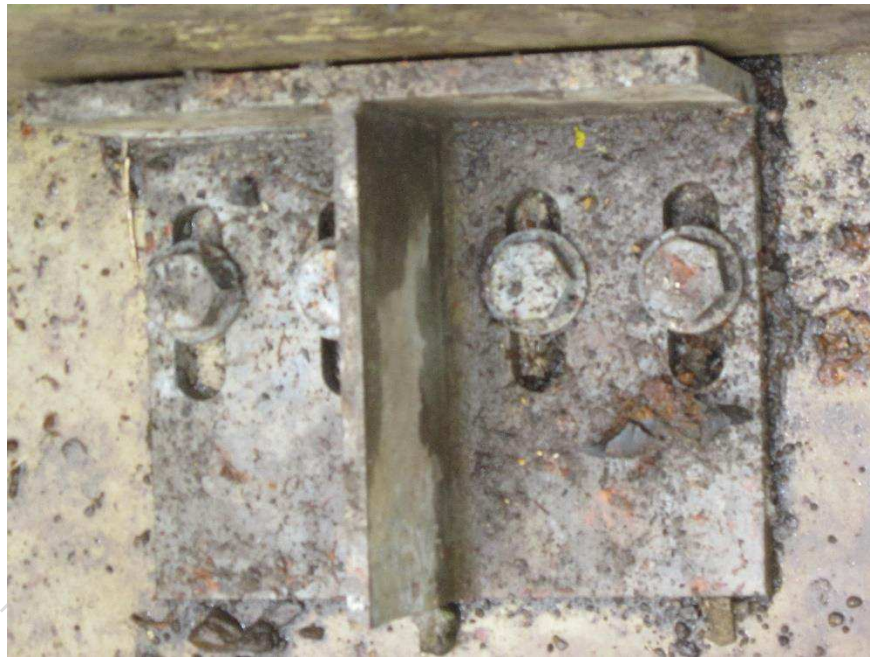
**Figure 19. Photograph showing longitudinal bracket not abutting spacer beam.**

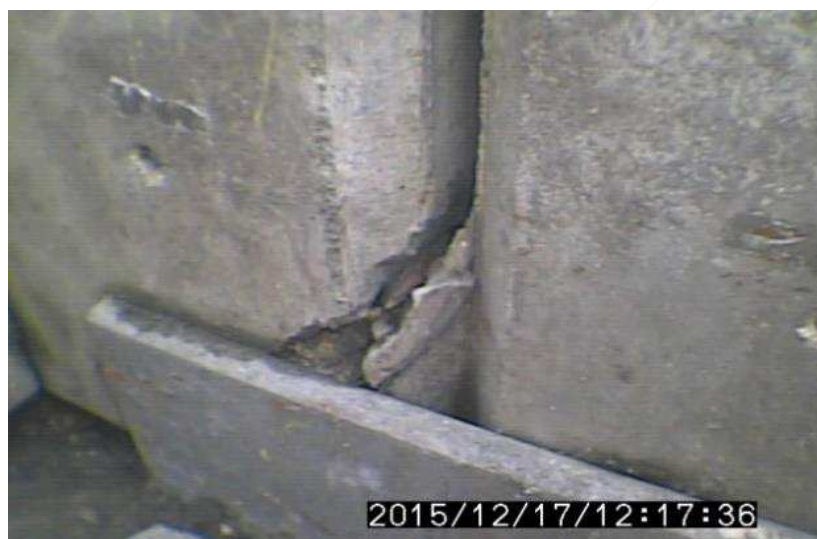
135. Investigation K was carried out to assess concrete damage at the bottom of the joints in the guiderails at all locations where excavation had been carried out for Investigations B, E, F and I. There have been two investigations, one in February 2016 and one in August 2016. In the first survey, out of some 360 beam ends, 48 beam ends had ‘significant’ or ‘severe’ spalling (see §136 and §137 below for defining of these terms), which in our opinion are likely to have given rise to exposure of reinforcement and/or require repair – this constitutes 13.4%. In the second survey, out of 401 beam ends, 54 beam ends had significant or severe spalling – this constitutes 13.5% had ‘significant’ or ‘severe’ spalling. In addition to these, some 12% of beam ends were found to have slight spalling which we consider to be sufficiently small to not warrant repair.

**Figure 20. Spalling behind lateral restraint bracket**

138. We believe that the cause of the spalling is the localised pressure exerted by the lateral restraint brackets on the concrete at the lower corner of the guiderails. In particular, if the bracket is not perfectly aligned against the concrete of the guiderail, there would be a point load contact which would then cause the spalling of the concrete.

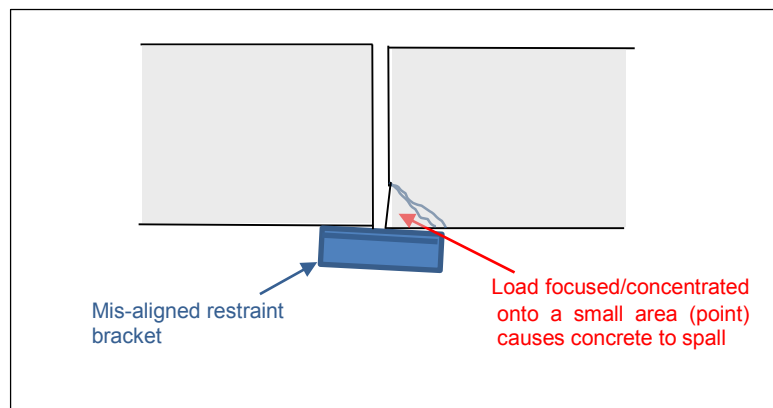
**Figure 21. Diagram (Sectional Plan View) showing how spalling can occur**

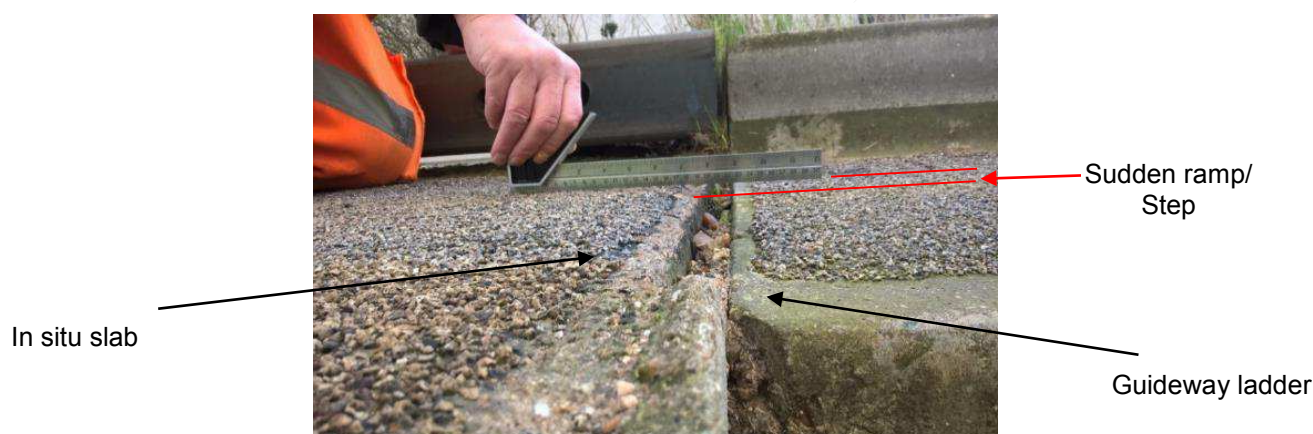
144. A slab interface occurs at the junction of a guideway ladder with an in situ concrete slab. They are located at road crossings and burst throughs where the busway becomes unguided.
145. The levelling surveys carried out in Investigation D identified sudden ramps/steps at slab interfaces some of which are greater than 12mm. Some of these are associated with bearing/shim loss but we believe that others may be related to a construction defect with the in situ guiderail/slab being laid high and then the very end being ramped down to the joint as illustrated in the photograph below.

**Figure 22. Step at joint between guiderail and insitu slab**
