Cambridgeshire Guided Busway

Report on Guideway Defects and Corrective Measures

Cambridgeshire Guided Busway
Cambridgeshire County Council v BAM Nuttall Ltd.

| Date | : | 11 September 2014 |

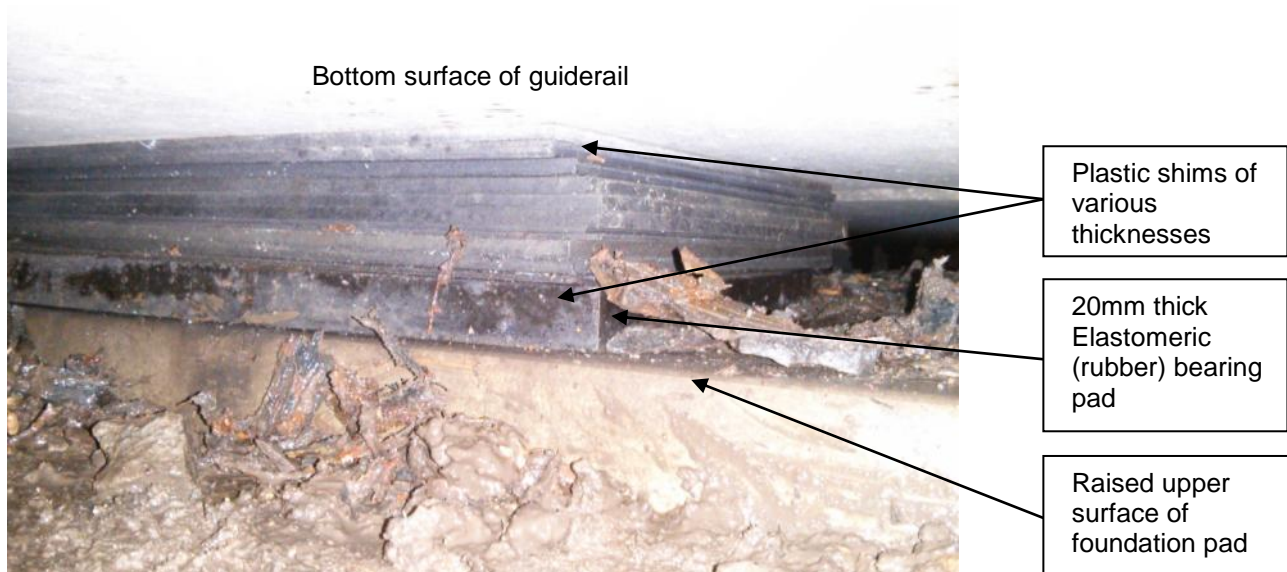
12. BNL's design included for there to be 10mm of shims in place on construction and permitted a maximum of a further 25mm to be placed if necessary. Limited exploratory excavations to examine the bearings and shims along the site, where no previous adjustments have been made, have shown that the depth of shims present is variable where shallow foundations are present. We believe this reflects corrections to the level of the guideway undertaken by BNL prior to handover to the Council. The depth of shims occasionally exceeds BNL's design limit of 35mm as can be seen in the photograph below.

Figure 3. Photograph of a foundation pad upon which there are more than 35mm of shims.

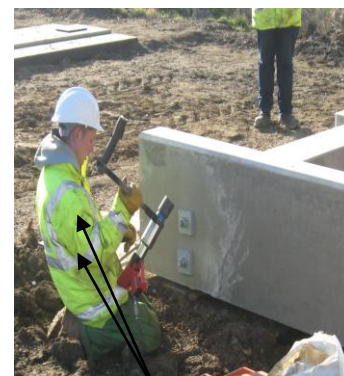
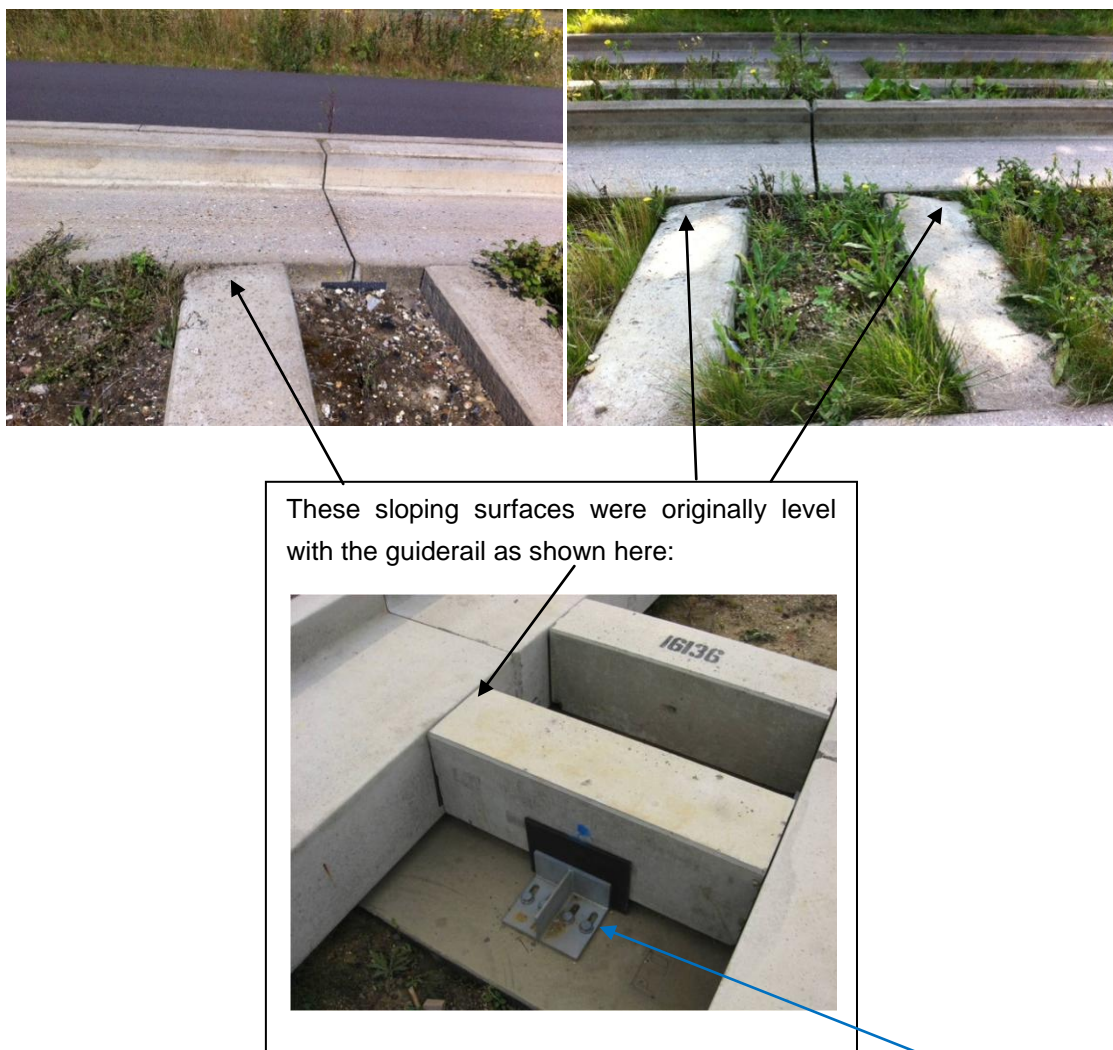
32. In addition, because the restraint bracket rests against the spacer beam at the bottom (see photograph at Figure 4 above), there will be a rotating force (torsion) applied to the spacer beam when the buses brake or accelerate. There is insufficient friction to resist this and this causes the spacer beams to rotate as may be seen in these photographs below.

Figure 9. Photographs of rotated spacer beams.

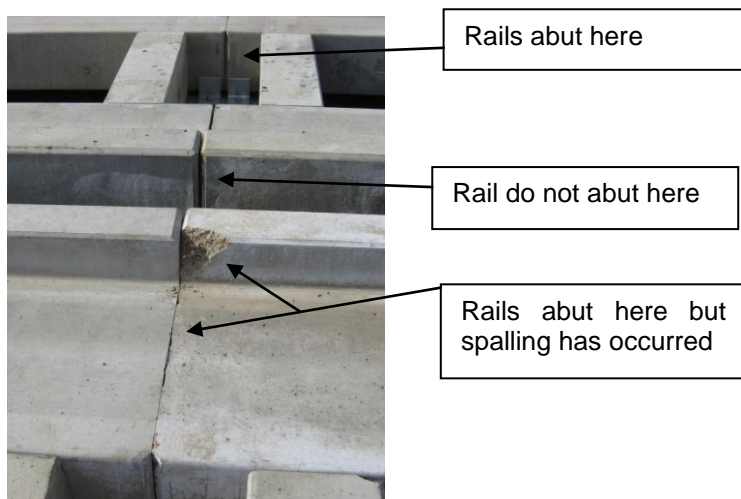
37. Issues (ii) and (iii) are dealt with at §31 to §34 above and Defect 268 relates to the fact that there are situations in which guidrails at fixed ends do not abut one another.
38. Where the guidrails do not touch and there are gaps at the joint, therefore, there is lack of longitudinal restraint.

Figure 11. Photograph of guiderails not abutting, and spalling in a location where they do abut.

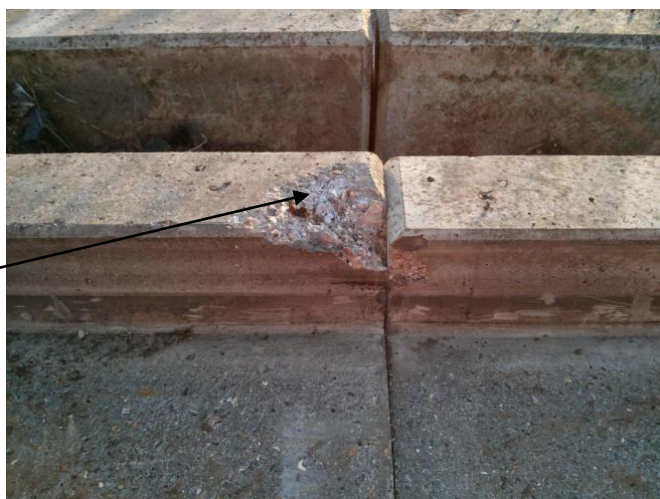
39. Where the guiderails do touch, however, there is the risk of spalling because of localised pressure points.
40. In addition there is the likelihood of foundation movement (up and down) and this will cause rotation to occur at the joints. If the guiderails are touching, either the guiderails will be forced apart with the restraint brackets sliding in their slotted holes or spalling of concrete will occur as has occurred here (Figure 11 and Figure 12). Examples of spalling and failed spalling repairs are also shown in Appendix C.

Figure 12. Spalling of concrete.

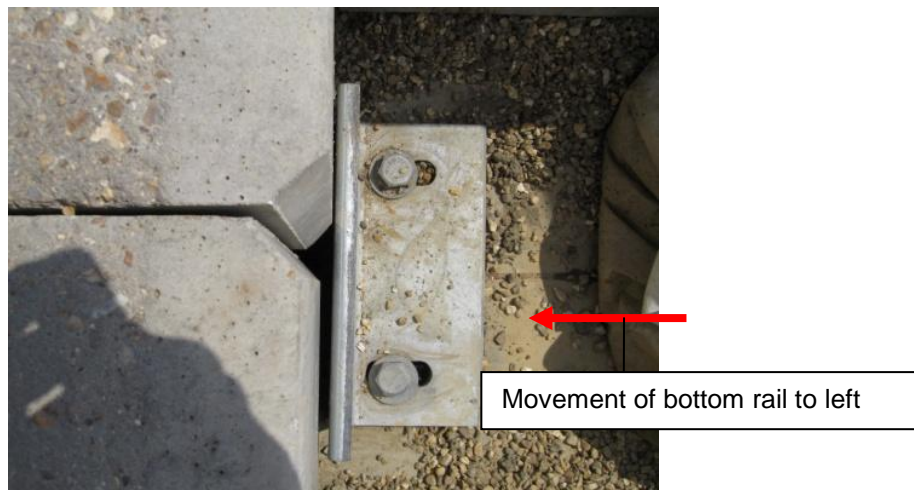
42. Defect 288 has been notified because steps have formed in the guiderail faces caused by lateral movement of the guiderails. Such movement means the lateral restraint brackets, which, like the longitudinal restraint brackets, contain slotted holes (see Figure 13 below).

Figure 13. Photograph of a guiderail that has moved to the left, and that now does not abut the lateral restraint bracket.

43. This means that again there is reliance upon friction between the brackets and the foundation and evidently this is insufficient. According to Defect Notification 288A, steps of up to 7mm have been observed. See photographs in Appendix C (starting on page 67).

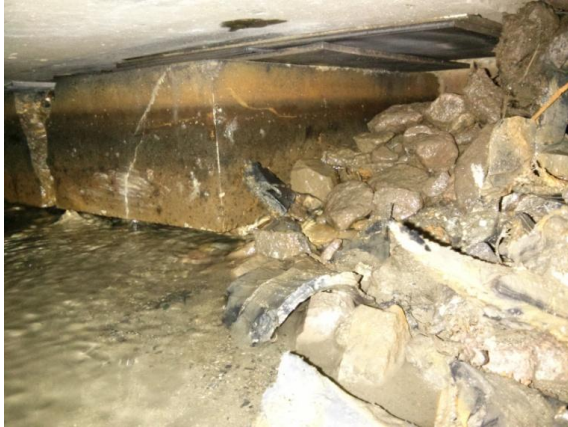
44. These defect notifications relate to the foundation at a change in depth of the concrete guiderails (the interface between Type 1 and Type 2 beams³). At these locations, a precast concrete support block has been provided beneath the thinner Type 2 beam to make up the difference in depth.
45. Photographs show that this support block has failed resulting in movement of the bearings/shims. The spacer block is unstable, being loosely laid on the precast foundation pad, and cannot transmit the loads adequately, evidenced by failure. In our opinion, the precast spacer block should have been bedded on epoxy mortar. This is illustrated in the photographs at Figure 14 and Figure 15 below, which also show slippage of shims and displaced bearing pad.

Figure 14. Photograph showing cracked block and displaced shims

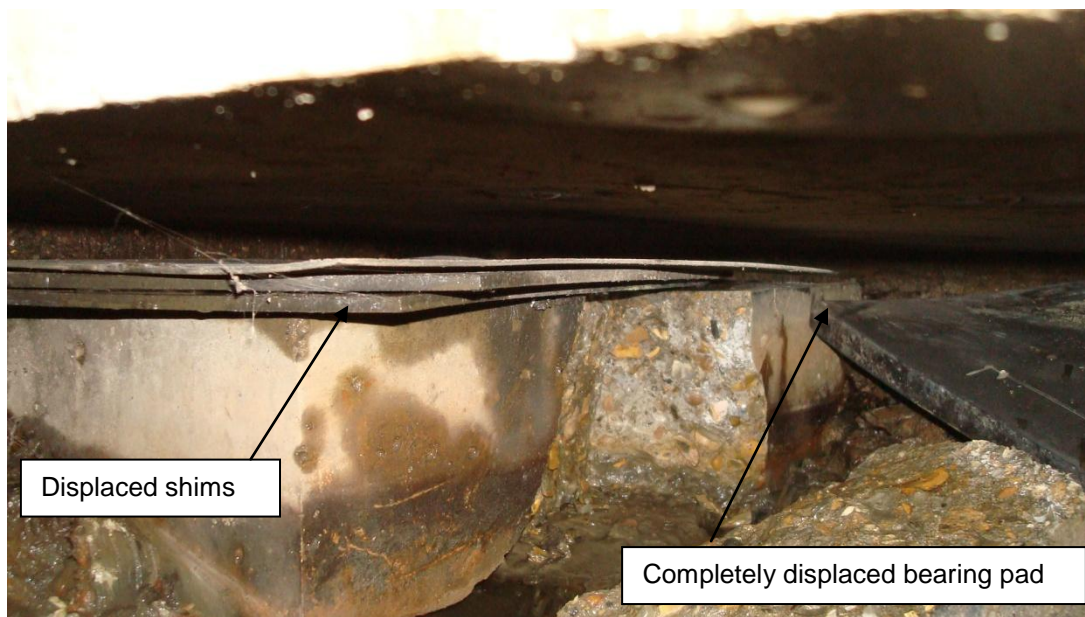
Figure 15. Photograph showing displaced shims and bearing pad.

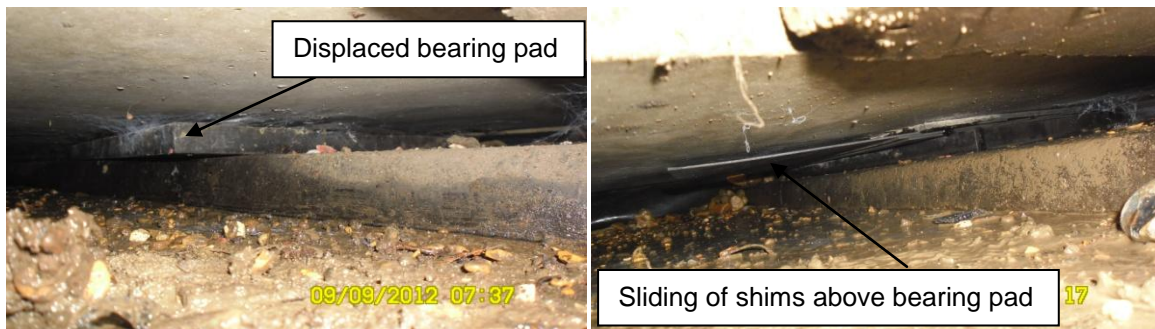
46. These defect notifications relate to the slippage of bearing pads and/or shims from their intended positions resulting in steps in the running surface and see-sawing of the guiderails.

Figure 16. Photograph of a displaced bearing pad (left) and slipped shims (right).

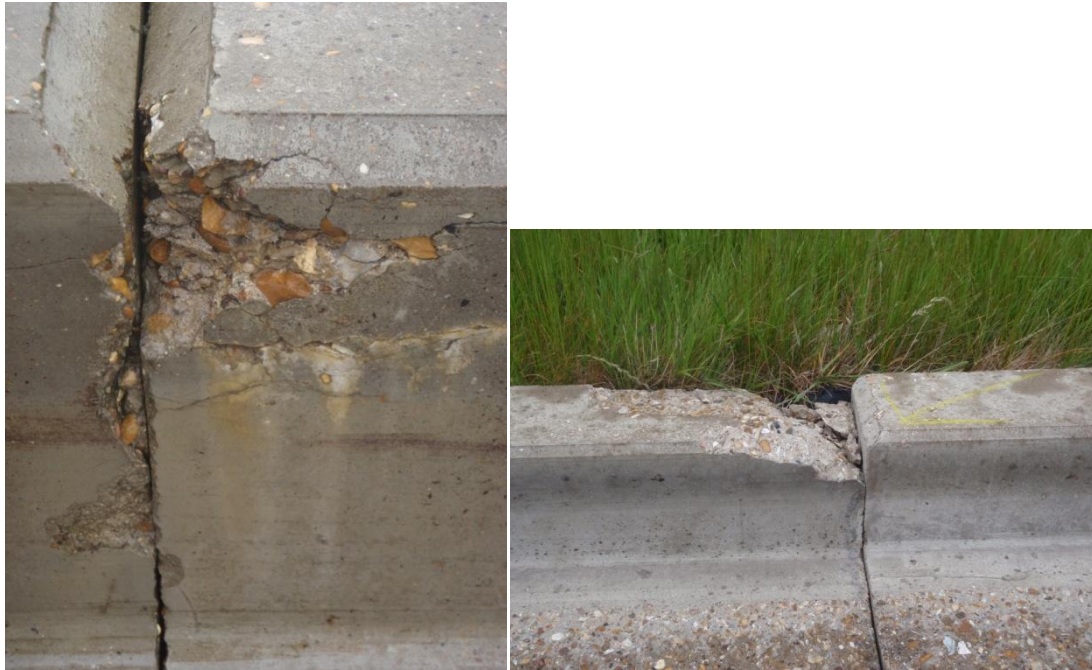
51. The consequence of this defect is that breaking off of a fragment of concrete (i.e. spalling) is likely to occur as shown. There are further examples of spalling in Appendix C.

Figure 18. Two examples of spalling.

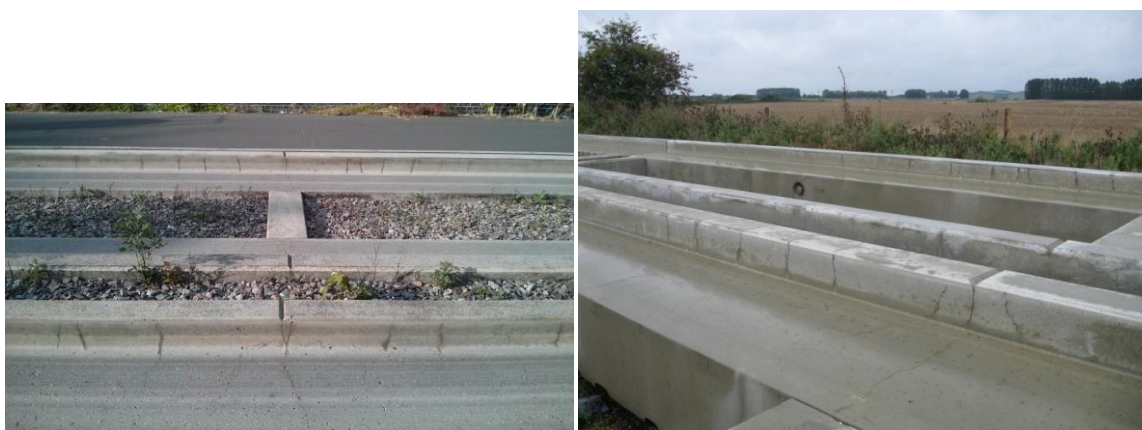
52. This defect notification relates to excessive cracking that has been observed in the guiderrails, principally over the central support of two-span beams. The contract requirement is for cracks to be no wider than 0.25mm, but cracks wider than this have, according to the Defect Notification, been recorded. We have additionally carried out calculations that show excessive cracking to be theoretically expected – so the theory has been borne out in practice.

Figure 19. Examples of excessive cracking in guiderrails

53. The excessive cracking will influence the durability of the guiderrails and potentially shorten their life if correction is not carried out.

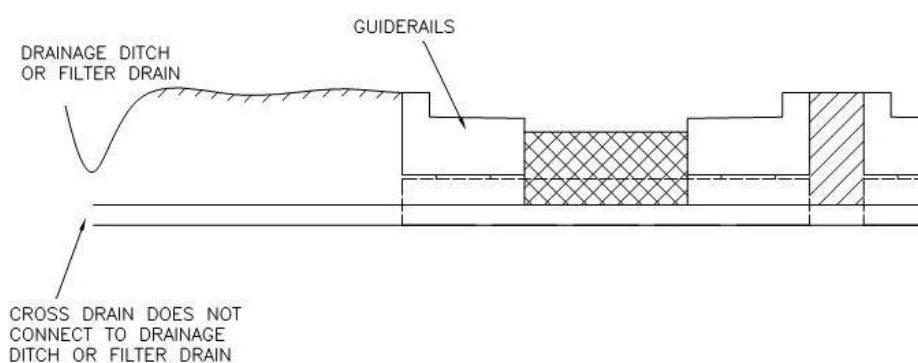
54. Defect 292 has been notified in respect of non-functioning infiltration drains over a length of guideway (between chainage 17+530 and 17+710) in the vicinity of Bridge Road Bridge, Histon. Standing water occurs around the guide tracks. Investigations arranged by the PM have shown that the cross drains do not connect with the longitudinal side drains which, in part, act as infiltration trenches. These trenches are either insufficiently deep for the connection of the cross drains or the cross drains do not extend sufficiently to connect with the side drains. The construction does not comply with the accepted design.

Figure 20. Cross section showing non-connection of drainage

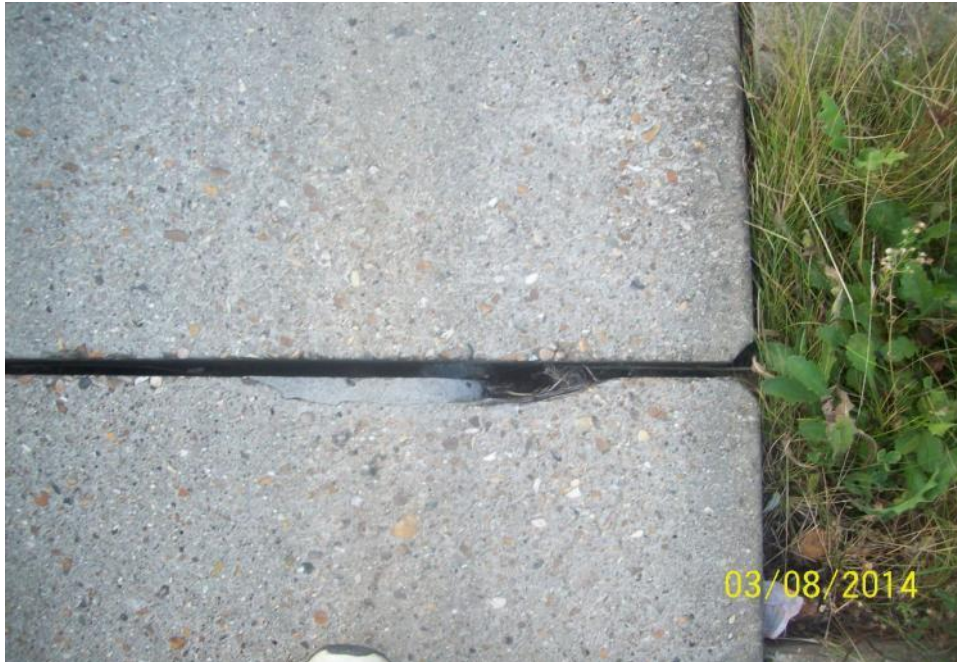
CH19261 C/B – Previous concrete repair has failed (nearside)

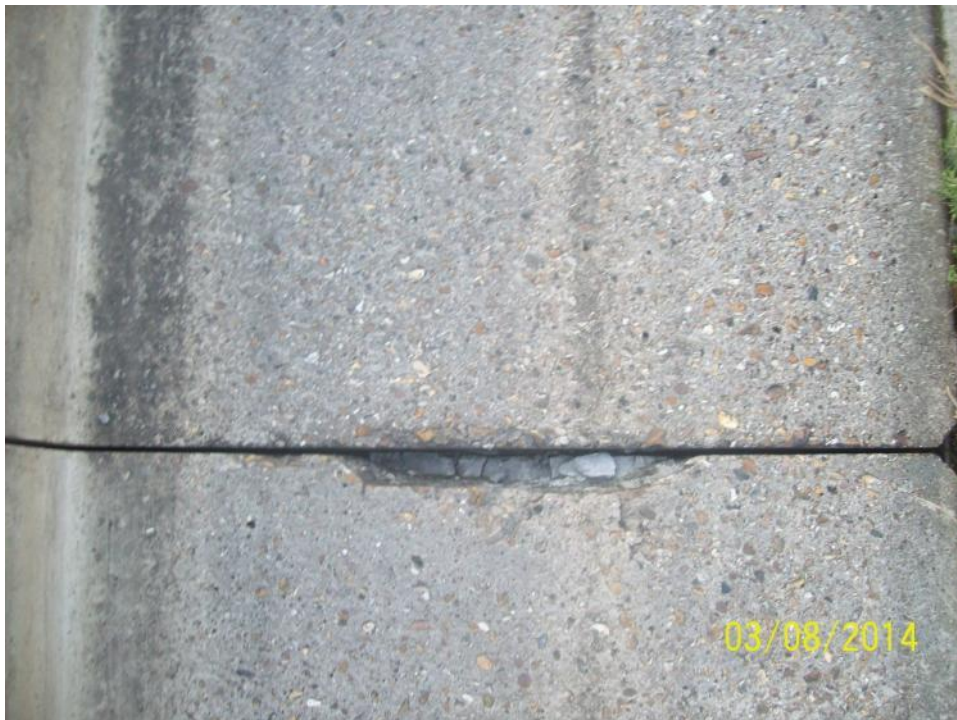
CH18876 C/B – Previous concrete repair has failed (nearside)

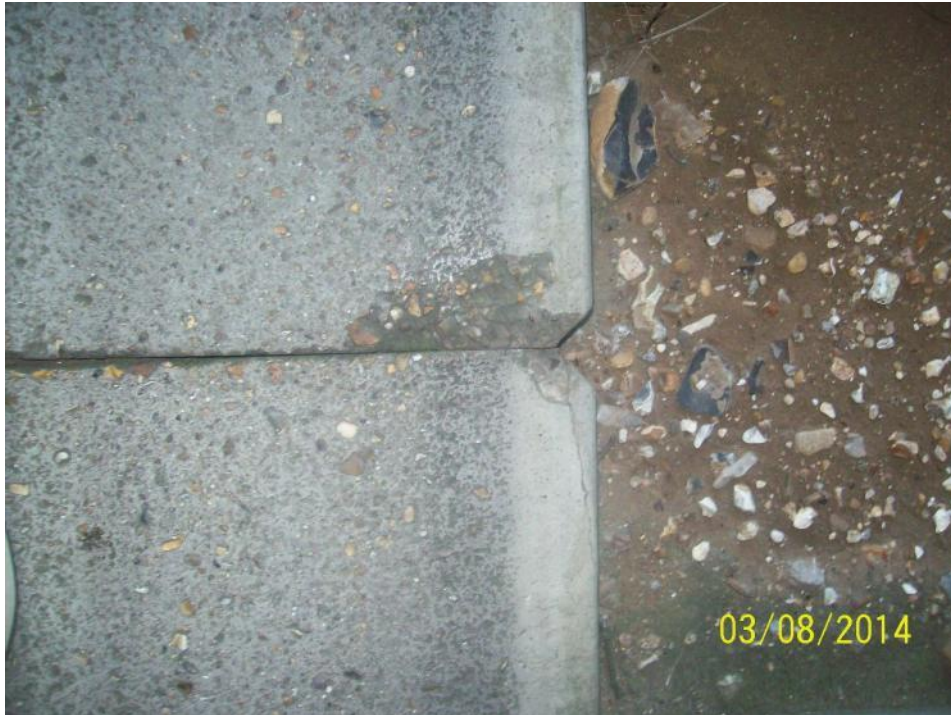
CH18786 C/B – Spalling of concrete on running surface (offside)

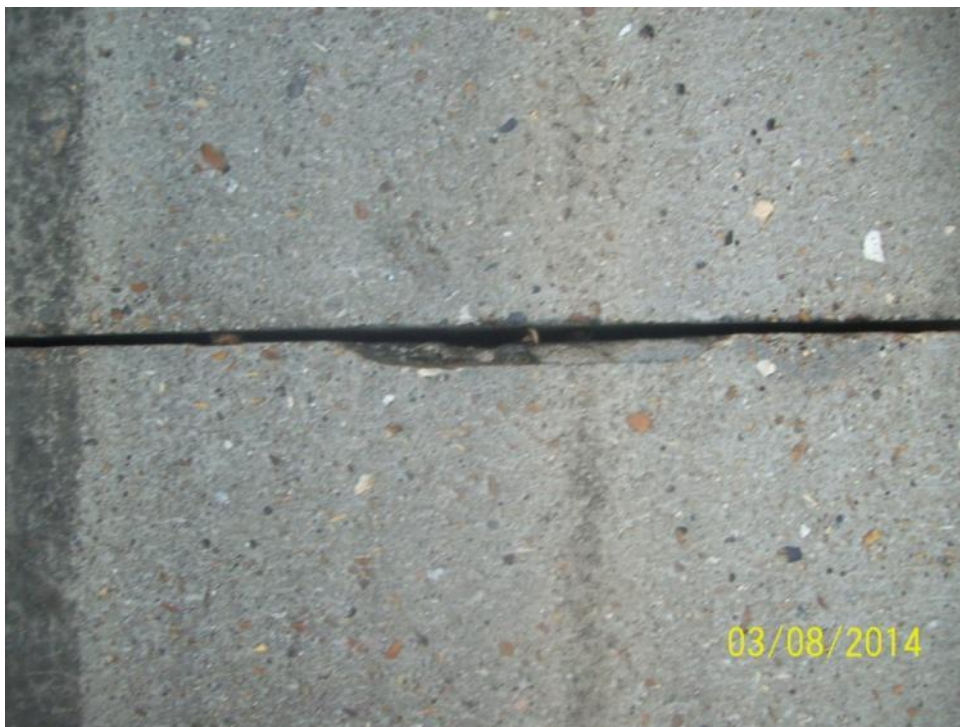
CH18756 C/B – Previous concrete repair has failed (nearside)

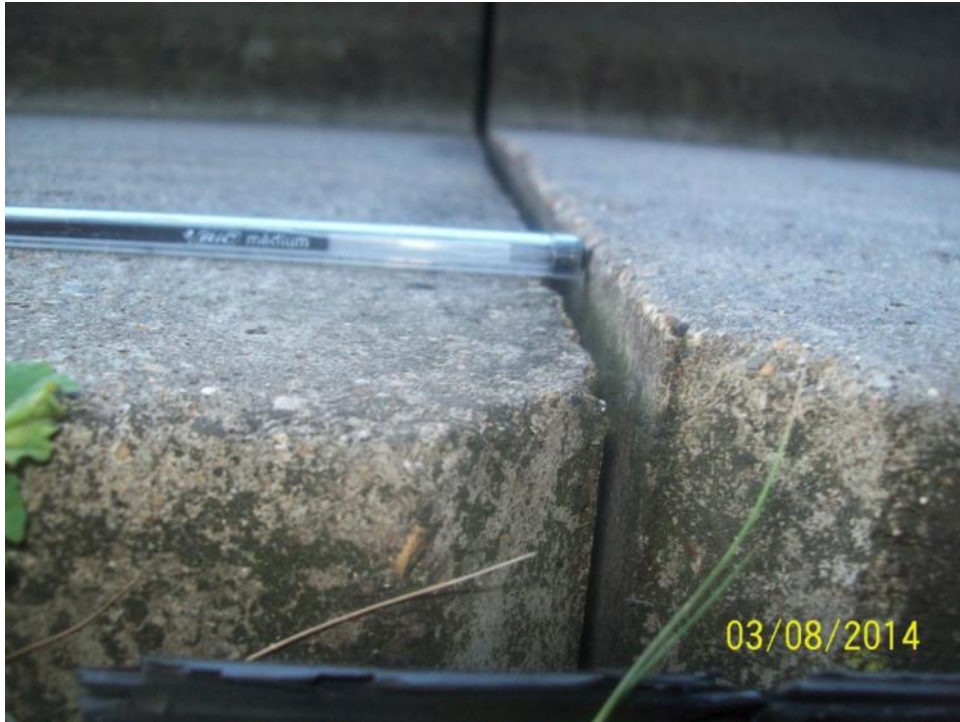
CH18261 S/I B – beam dropped (nearside)

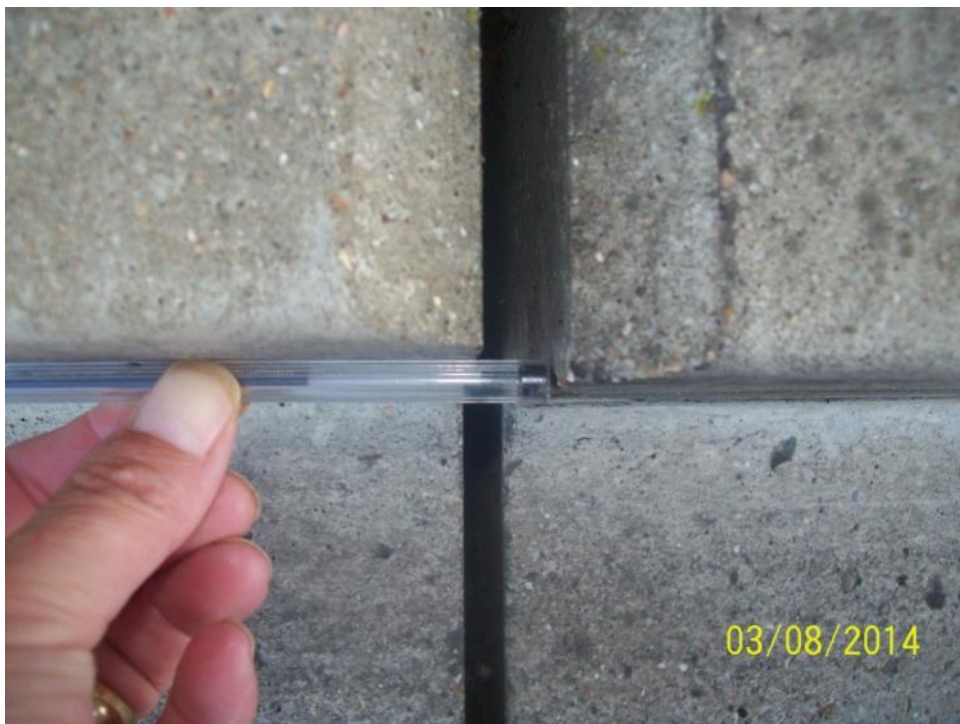
CH17856 C/B – Laterally displaced (offside)

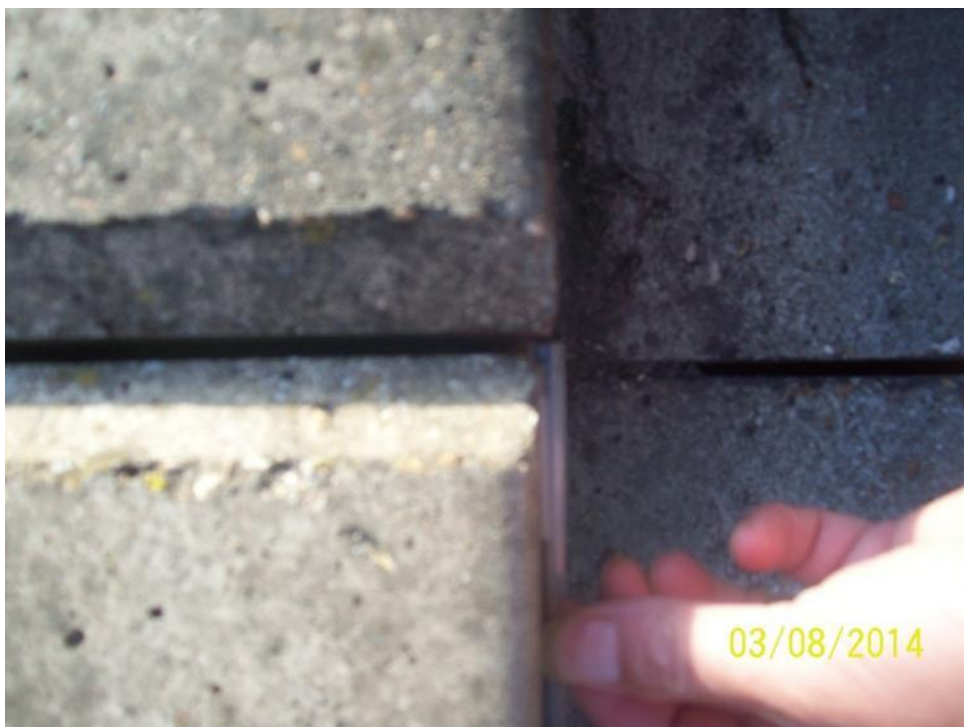
CH17706 C/B – Laterally displaced (nearside)

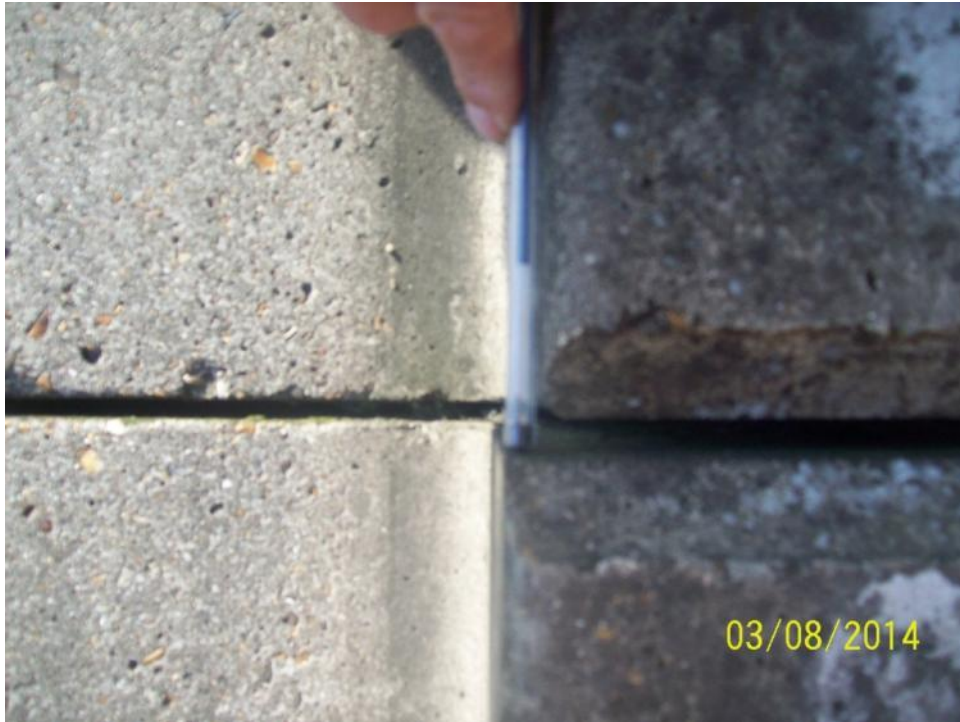
CH17691 S/I B – Laterally displaced (offside)

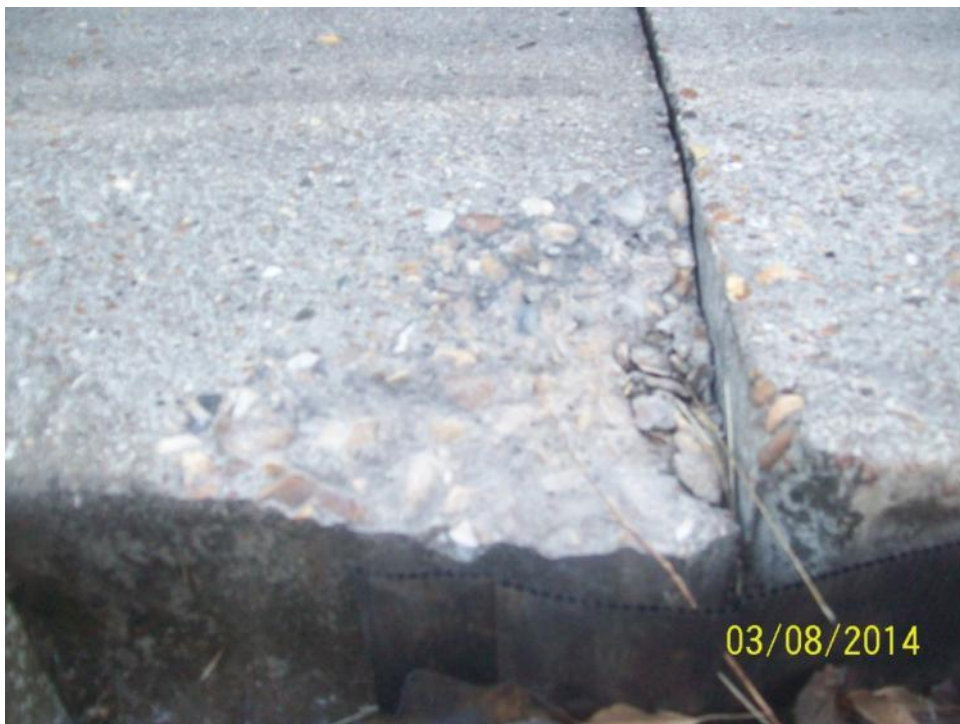
CH17646 C/B – spalling of concrete on running beam (nearside)

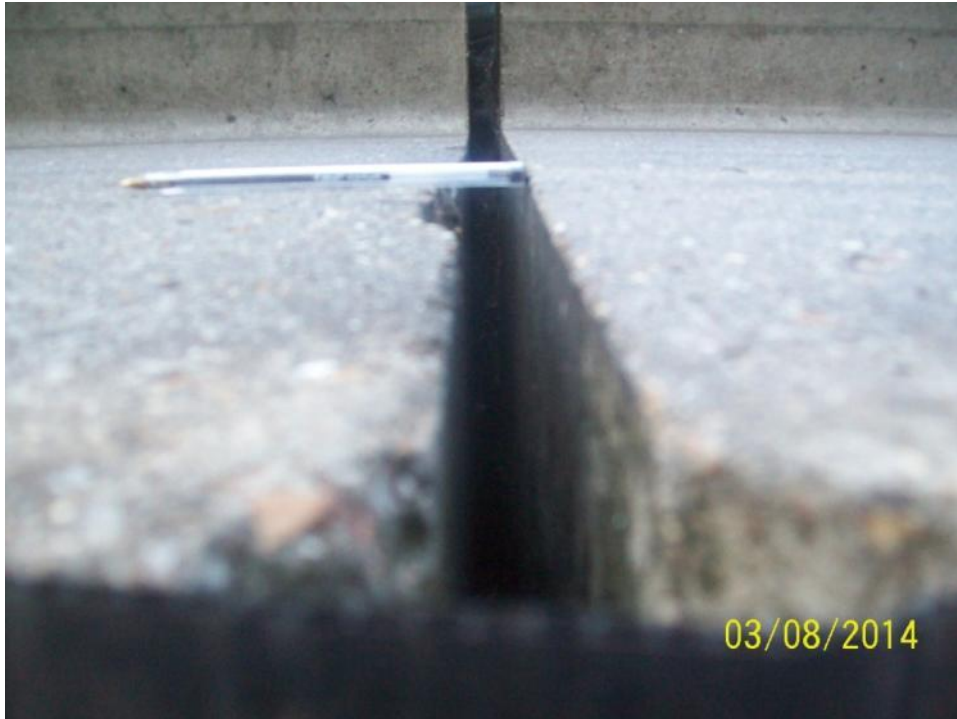
CH17631 C/B – beam dropped (offside)

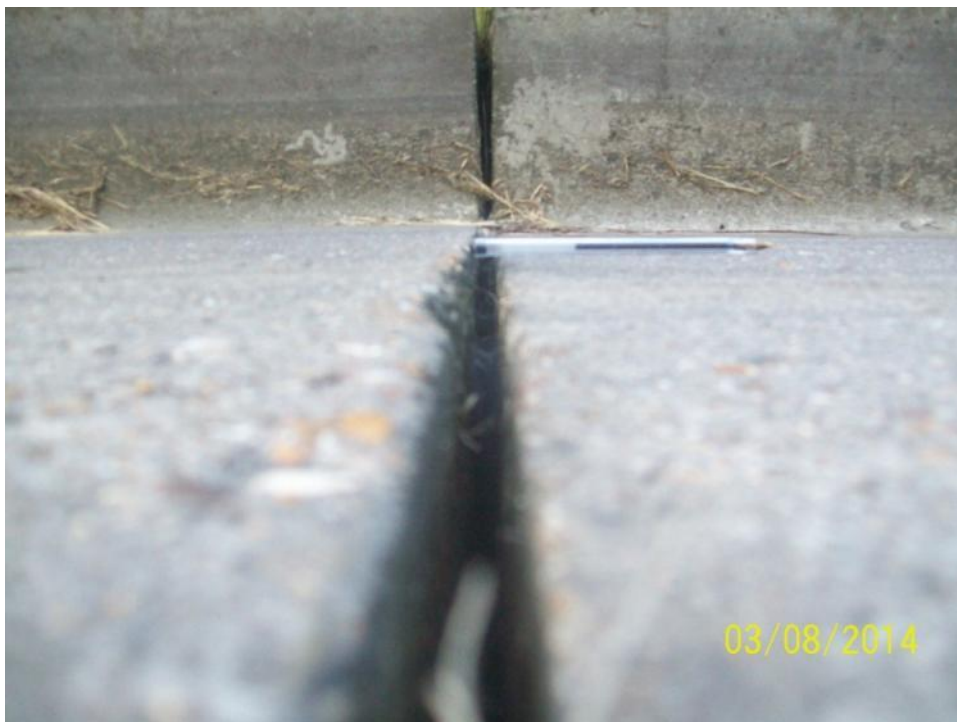
CH17631 SI/B – beam dropped (nearside)

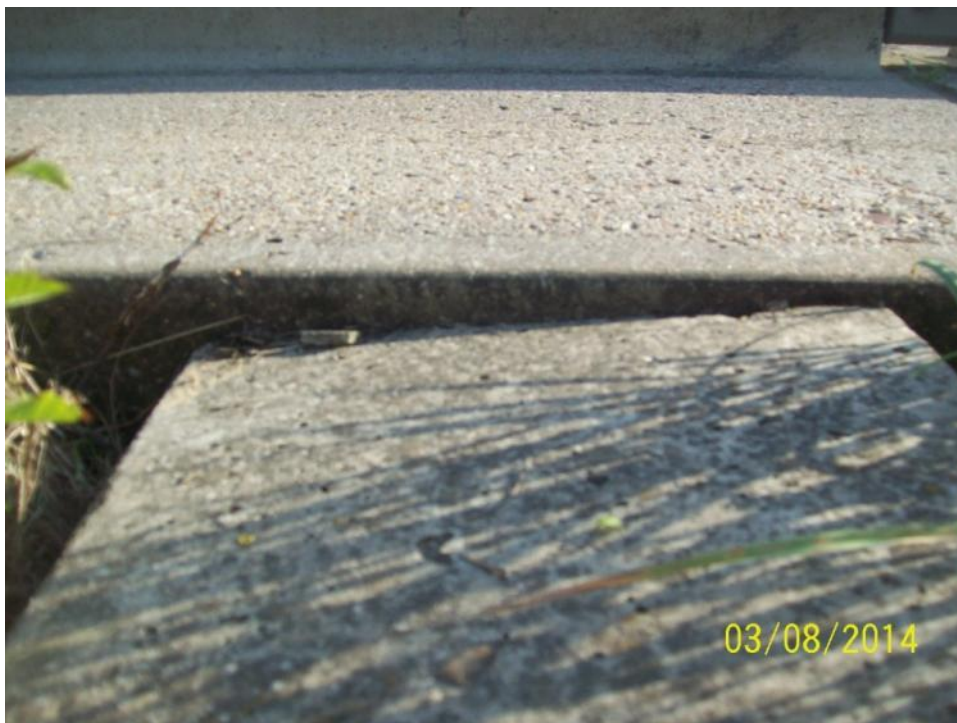
Beam 1 - Twisting spacer beam

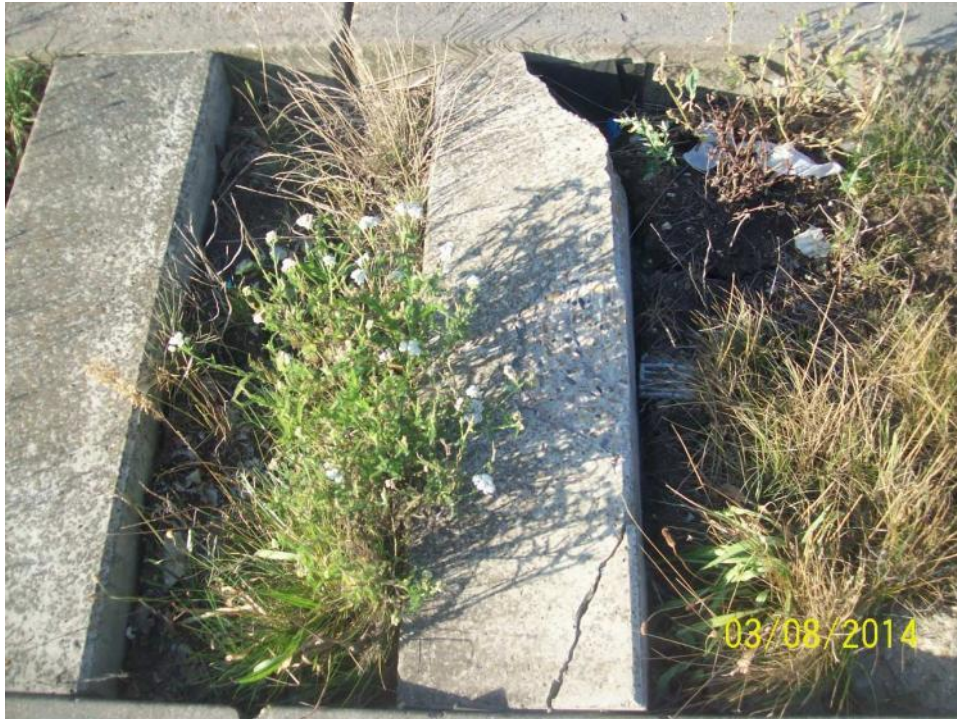
Beam 9 – Broken spacer beam

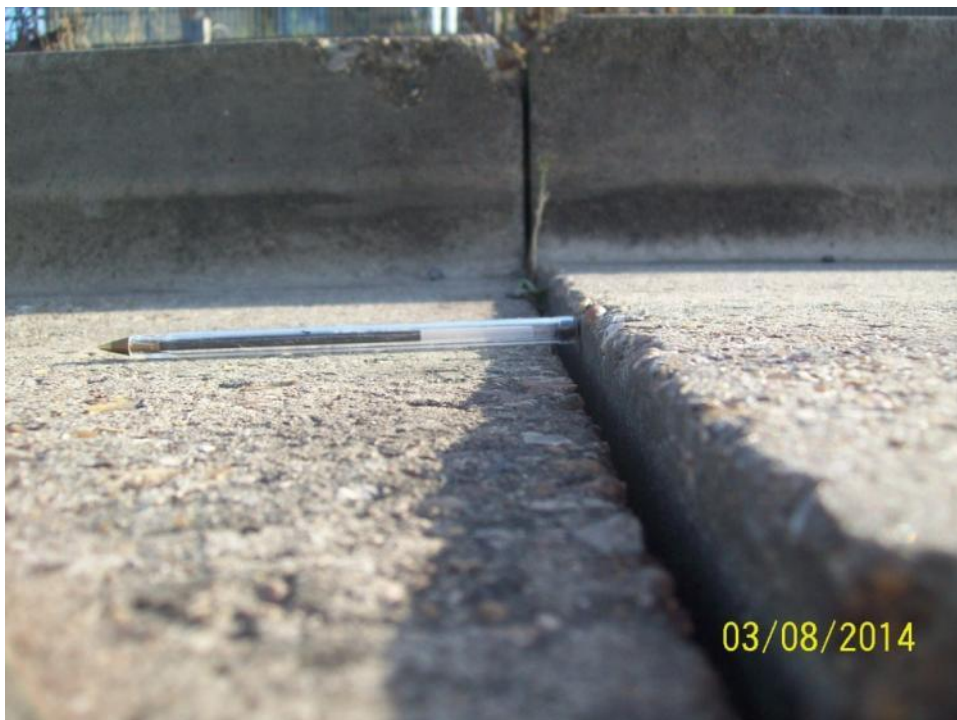
Beam 10 – Dropped beam

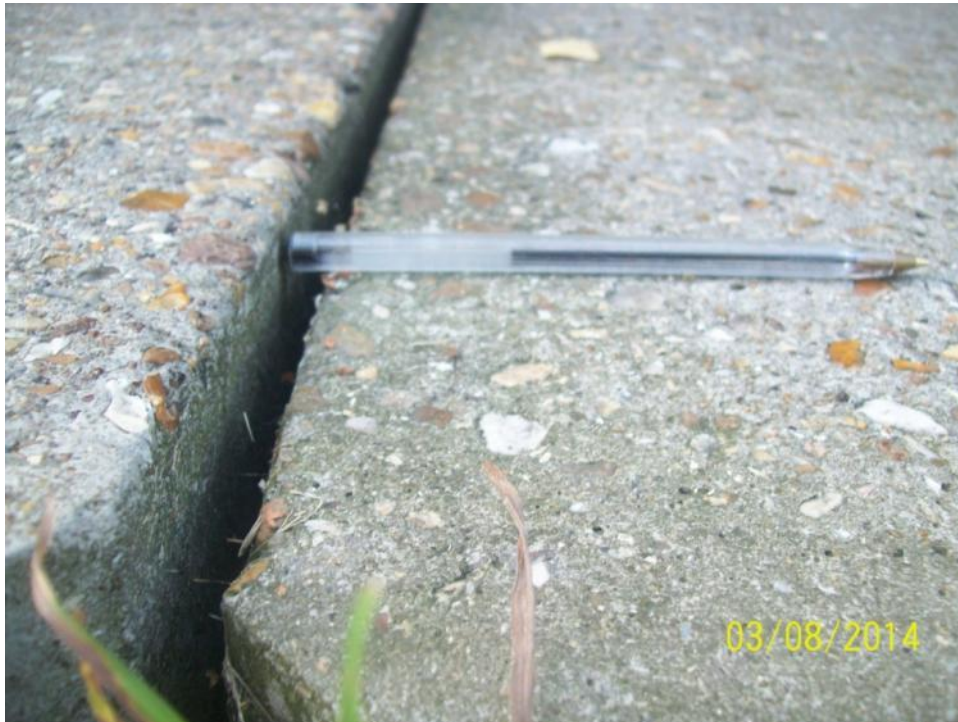
6th beam from Shelford Rd Bridge towards P&R – dropped beam

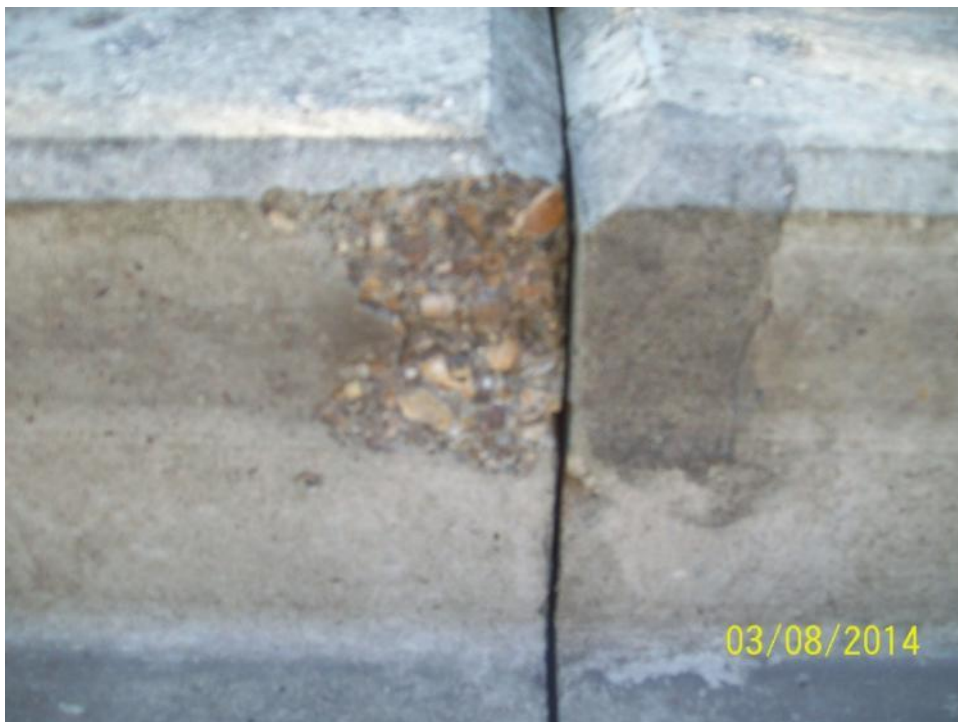
CH43102 – spalling of concrete on upstand

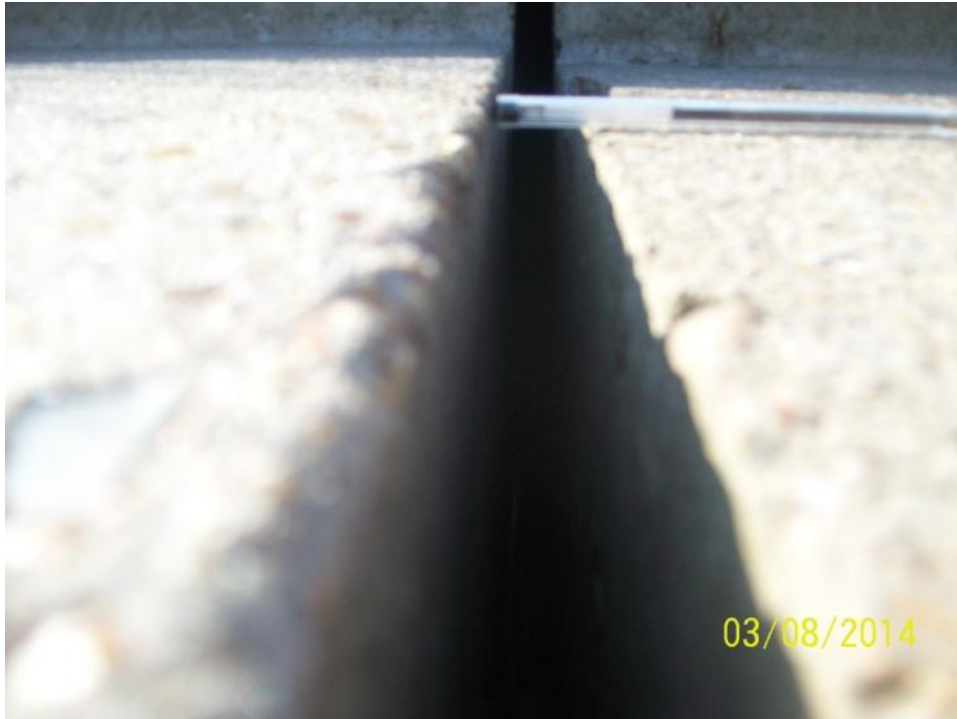
CH43087 – dropped beam

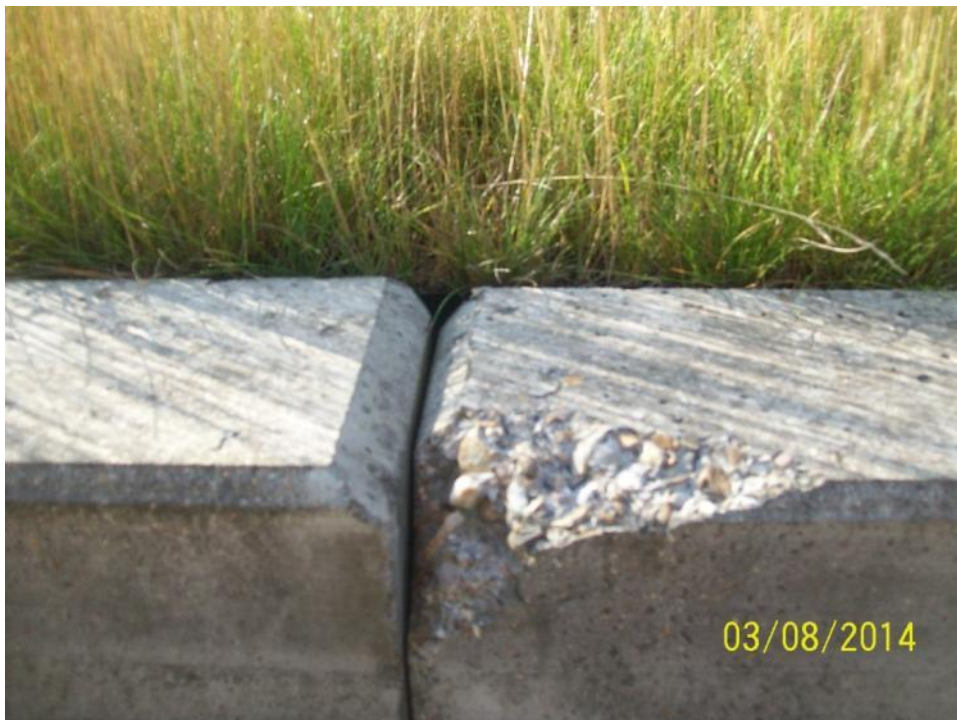
CH43072 - spalling of concrete on upstand

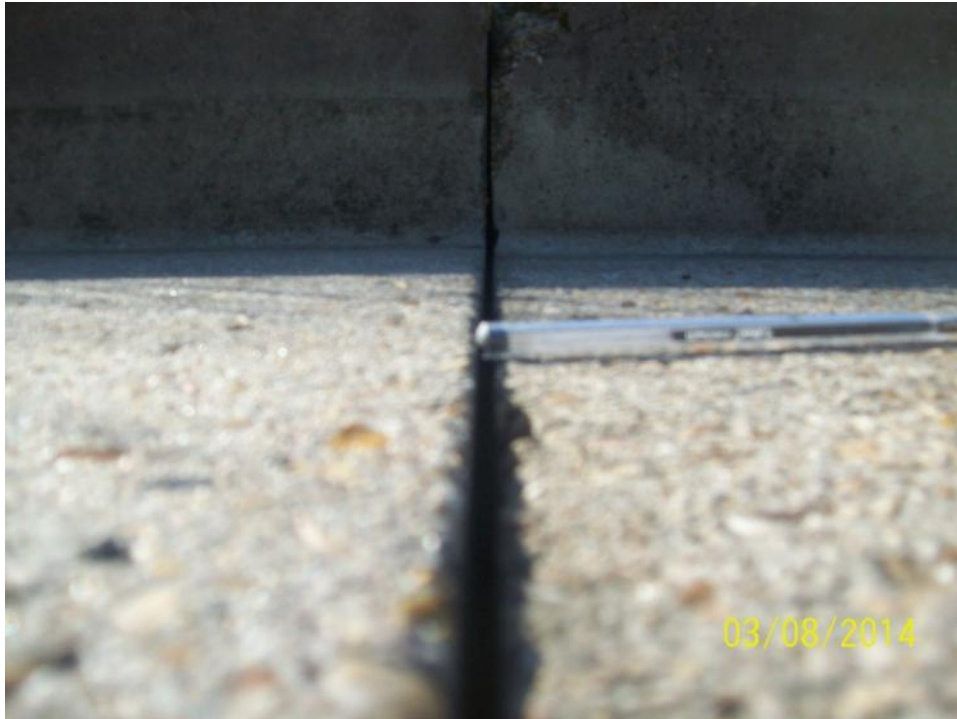
CH43072 - dropped beam

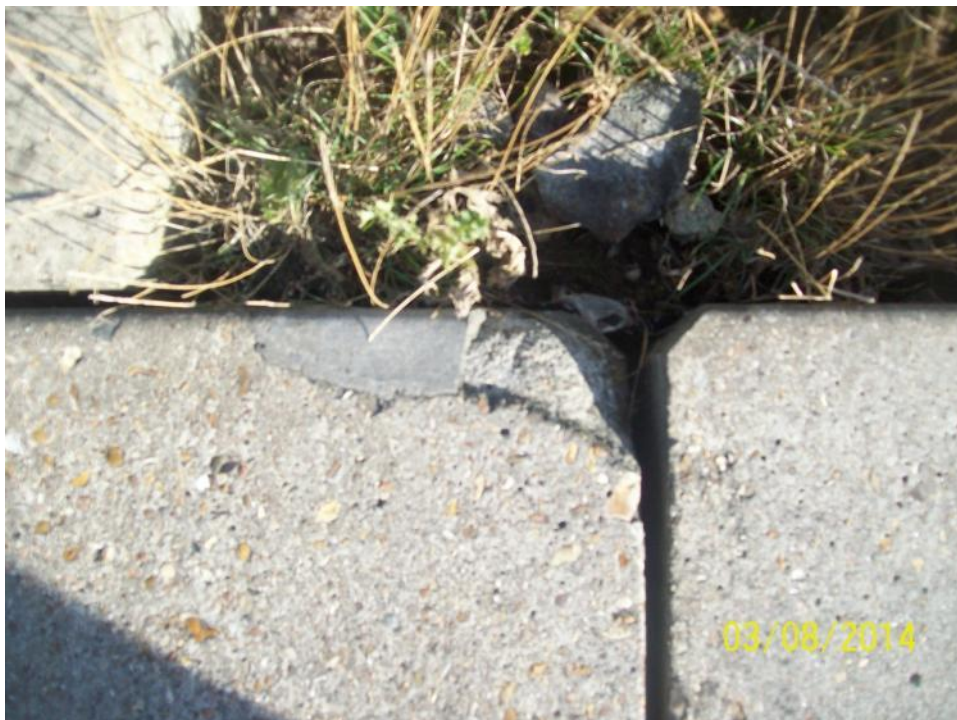
CH42997 – Previous concrete repair has failed

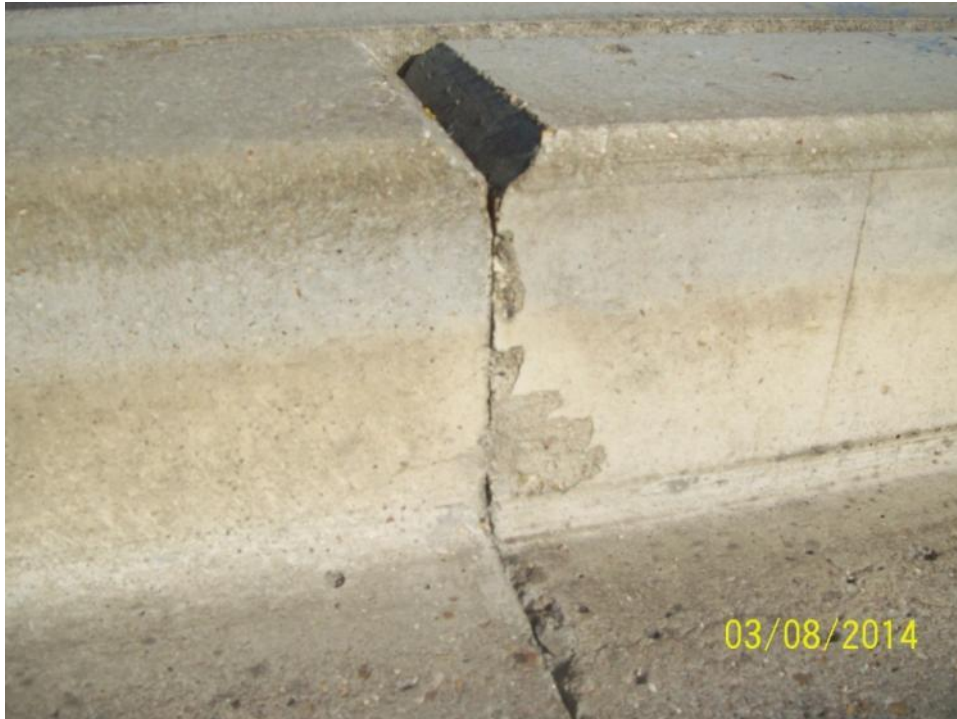
CH42274 S/B – spalling of concrete on upstand (nearside)

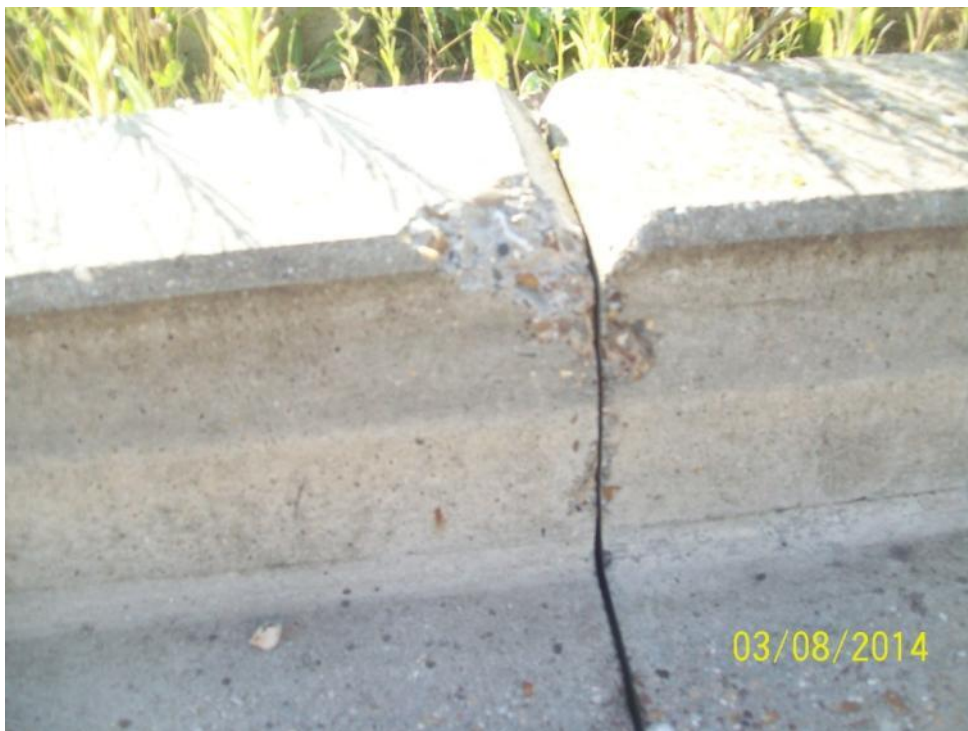
CH42259 S/B – spalling of concrete on upstand (offside)
