Cambridgeshire Guided Busway

Report on Guideway Defects and Corrective Measures

Cambridgeshire Guided Busway
Cambridgeshire County Council v BAM Nuttall Ltd.

| Date | : | 11 September 2014 |

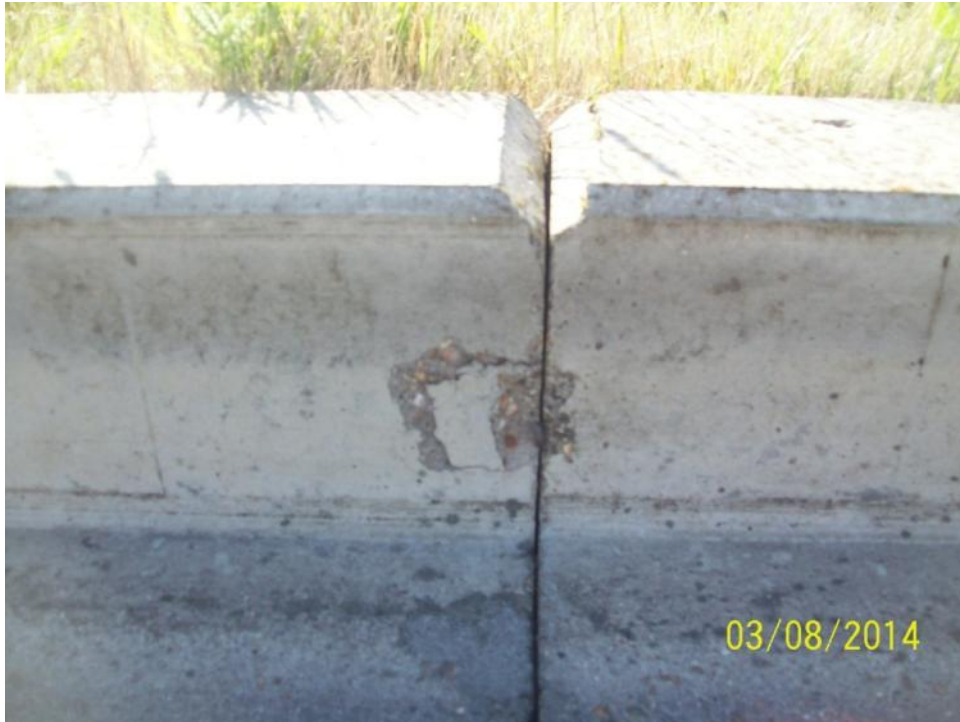
CH42259 P&R/B – spalling of concrete on upstand (nearside)

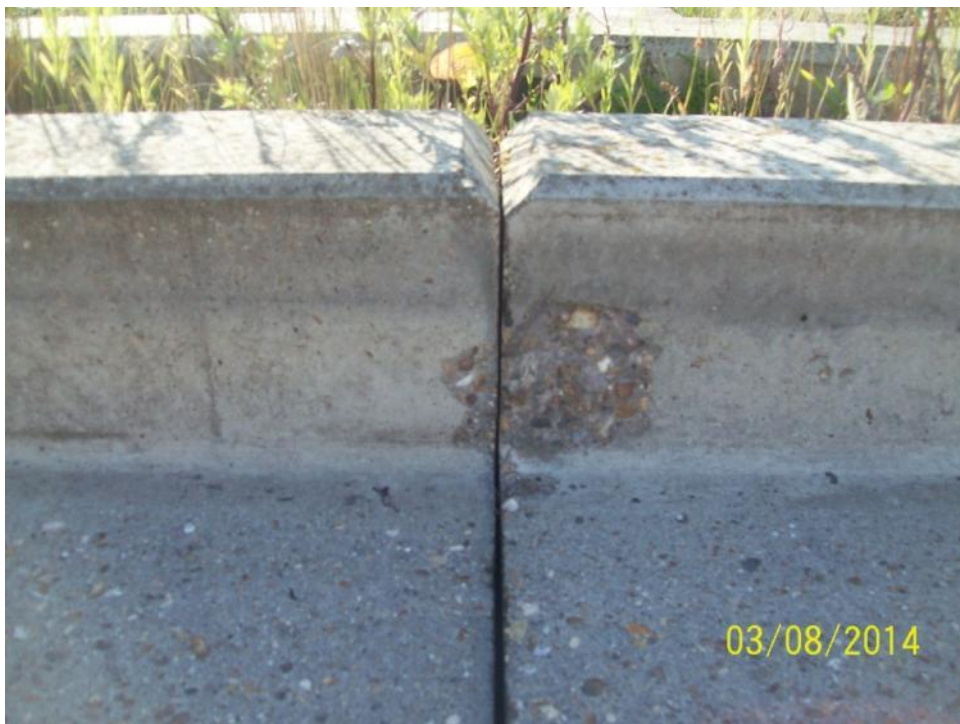
CH42229 S/B – spalling of concrete on upstand (offside)

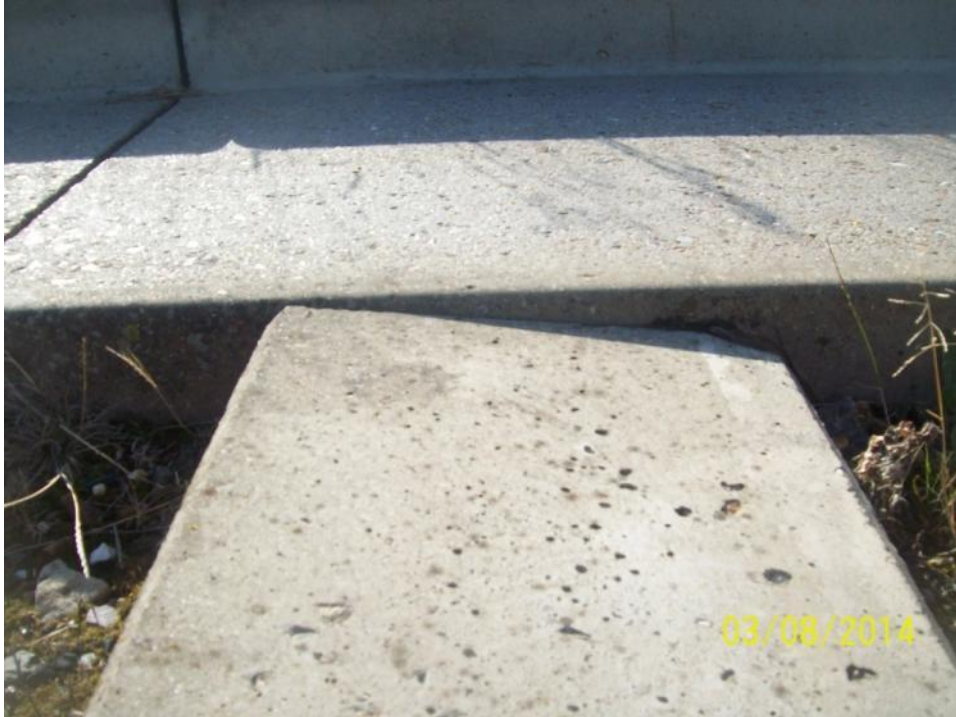
CH42199 S/B – Twisting spacer beam

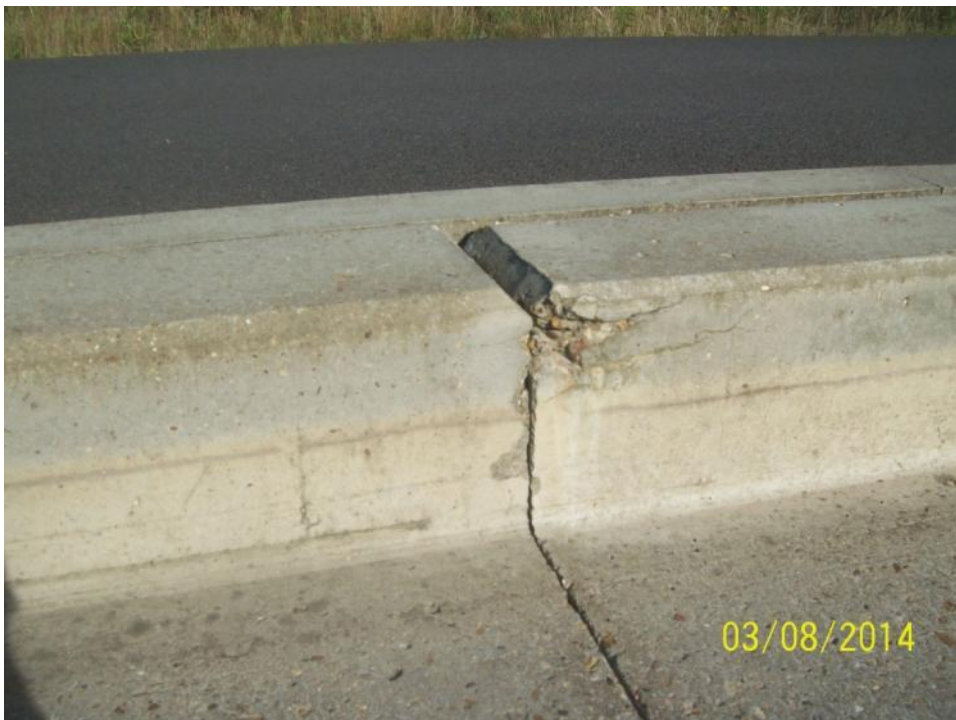
CH42124 S/B – spalling of concrete on upstand (nearside)

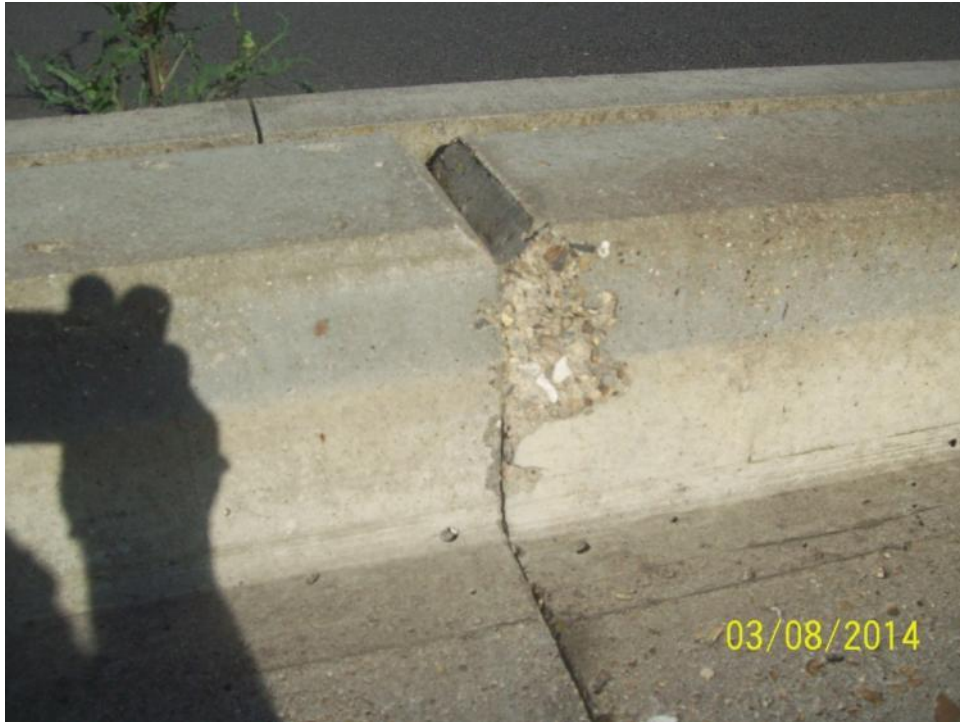
CH41944 S/B – spalling of concrete on upstand (nearside)

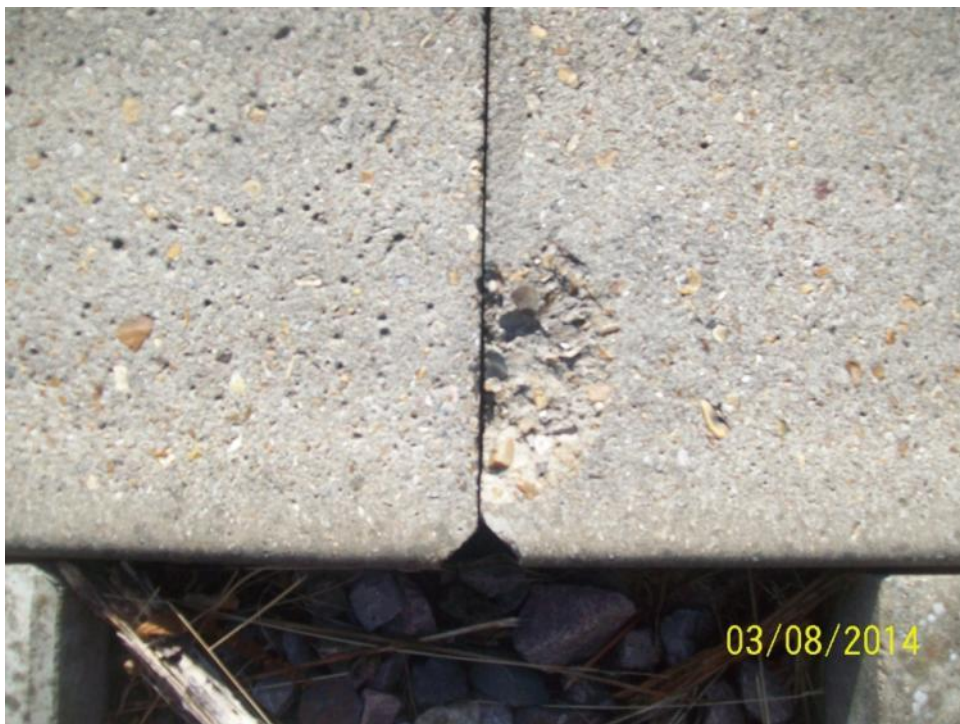
CH41048 P&R/B – spalling of concrete on running beam (nearside)

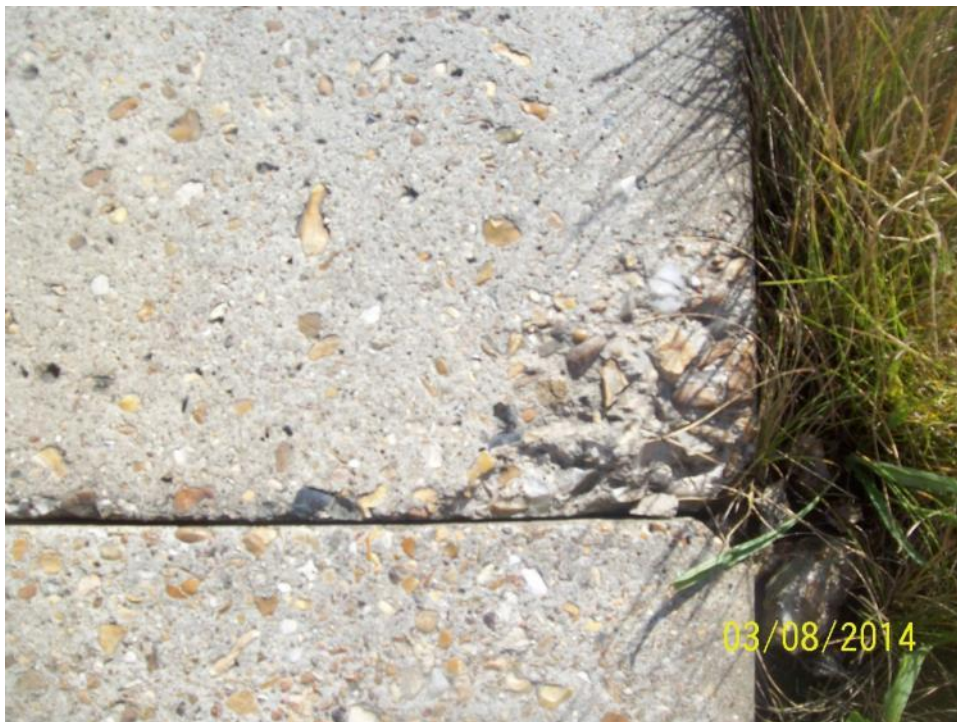
CH60262 H/B - spalling of concrete on running beam (nearside)

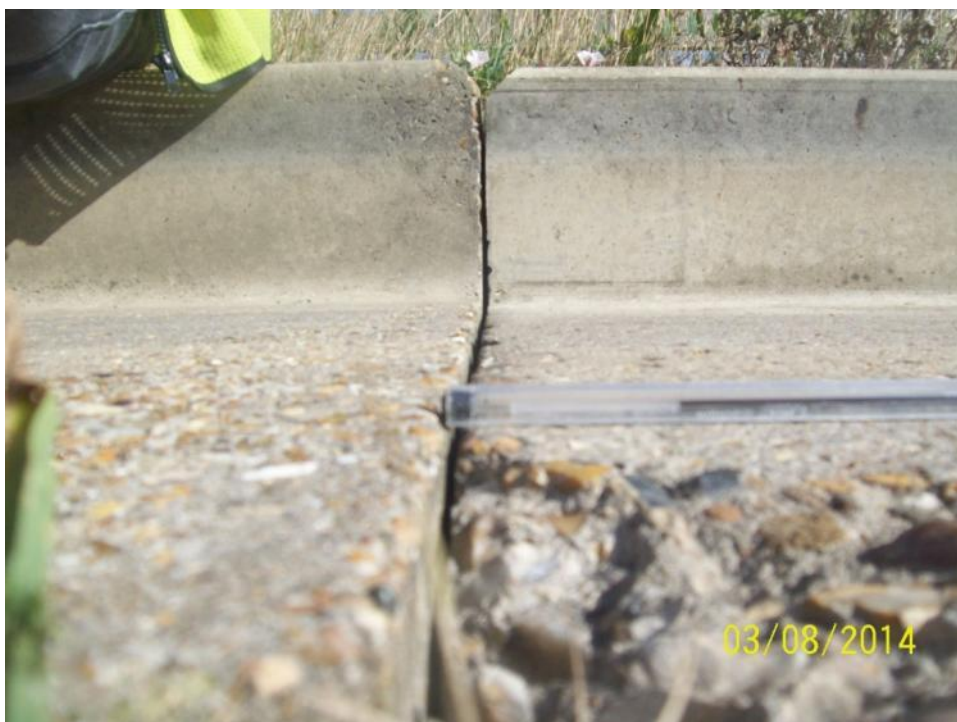
CH60262 H/B – dropped beam (nearside)

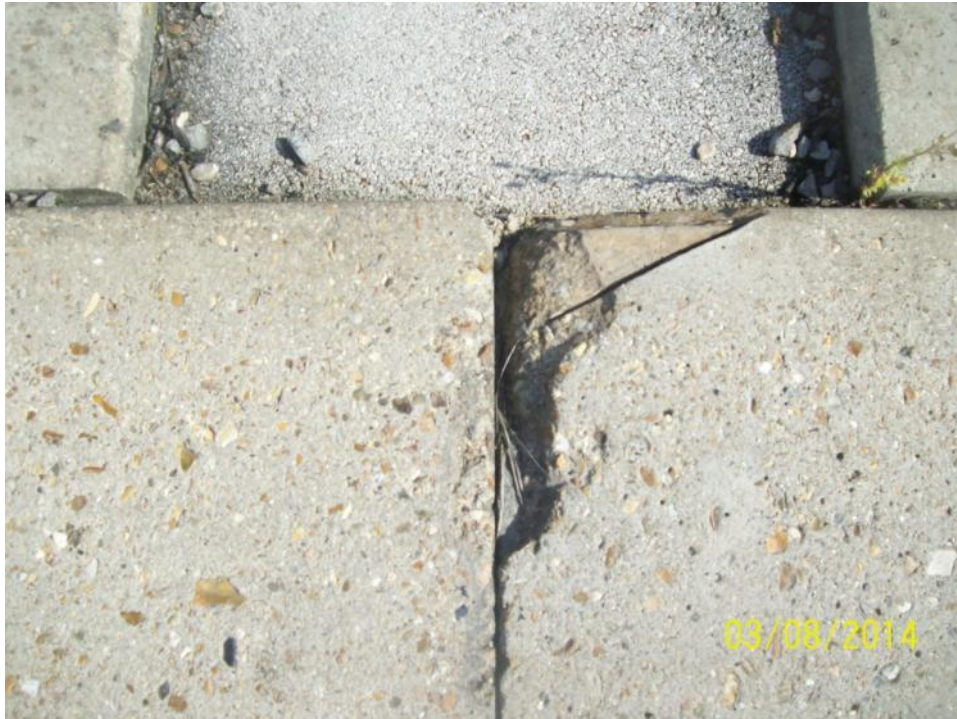
CH60387 H/B – spalling of concrete on running beam (offside)

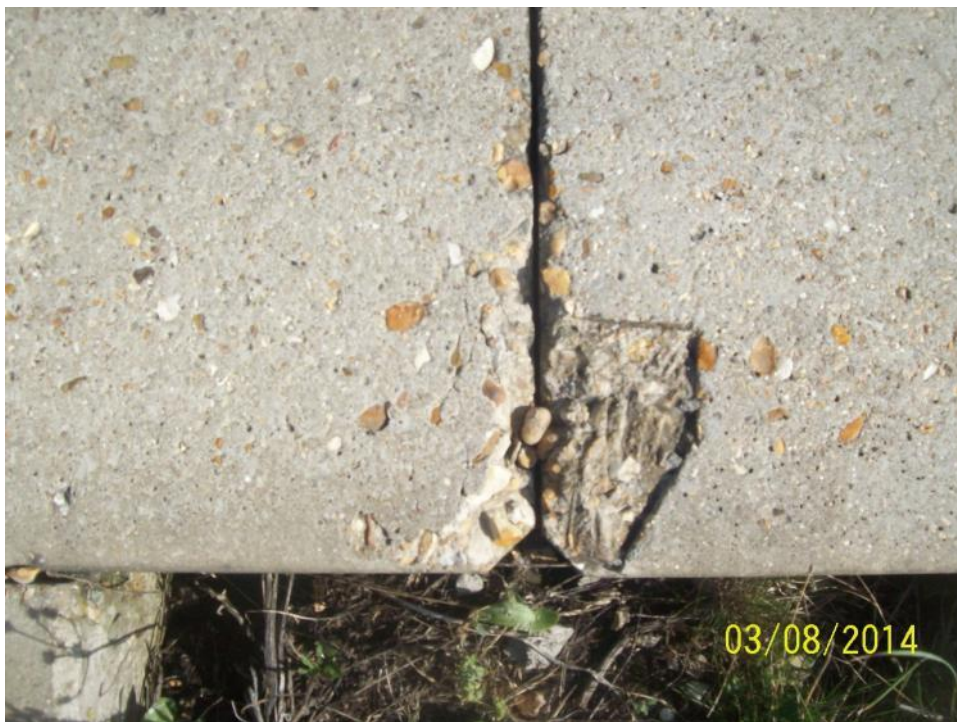
CH60417 H/B - spalling of concrete on running beam (nearside)

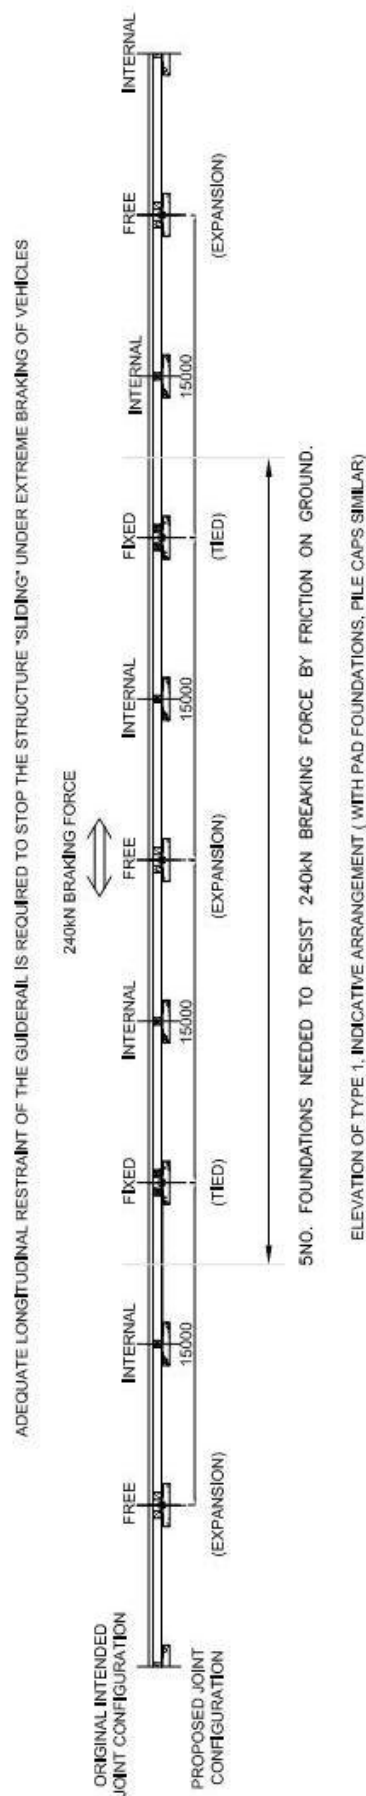
LACK OF LONGITUDINAL RESTRAINT PROVIDED AT "FIXED" SUPPORT JOINTS BY THE FOUNDATIONS/ SUBSTRUCTURE, A SINGLE "FIXED" SUPPORT IS INADEQUATE TO RESTRAIN THE MAXIMUM REQUIRED LONGITUDINAL (BRAKING) FORCES. THESE FORCES NEED TO BE DISTRIBUTED AND SPREAD OVER NOMINALLY FIVE ADJACENT FOUNDATIONS SUPPORTS. REPLACEMENT BEARINGS AND SHIMS TO BE PROVIDED AT ALL SUPPORTS TO FACILITATE THE TRANSFER OF THE LONGITUDINAL, AS WELL AS THE TRAVERSE, FORCES FROM THE GUIDERAILS DOWN INTO THE FOUNDATIONS. ALSO REFER TO FIGURES 2 AND 3.
