# TECHNICAL NOTE 1

| <b>SUBJECT:</b> | A14 NMU Routes BN18 and BN22 Safety Reviews | | |
| <b>PROJECT:</b> | A14 NMU Bridges | <b>AUTHOR:</b> | [REDACTED] |

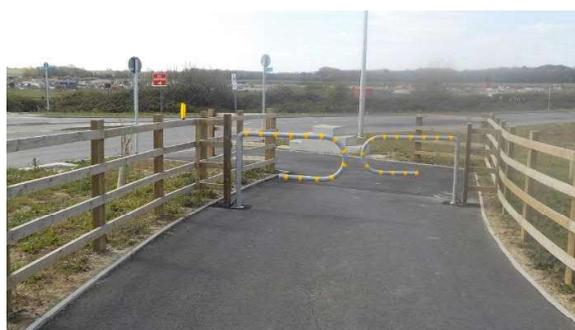
Figure 7- View looking towards uncontrolled crossing

Cyclists descending the ramp at Swavesey south have good visibility to approaching cyclists/ pedestrians and will be slowing down to the crossing due to the 90-degree bend. The risk of collision with other pedestrians/cyclists and vehicles at this location is low.

It is recommended that the chicane barrier arrangement at this location is removed. It is also recommended that a form of vehicle access control is provided to prevent unauthorised vehicles from accessing the NMU route.

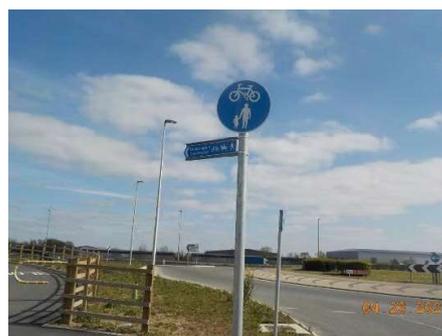
Figure 8 – Signage on Boxworth Road.

On the Swavesey south route, the gradients are more gentle and the route leads to an uncontrolled crossing via a 90-degree bend. At the tie in to Boxworth Road, there are wayfinding signs for pedestrians, cyclists and horse riders, but the shared signs leading to the NMU bridge is only signed for pedestrians and cyclists. It is therefore unclear whether horse riders are expected to use the bridge.

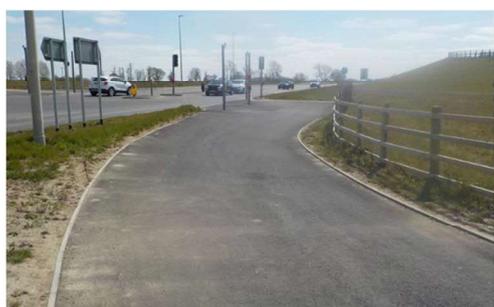
Figure 10 – View looking at controlled crossing

The slope on the northern approach ramp is gentle and unlikely to encourage higher cyclist speeds. The visibility to other approaching cyclists/ pedestrians is generally good. There is a wide verge serving as a buffer zone between the NMU route and the carriageway. The risk of speed and collisions with other pedestrians/cyclists or vehicles at this location is low.

- The chicane barrier arrangement is removed.
- A form of vehicle access control is provided to prevent unauthorised vehicles from accessing the NMU route.
- The hotel sign in the northern verge of The Willows is set further back and overgrown vegetation cut back to improve visibility to vehicles exiting The Cambridge Bar Hotel.
- Cycle logos are installed on the outside of the bend on the downward grade where visibility is poor to encourage cyclists to keep to the edge of the NMU route thereby minimising conflict with other users.

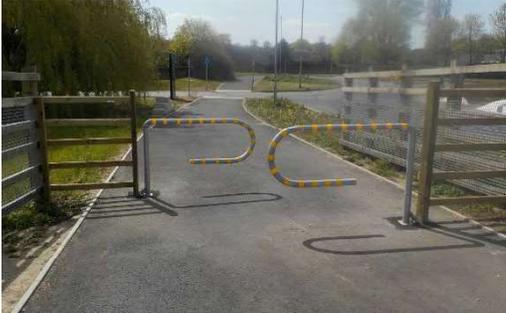
Figure 11 – View from route looking towards The Willows.

Visibility as the route approaches the Willows is generally good although it is partially obstructed by a large sign and overgrown vegetation in the northern verge of The Willows.

At the location of the southern barrier, cyclists will generally have good forward visibility to traffic however visibility to vehicles exiting The Willows is obstructed by the hotel sign and overgrown vegetation. Risk of collision with vehicles or other cyclists/pedestrians is low.
