# CONDITION REPORT & PLANNED COSTS

The Bargroves,  
Cromwell Road, St Neots PE19 2EY  
Prepared for  
Cambridgeshire County Council

November 2018

A condition survey and five-year budget costing for a single-storey, brick-constructed property in Cambridgeshire accommodating a youth centre and offices.

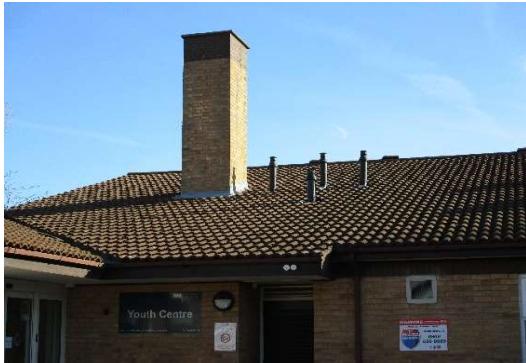
1. View of roof

1.01	Pitched roof	Concrete tiled truss roof with timber rooflights	Clean roof of moss and lichens and prepare and redecoration of roof lights in the medium term.	C					£5,000.00

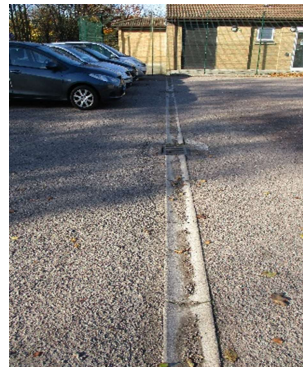
2. Broken dish channel, carpark

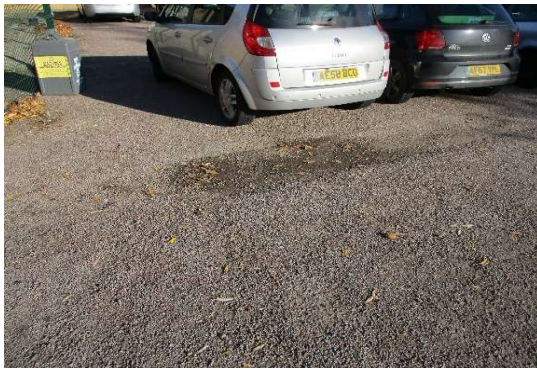
Internal Finishes	Minor redecoration will be required longer term and replacement floor coverings. See General Photos (s. 5, nos. 6-10).		2yrs
External Areas	Macadam/gravel hardstandings to South of building breaking up and disrepair and will require re-laying or patch repair during the timeframe. New concrete drainage channel required in the short term. See General Photos (s. 5, nos. 2 & 3).		Original
Mechanical Installations	Gas-fired boiler cylinder appears renewed within last few years (no certificate shown) and so no works will be anticipated.		Under 2yrs
	Radiator controls appear in good order. Unclear whether zonal thermostat exists but building in constant use and is small in size so likely a limited benefit.		30 yr

3. Breaking up hardstanding

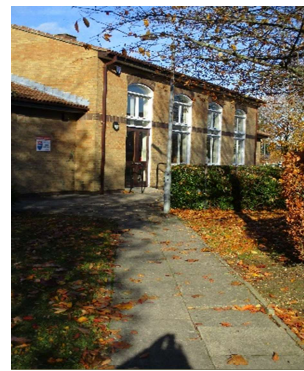
4. Elevation (east) with timber windows and doors and uneven concrete slabs

1.03	Timber window subframes/ East elevation	Sliding sash factory coated metal windows with painted timber sub-frames and spandrels.	External timber will require redecoration on a cyclical basis to maintain. Prepare and redecorate timber elements described. Includes access.	C			£1,500.00

1.04	Doors to elevations	Treated or painted timber doors within timber frames.	Prepare and redecorate timber elements described.	B			£10,000.00				
1.05	Brick elevations with concrete cills	Cavity constructed fair-faced brickwork and reinforced concrete window cills	In good condition with light soiling and 1no cracked cill. Allow to replace cill in short-term, followed by regular cleaning of elevations on cyclical basis.	B	£750.00			£500.00

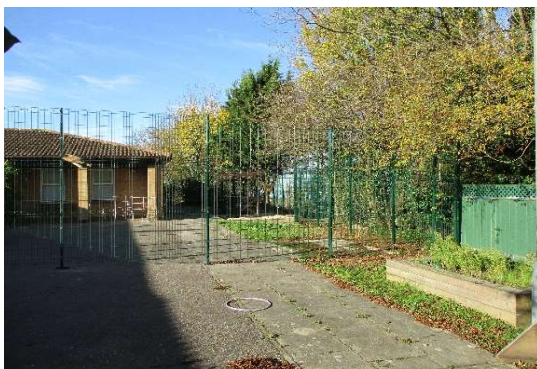
5. Rear hardstanding

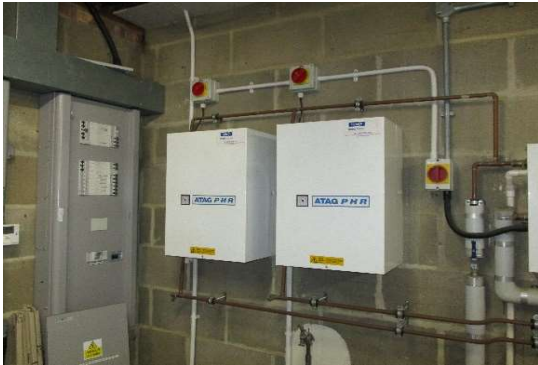
6. New oil-fired boilers, east end

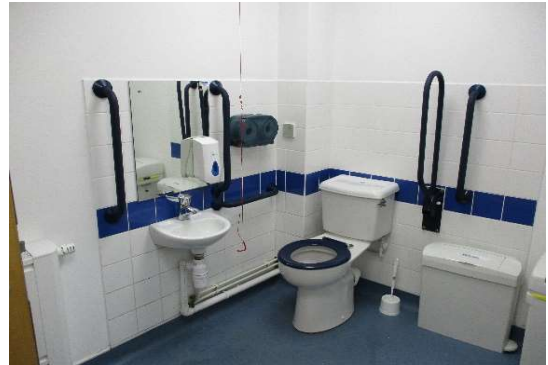
7. Accessible WC with modern fittings

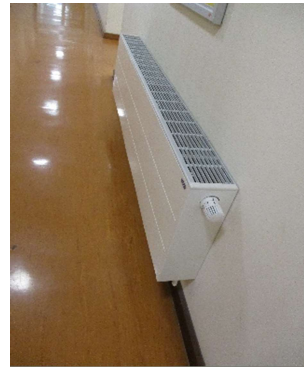
9. View of corridor and radiator

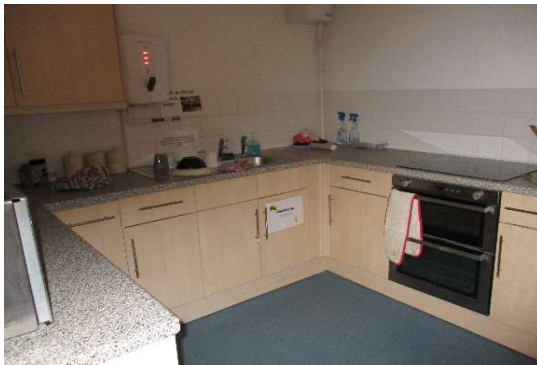
10. Kitchen
