Cambridgeshire County Council

Soil Affected Roads – Review of Sites and Treatment Options Report.

January 2024

JOB NUMBER: 5020600			DOC REF: 5020600/MIN/HPV/RP/300/320			
Revision	Purpose Description	Originated	Checked	Reviewed	Authorised	Date
P01	Draft	OJB	NT	PN		1/24
P02	Original Issue	AJ/OJB	NT/AB	PN	OJB	1/24

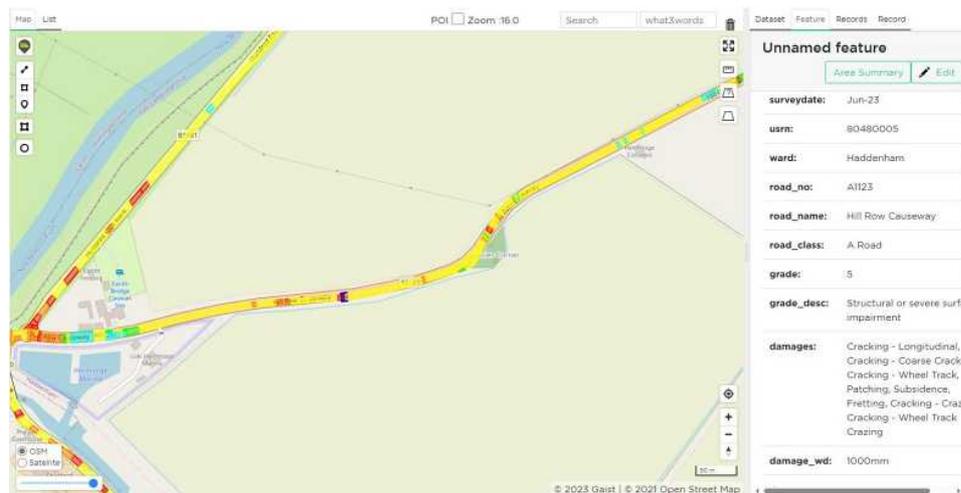
In Spring/Summer 2023 Gaist were commissioned by CCC to undertake a countywide pavement condition survey. This data set was reviewed for the 25 sites. The Gaist mapping shows Yellow and Cyan for serviceable roads and Red and Amber for sections in poor condition with a square metre summary. The survey also has a description of the condition with tags for subsidence, cracking, chip loss, fatting, potholes etc.

The limitation of this data set is that it includes all condition data. Pavement Condition Index (PCI) gives a good overall picture of condition however it includes surface deterioration information and did not provide specific undulation or structural failure areas. The example above at Hill Row Causeway is shown as serviceable, however there are significant undulations captured in the R3 data below. It was agreed at commissioning stage that further surveys would be required to determine the sections of road affected and to give an index to compare sites with.

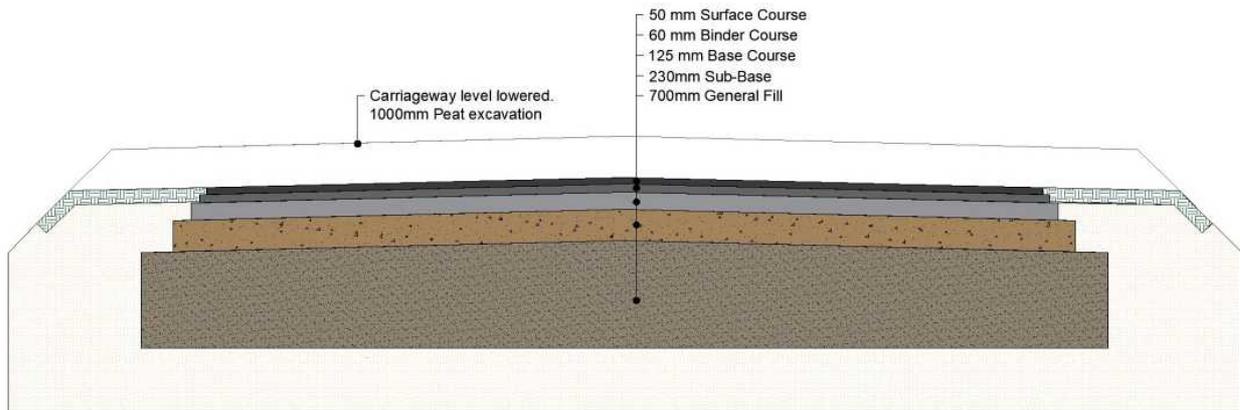
Treatment A - Full Depth Reconstruction

This method has been used to mixed but generally positive results on the previous DDR programme in 2018/19. The road is planed and excavated down to circa 400-450mm and disposed of or recycled and re-used. The new construction is built up with two geogrids and Type 4 material to create a stronger foundation layer prior to binder and surface course. The learning from the DDR programme is to use triaxial grids rather than biaxial grids or to consider emerging stronger grid technology such as Tensar Interax. In addition, where steep embankments and verges are an issue Geosynthetics Strataweb has been used to overlap through the formation level and down the verge to increase the slope stability. This is recommended where the site permits.

The guidance document suggests that a design life of 10 years may be achieved although some defects may appear before this, and so crack sealing and surface dressing should be used to extend the life of the pavement further.

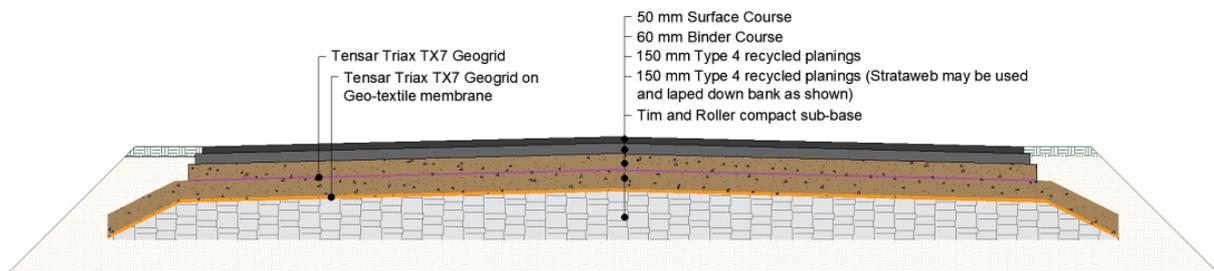
Treatment B - 'Drought Damaged' double grid method

Cost (Example 5000m ²)	Co2e/m ²	Output per shift (Example 5000m ² duration)	Lifespan (approx)
£182/m ² (£900k)	19.2	500m ² (10 Day)	Average 8-10yrs inc crack seal & surf dressing

This method has been used by CCC and other Local Authorities with soil affect roads (Norfolk, Essex and East Riding) with generally good results – Case Studies can be found in the Appendices. A geogrid can be incorporated below the recycled layer during in-situ recycling, all in a single pass. This saves time, money and carbon. When placed deeper in the road layers, geogrid is shown to mitigate the risk of cracking and deformation propagating to the road surface. The trial undertaken by CCC at Cants Drove used cement as the primary binder, but this Report proposes the use of foamed bitumen to provide enhanced flexibility, however savings of up to 50% could be achieved by following the previous cement-based approach. This geogrid approach is five times quicker than the double geogrid treatment thereby minimising the impact on residents, businesses, and the travelling public with lower costs associated with a shortened programme. Although foamed bitumen requires a small amount of cement, trials are underway to use an alternative ‘ultra-low’ carbon binder made from calcined clay.

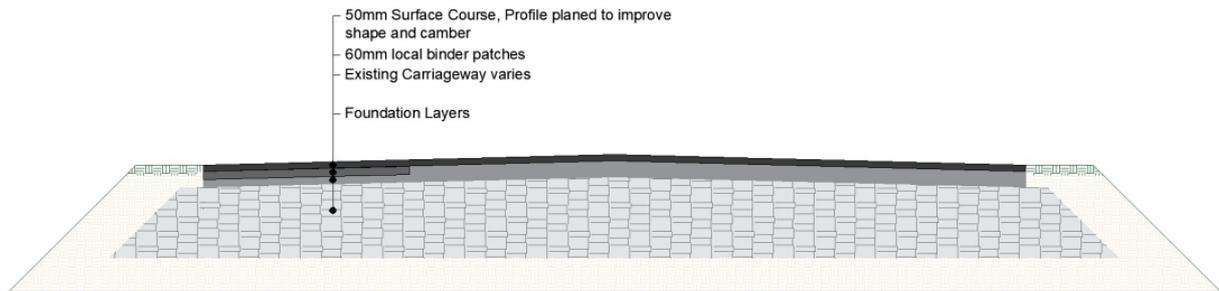
Treatment E - Plane and inlay with Binder patches

This option is used extensively on the majority of the network and outside of the soil affected roads sites. Binder patches are used to remedy localised failure areas and the shape of the road can be improved by profile planing and inlaying. This option would prove cheapest and so could cover the widest area however it is only included for comparison as it does not resolve the deep-seated foundation issues associated with the roads covered by this Report. At best it would give 1-2 years before extensive cracking and undulations reappear and there is widespread evidence across the county to support that estimate.

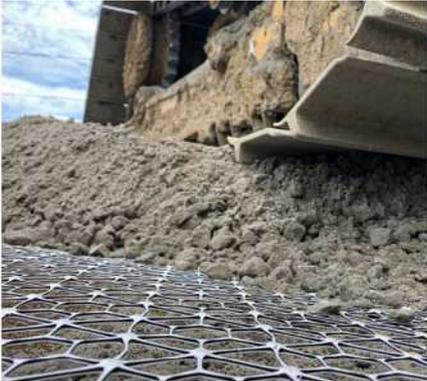
- Tensar Interax** – Biaxial grids have not performed as well as Triaxial grids at sites which have previously had geogrids incorporated. The type of deformation seen in soil affected roads is not linear and often is a combination of tree roots, edge failures and seasonal heave due to water in the sub-grade. Tensar have recently brought to market their new Interax grid which should improve on the performance of a Triaxial grid by using varying ‘openings’ to create better interlock and to spread the acting load more efficiently through the grid. Interax could also be installed using the rapid ‘one-pass’ In-Situ Recycling technique.

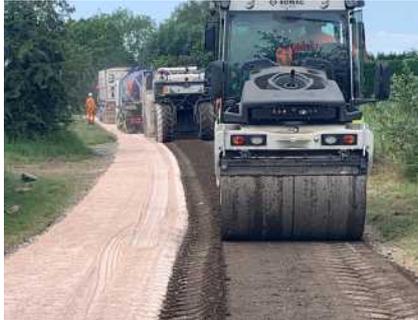
- In-Situ Recycling with an ‘ultra-low’ carbon binder** – In collaboration with Norfolk County Council (NCC) and Hoffman Green, SPL have undertaken the first highway project in UK to use their H-EVA calcined clay product as an alternative to Portland Cement. Completed in May 2023, saving 55% CO₂, the client has already deemed the trial a success based on ongoing monitoring and testing. Confidence and their carbon aspirations has already given rise to NCC supporting its wider adoption in 2024.

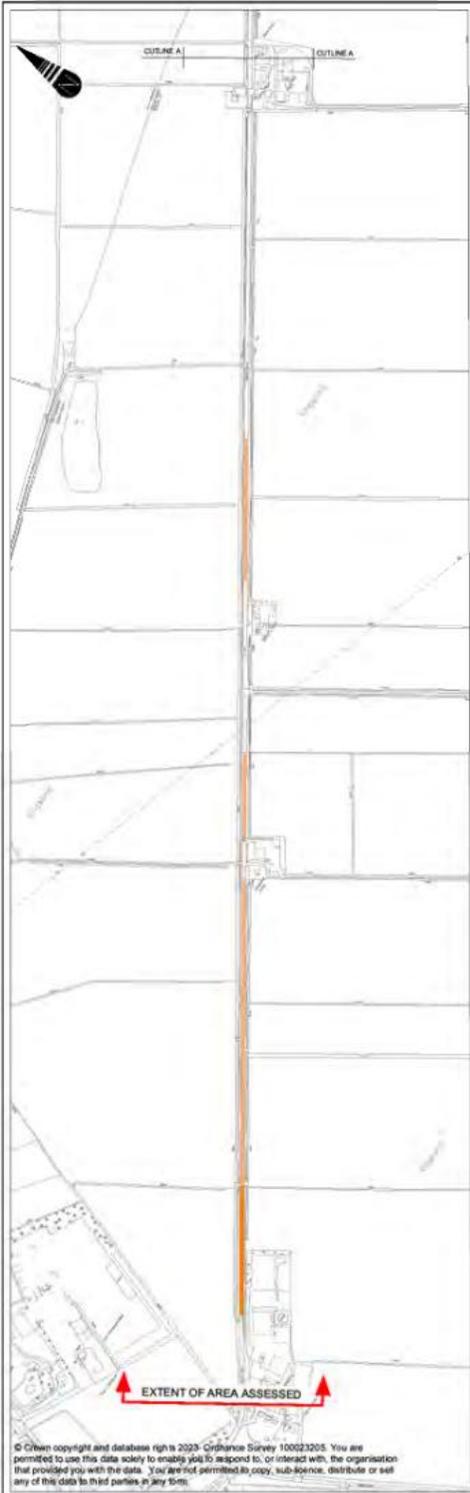
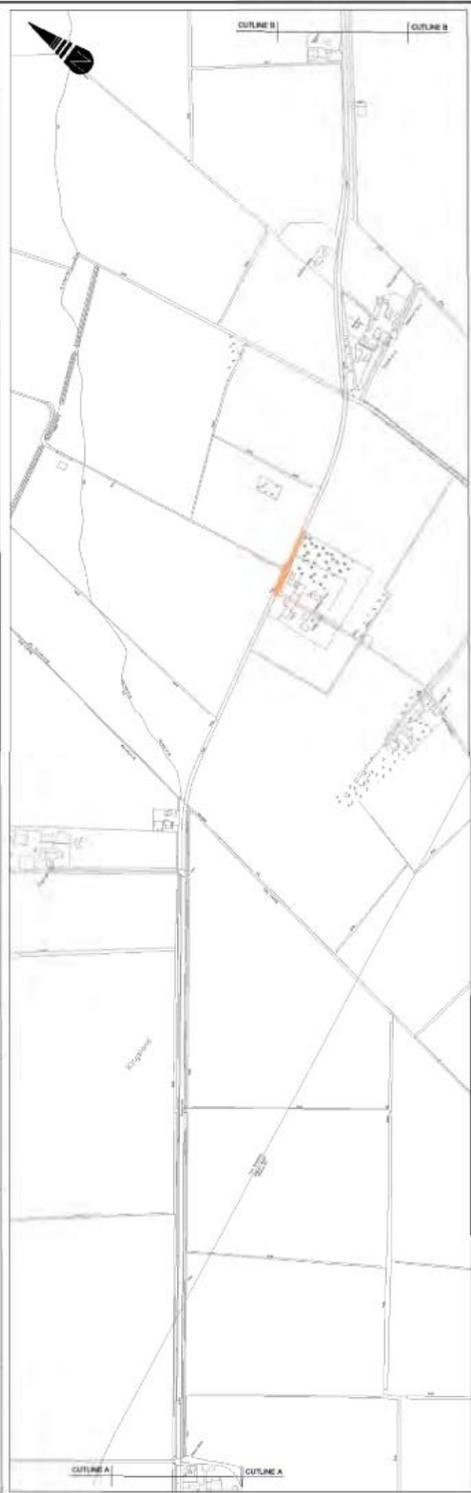
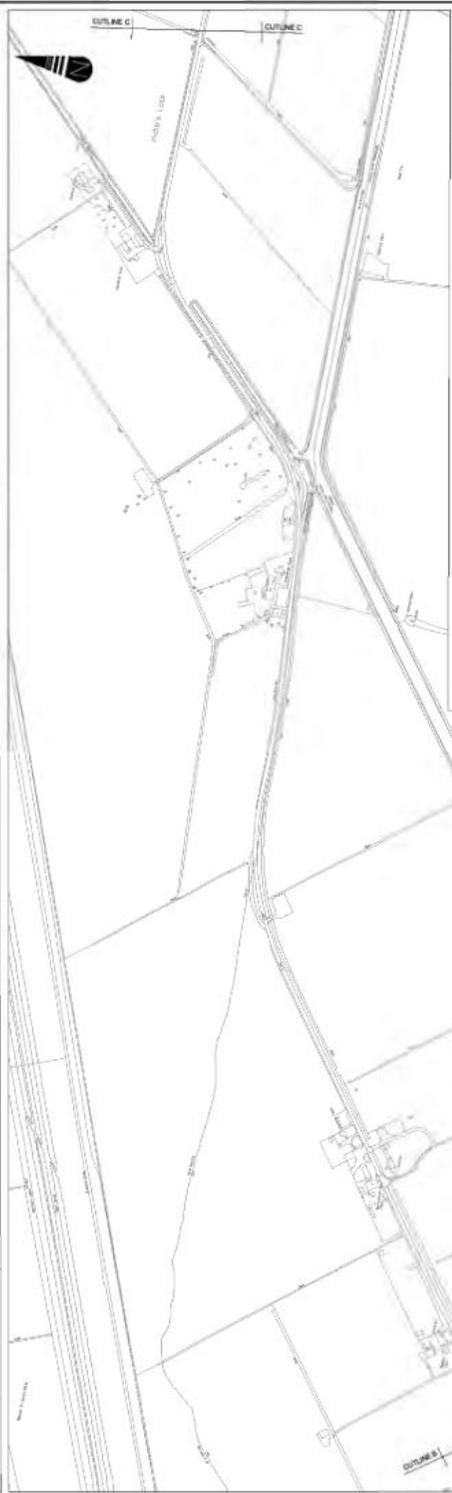
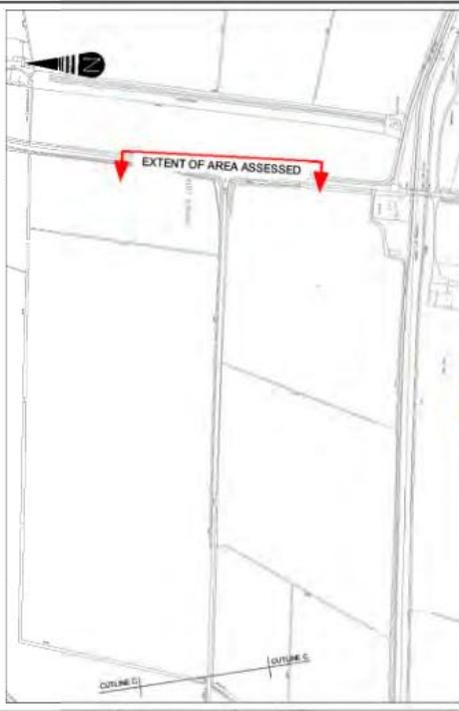
KEY:
 No R3 Survey data available. Treatment areas determined from Gaist pavement condition survey and visual inspection from video footage.

Poor Condition
 8343m²
 Very Poor Condition
 1672m²
 Total treatment area: 10015m²

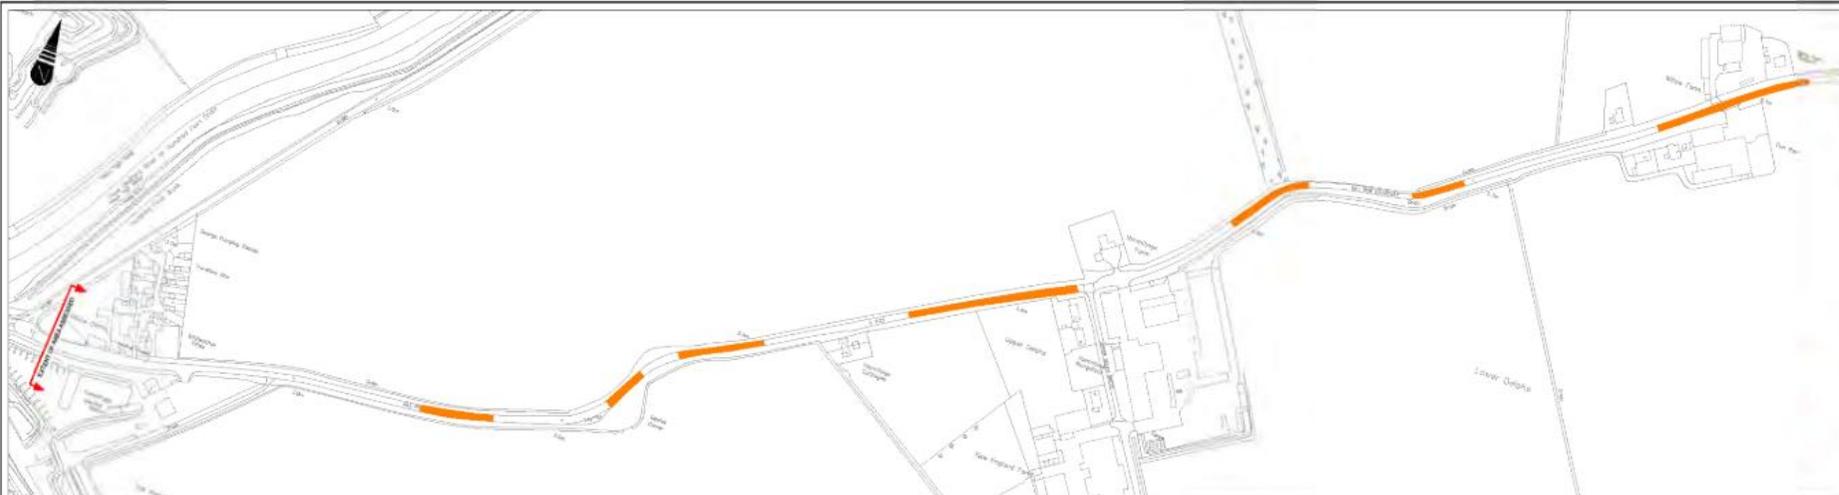
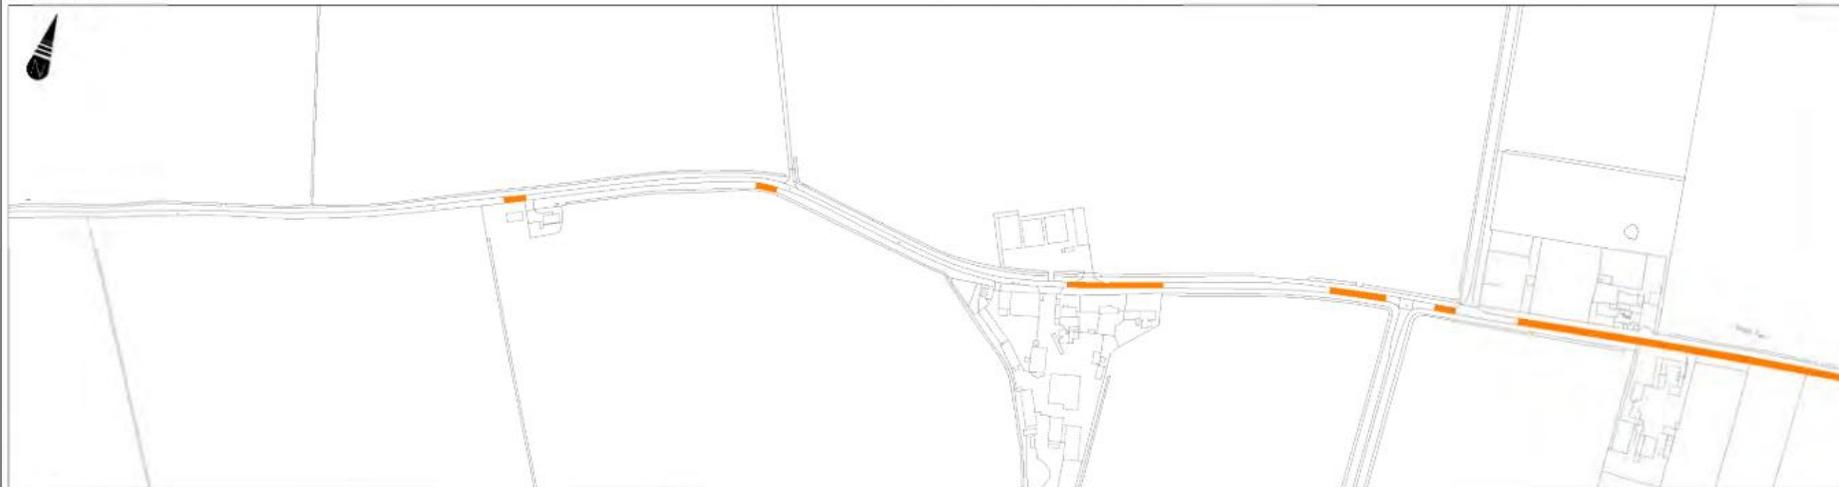
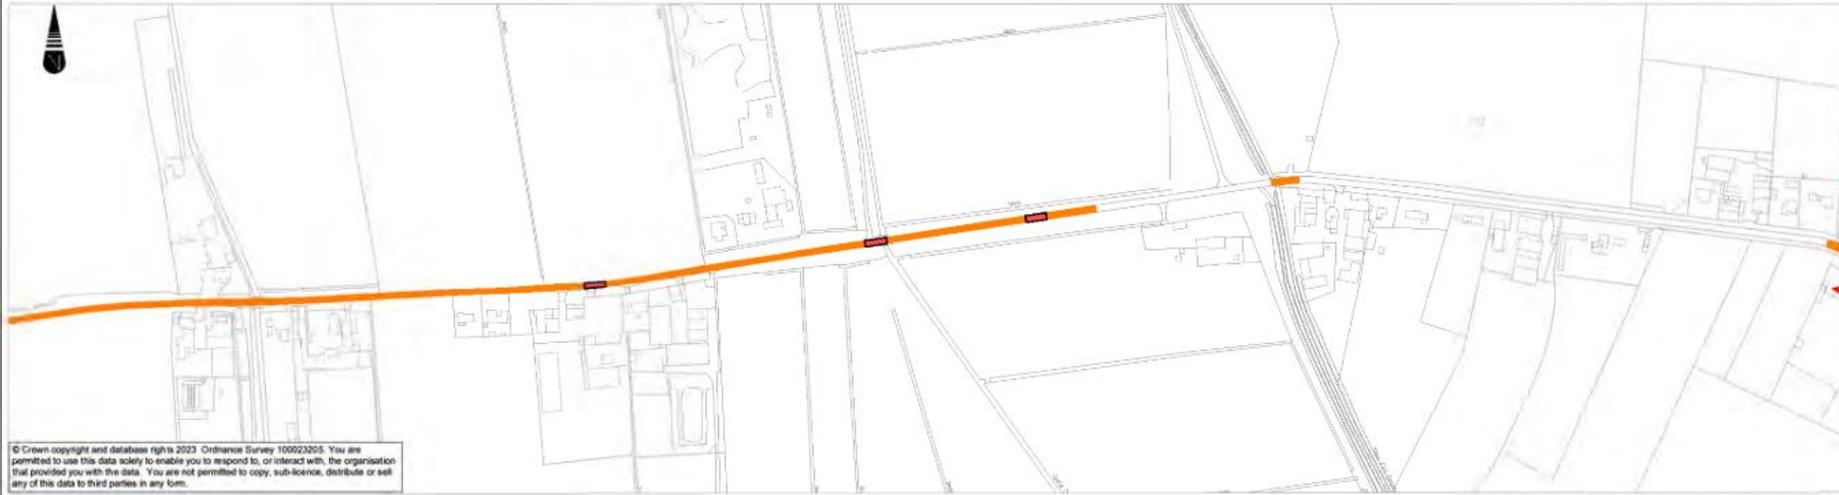
Title
HILL ROW CAUSEWAY AREA OF INTEREST 002

- IRI 7-15
12641m²
- IRI15-30
344m²
- IRI 30+ Extremely Poor Condition
0m²

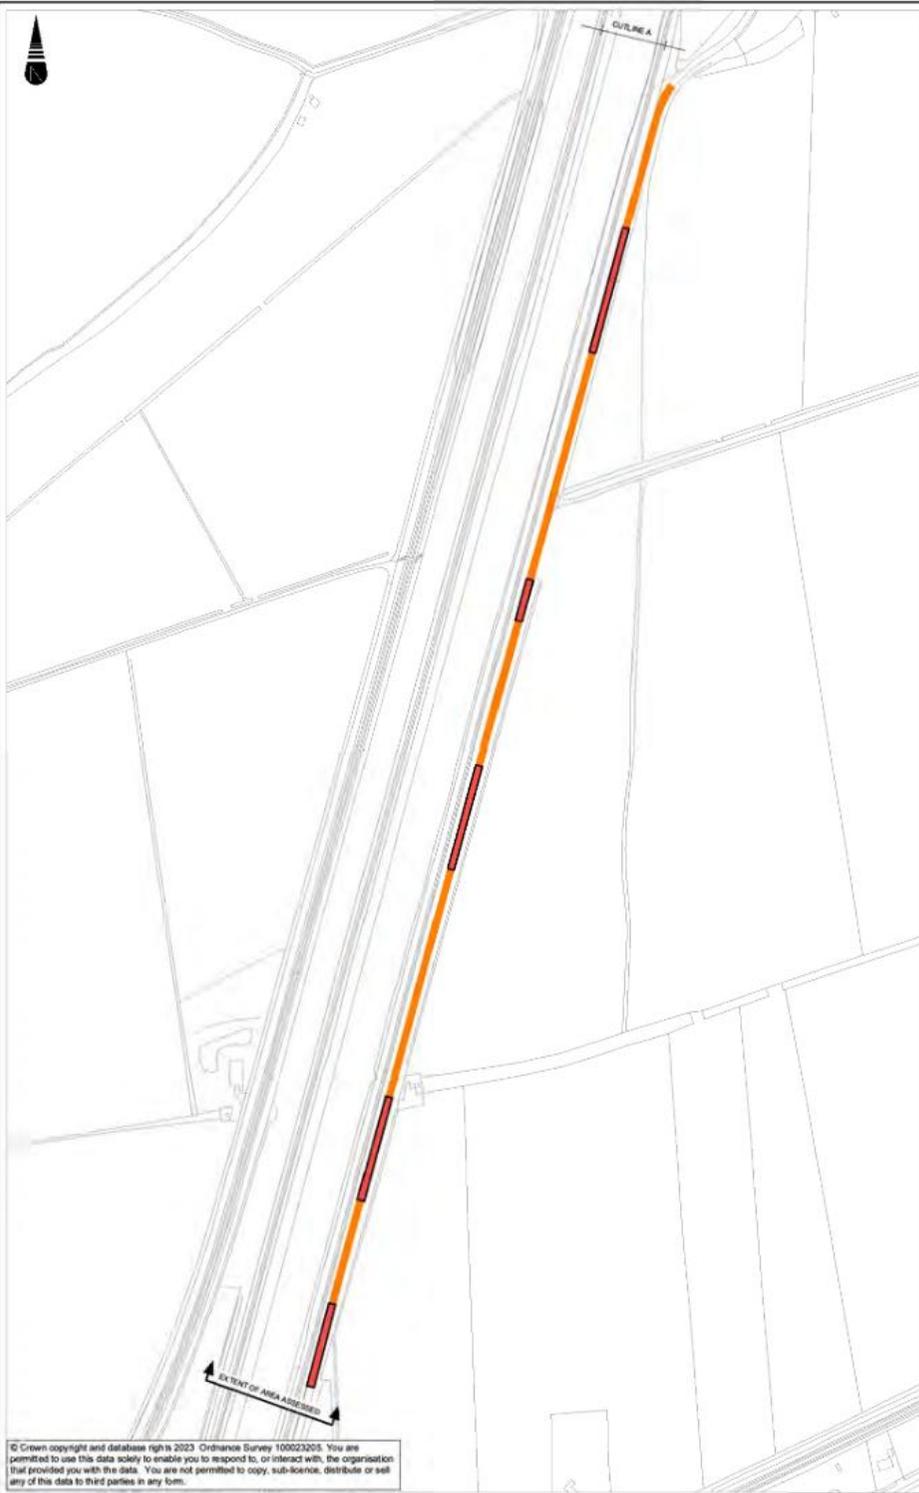
KEY:
International Roughness Index (IRI)
7+ is categorised as poor to very poor requiring intervention.

- IRI 7-15
9193m²
- IRI15-30
2842m²
- IRI 30+ Extremely Poor Condition
0m²

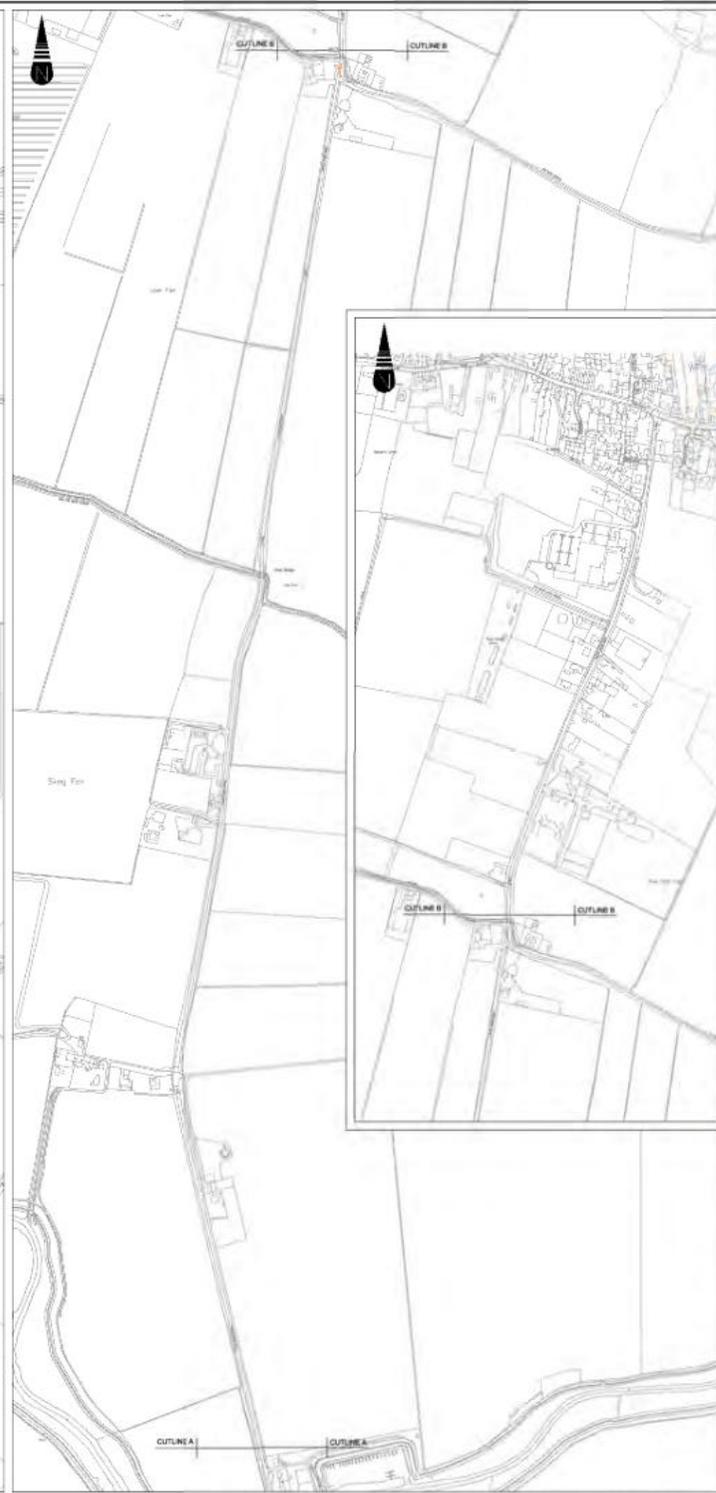
KEY:

No R3 Survey data available. Treatment areas determined from Gaist pavement condition survey and visual inspection from video footage.

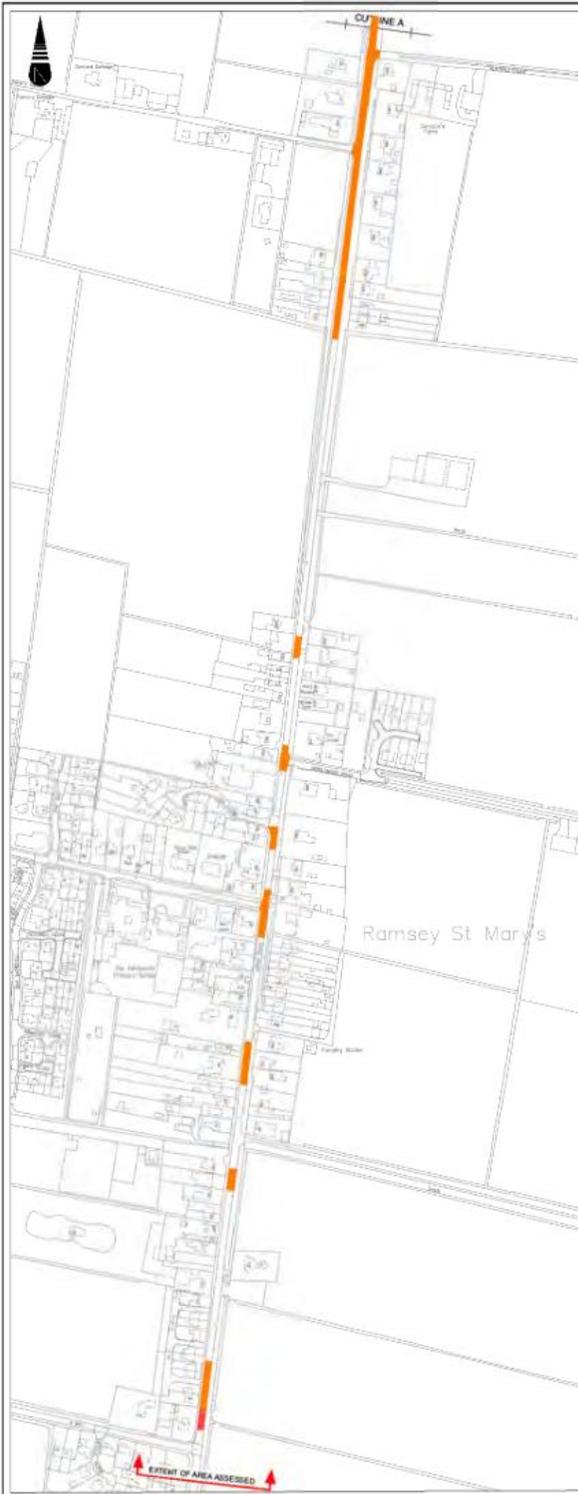
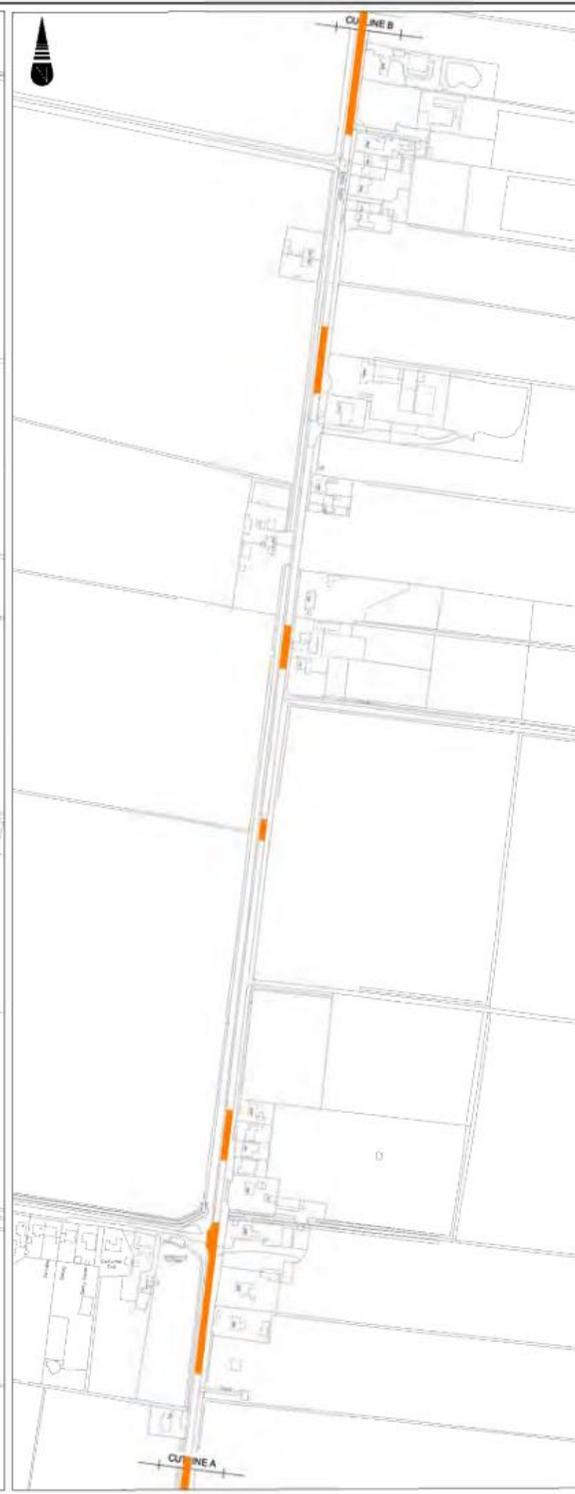
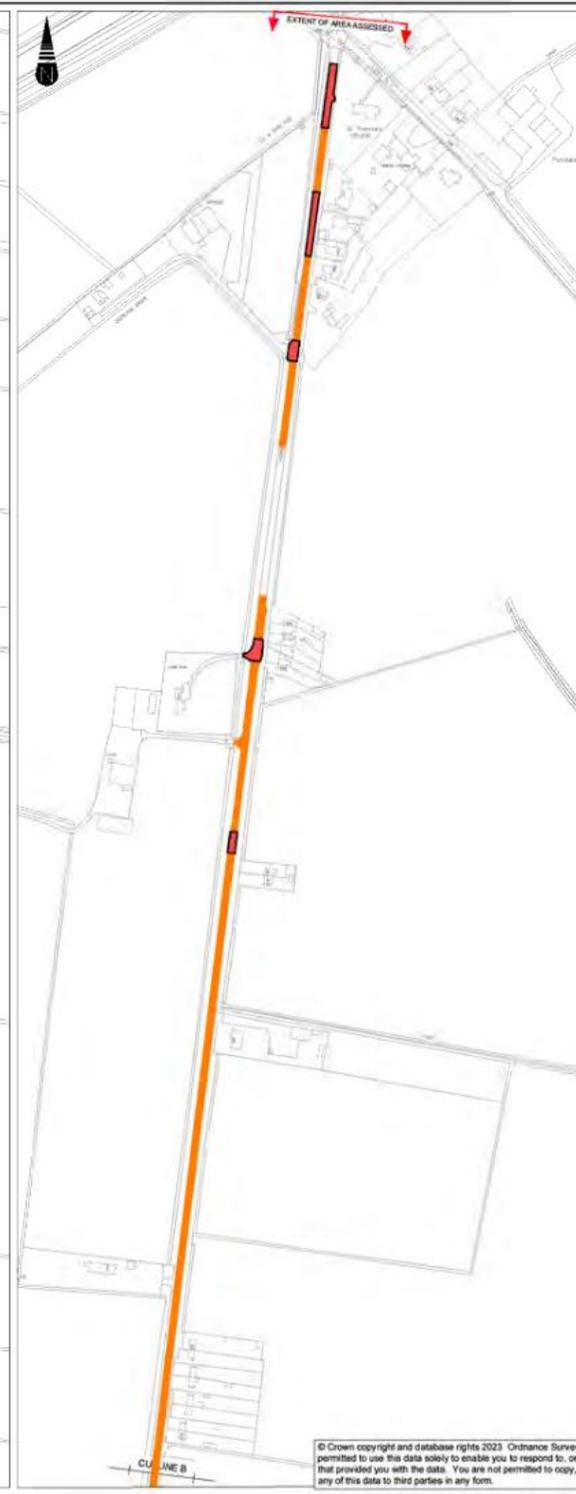
KEY:

International Roughness Index (IRI)
7+ is categorised as poor to very poor
requiring intervention:

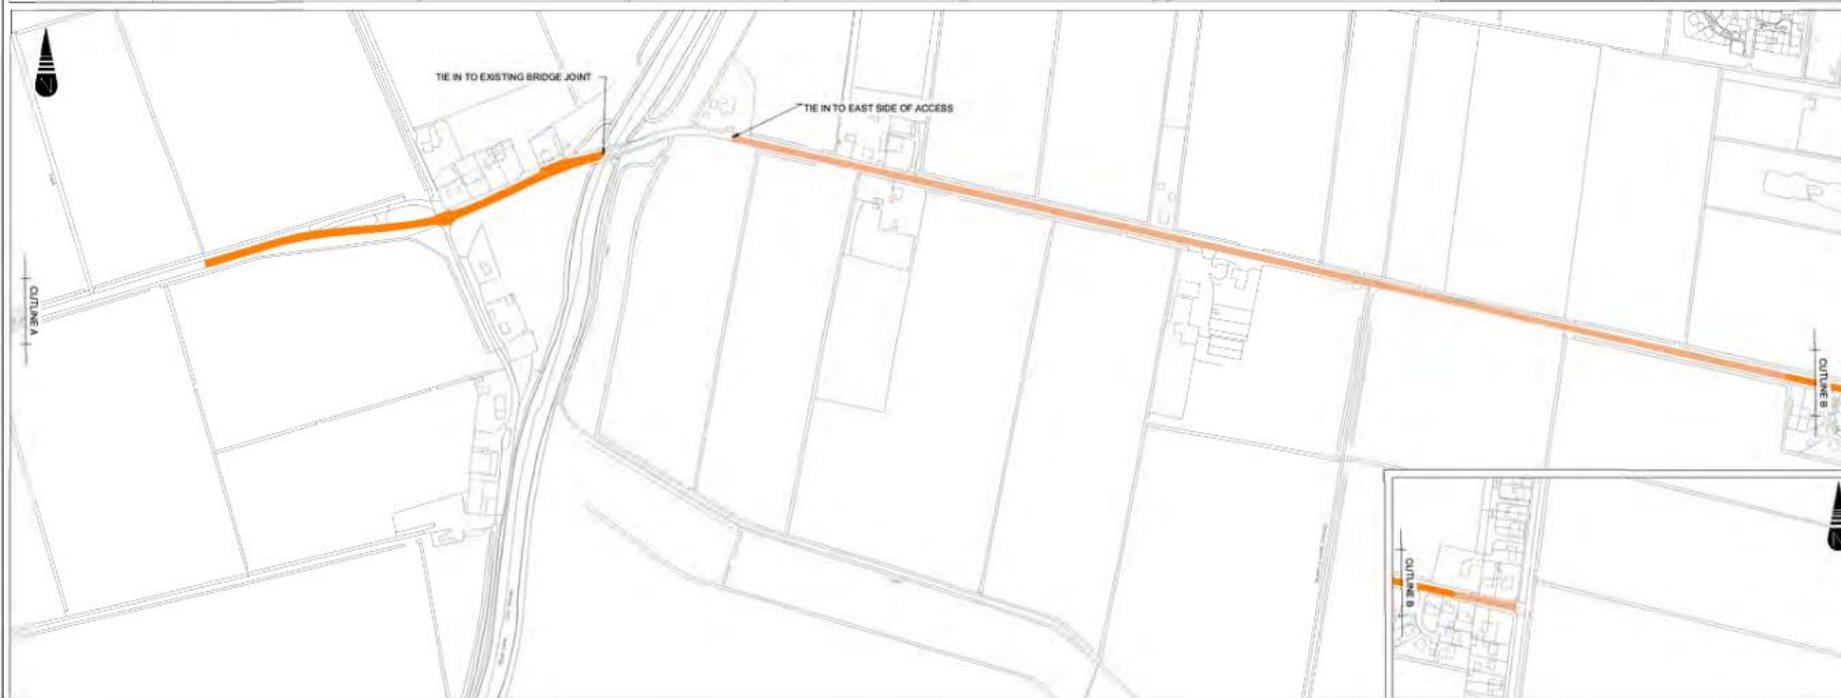
KEY:
 No R3 Survey data available. Treatment areas determined from Gaist pavement condition survey and visual inspection from video footage.

Poor Condition
13706m²

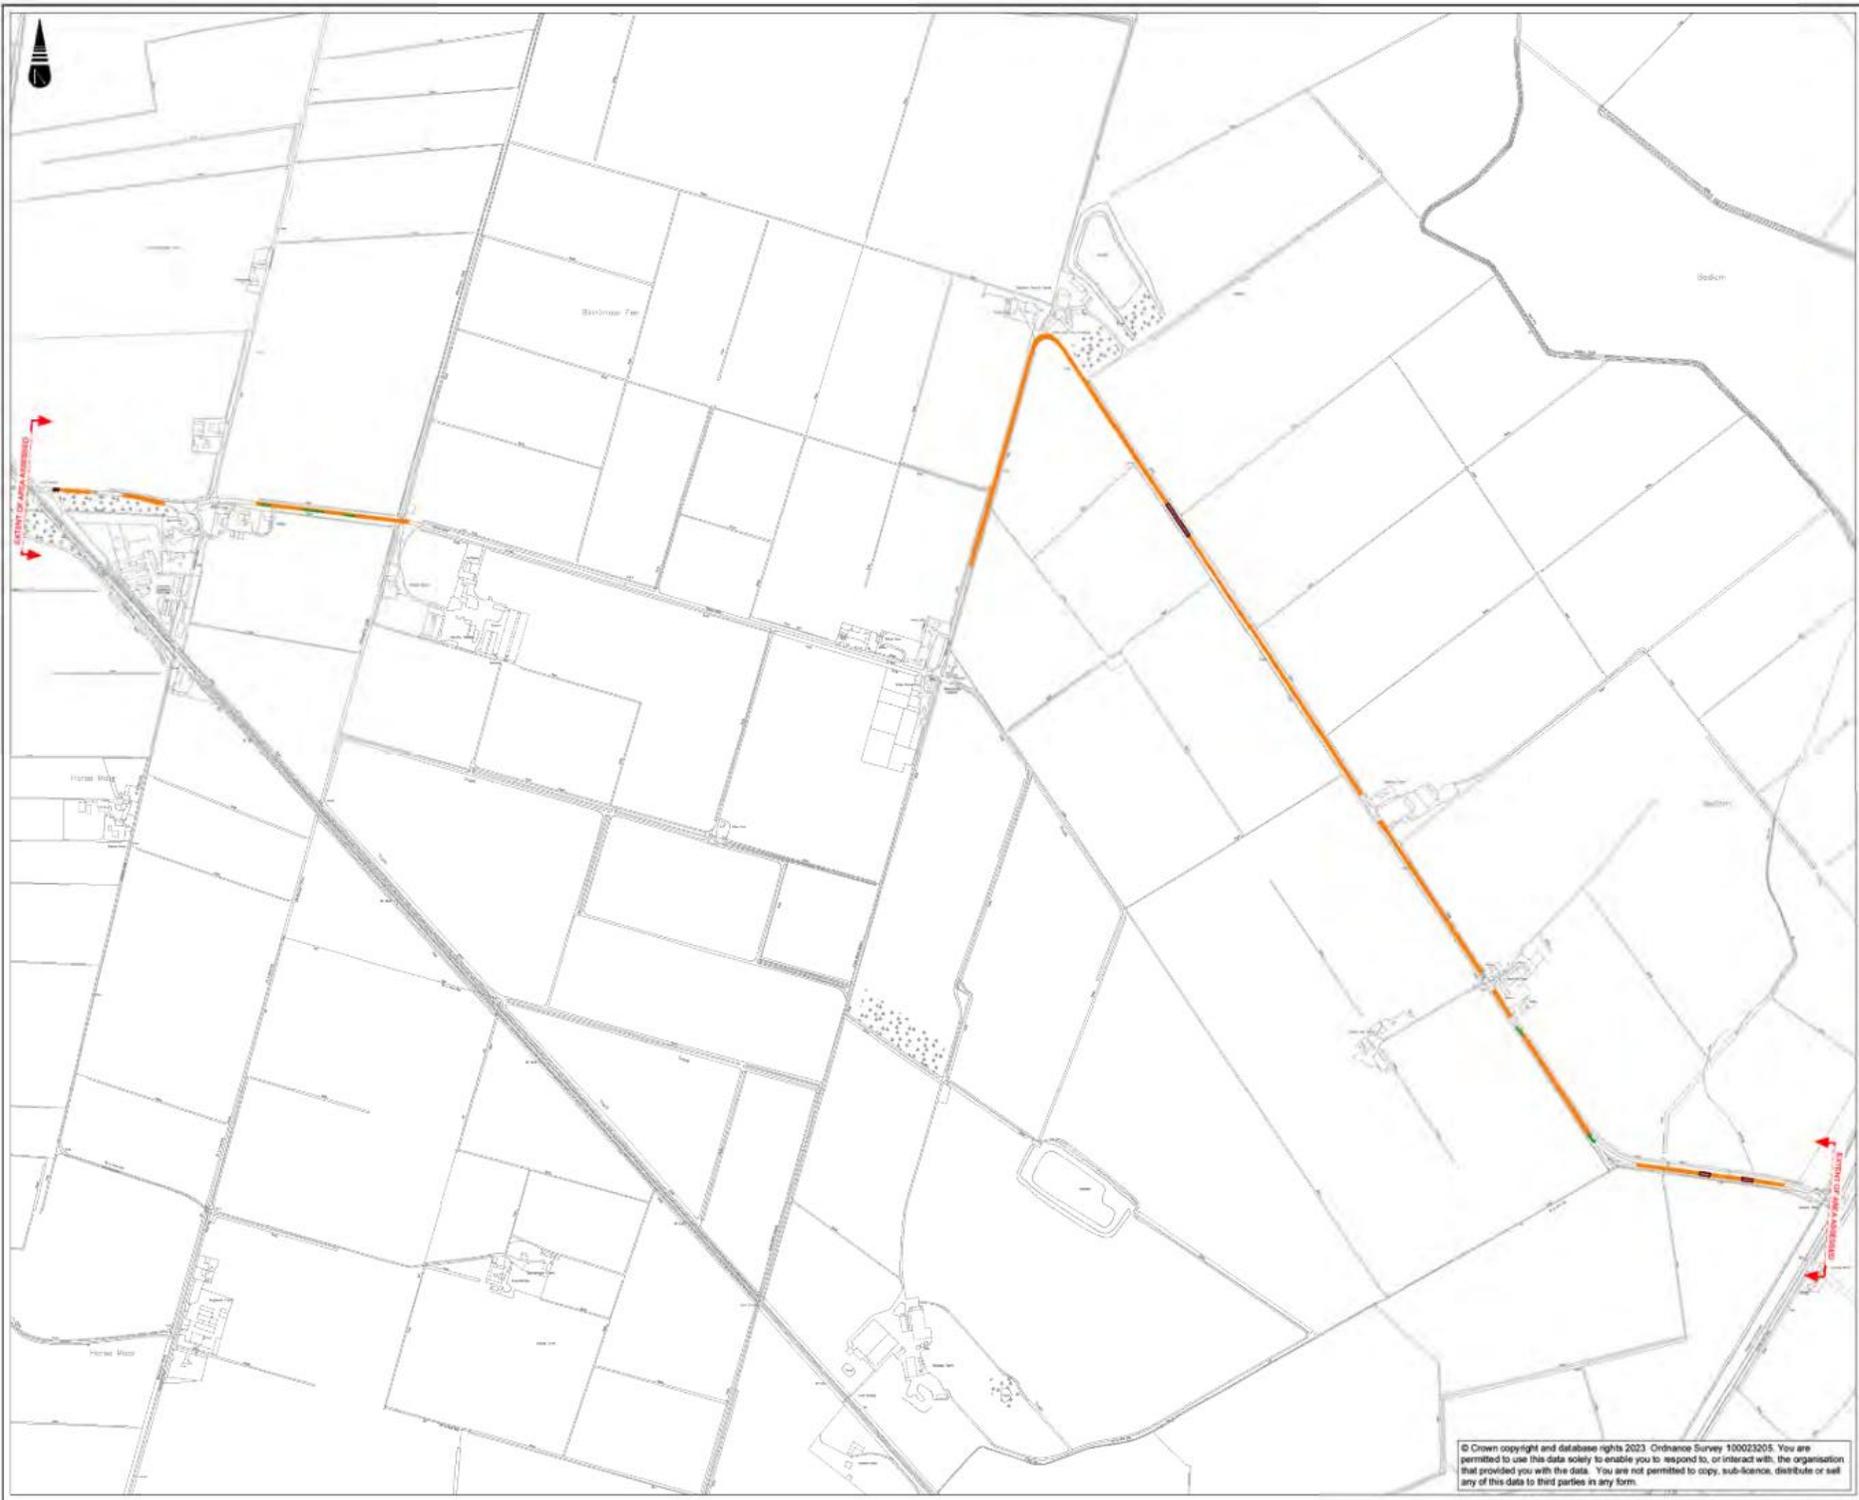
KEY:

International Roughness Index (IRI)
7+ is categorised as poor to very poor
requiring intervention:

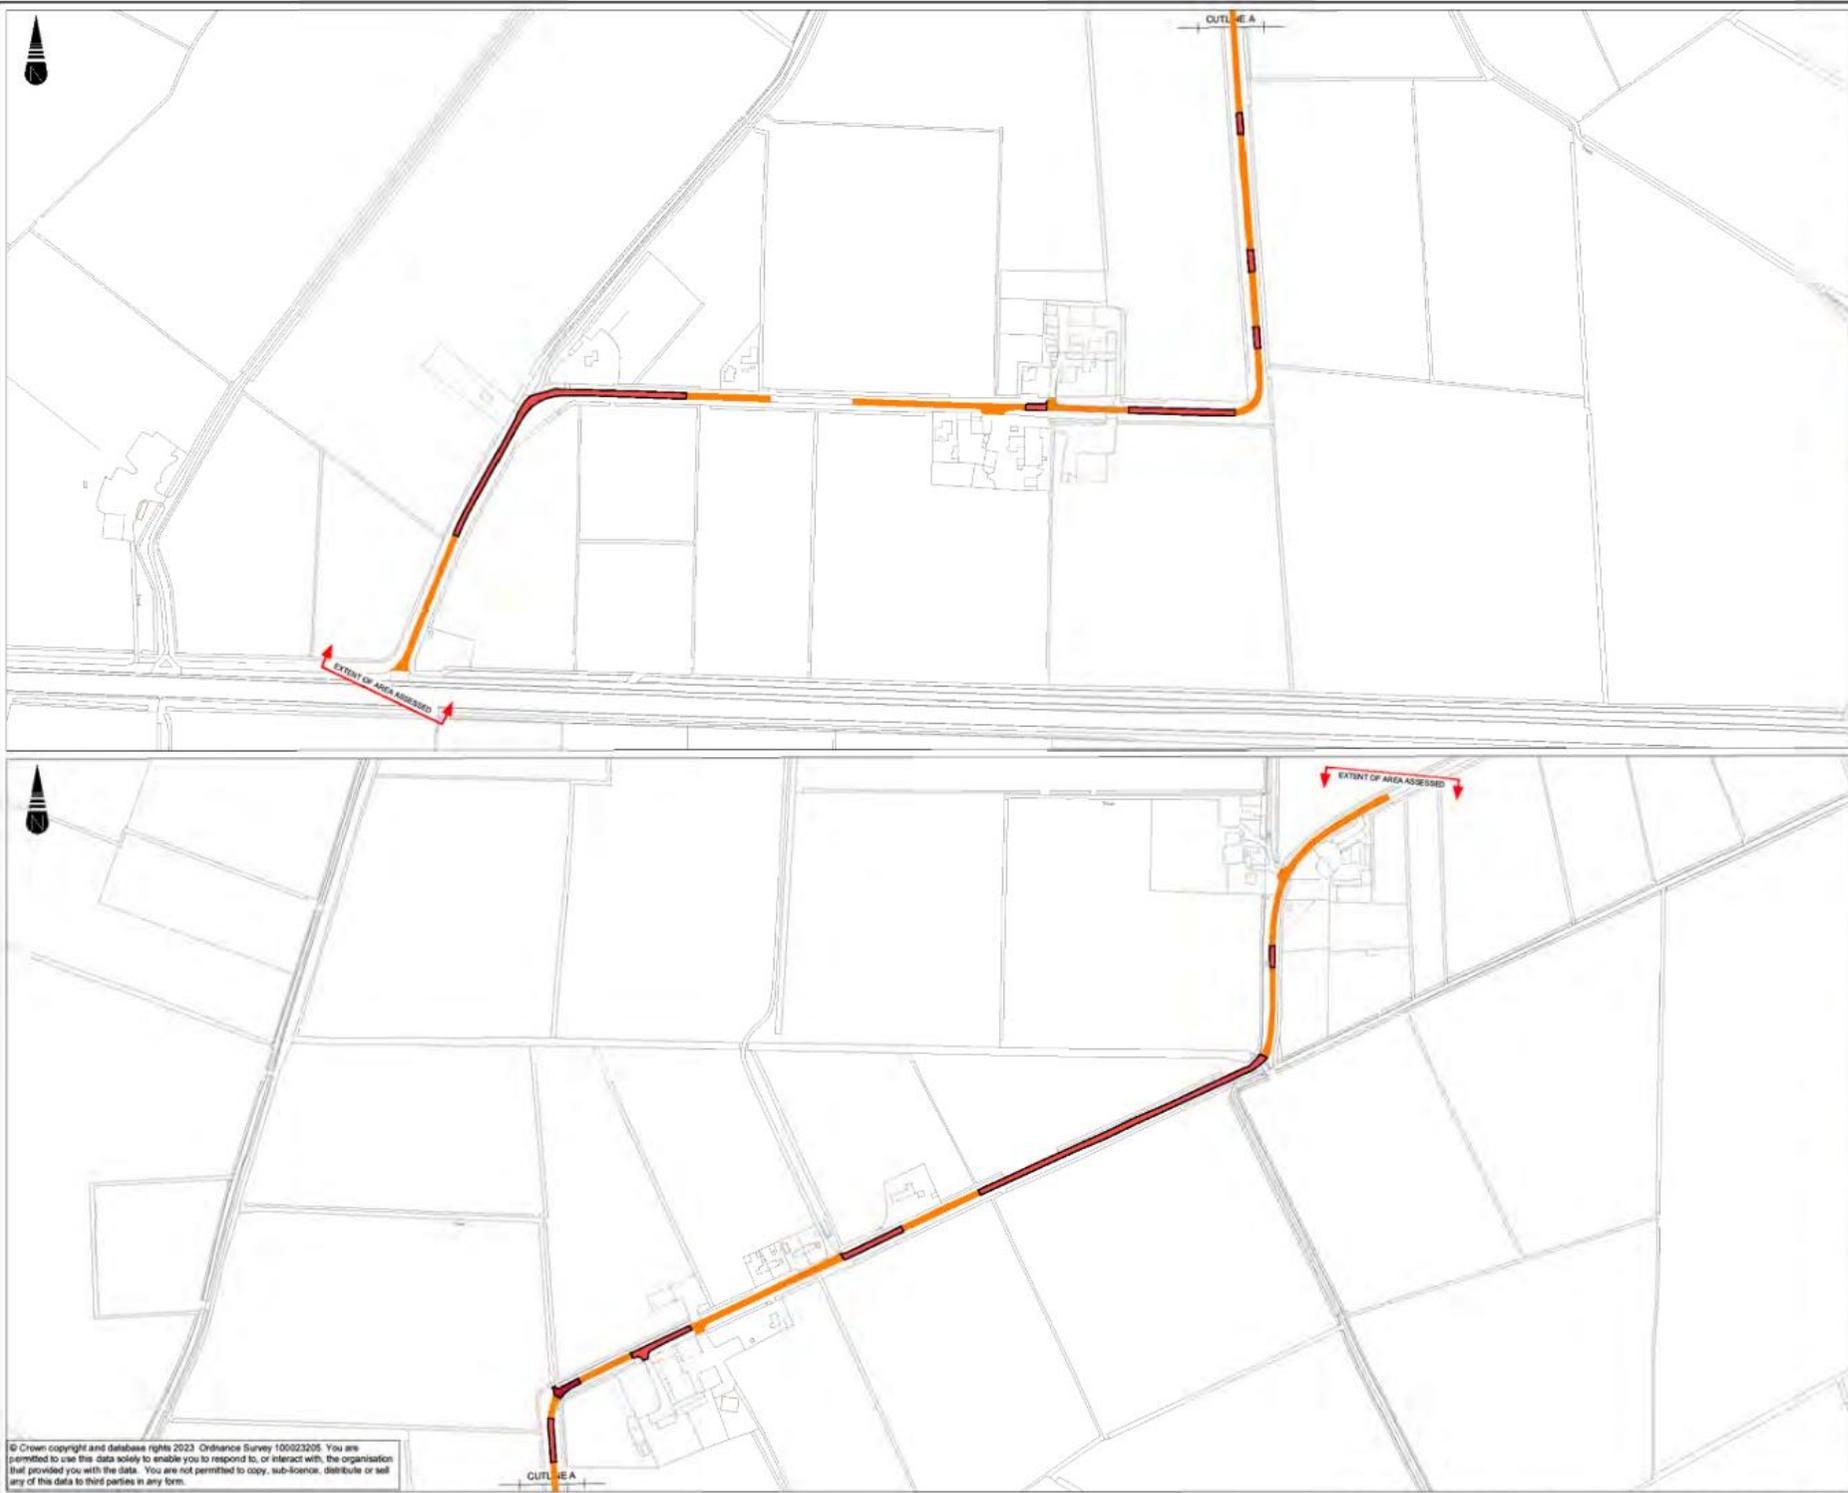
KEY:

International Roughness Index (IRI)
7+ is categorised as poor to very poor requiring intervention:

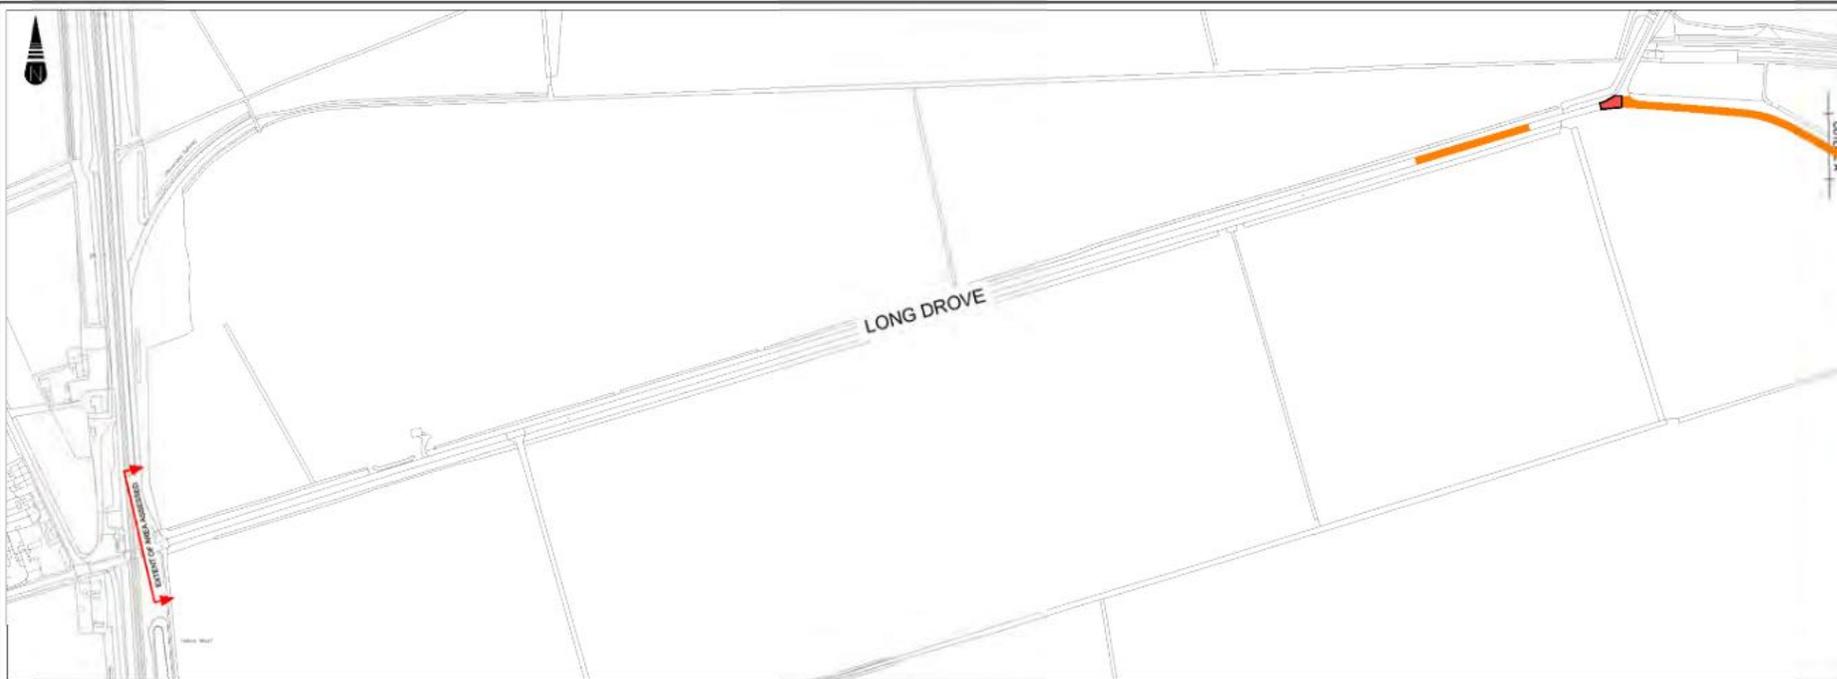
Total treatment area: 6941.2m²
