Cambridgeshire County Council

Soil Affected Roads – Review of Sites and Treatment Options Report.

January 2024

JOB NUMBER: 5020600			DOC REF: 5020600/MIN/HPV/RP/300/320			
Revision	Purpose Description	Originated	Checked	Reviewed	Authorised	Date
P01	Draft	OJB	NT	PN		1/24
P02	Original Issue	AJ/OJB	NT/AB	PN	OJB	1/24

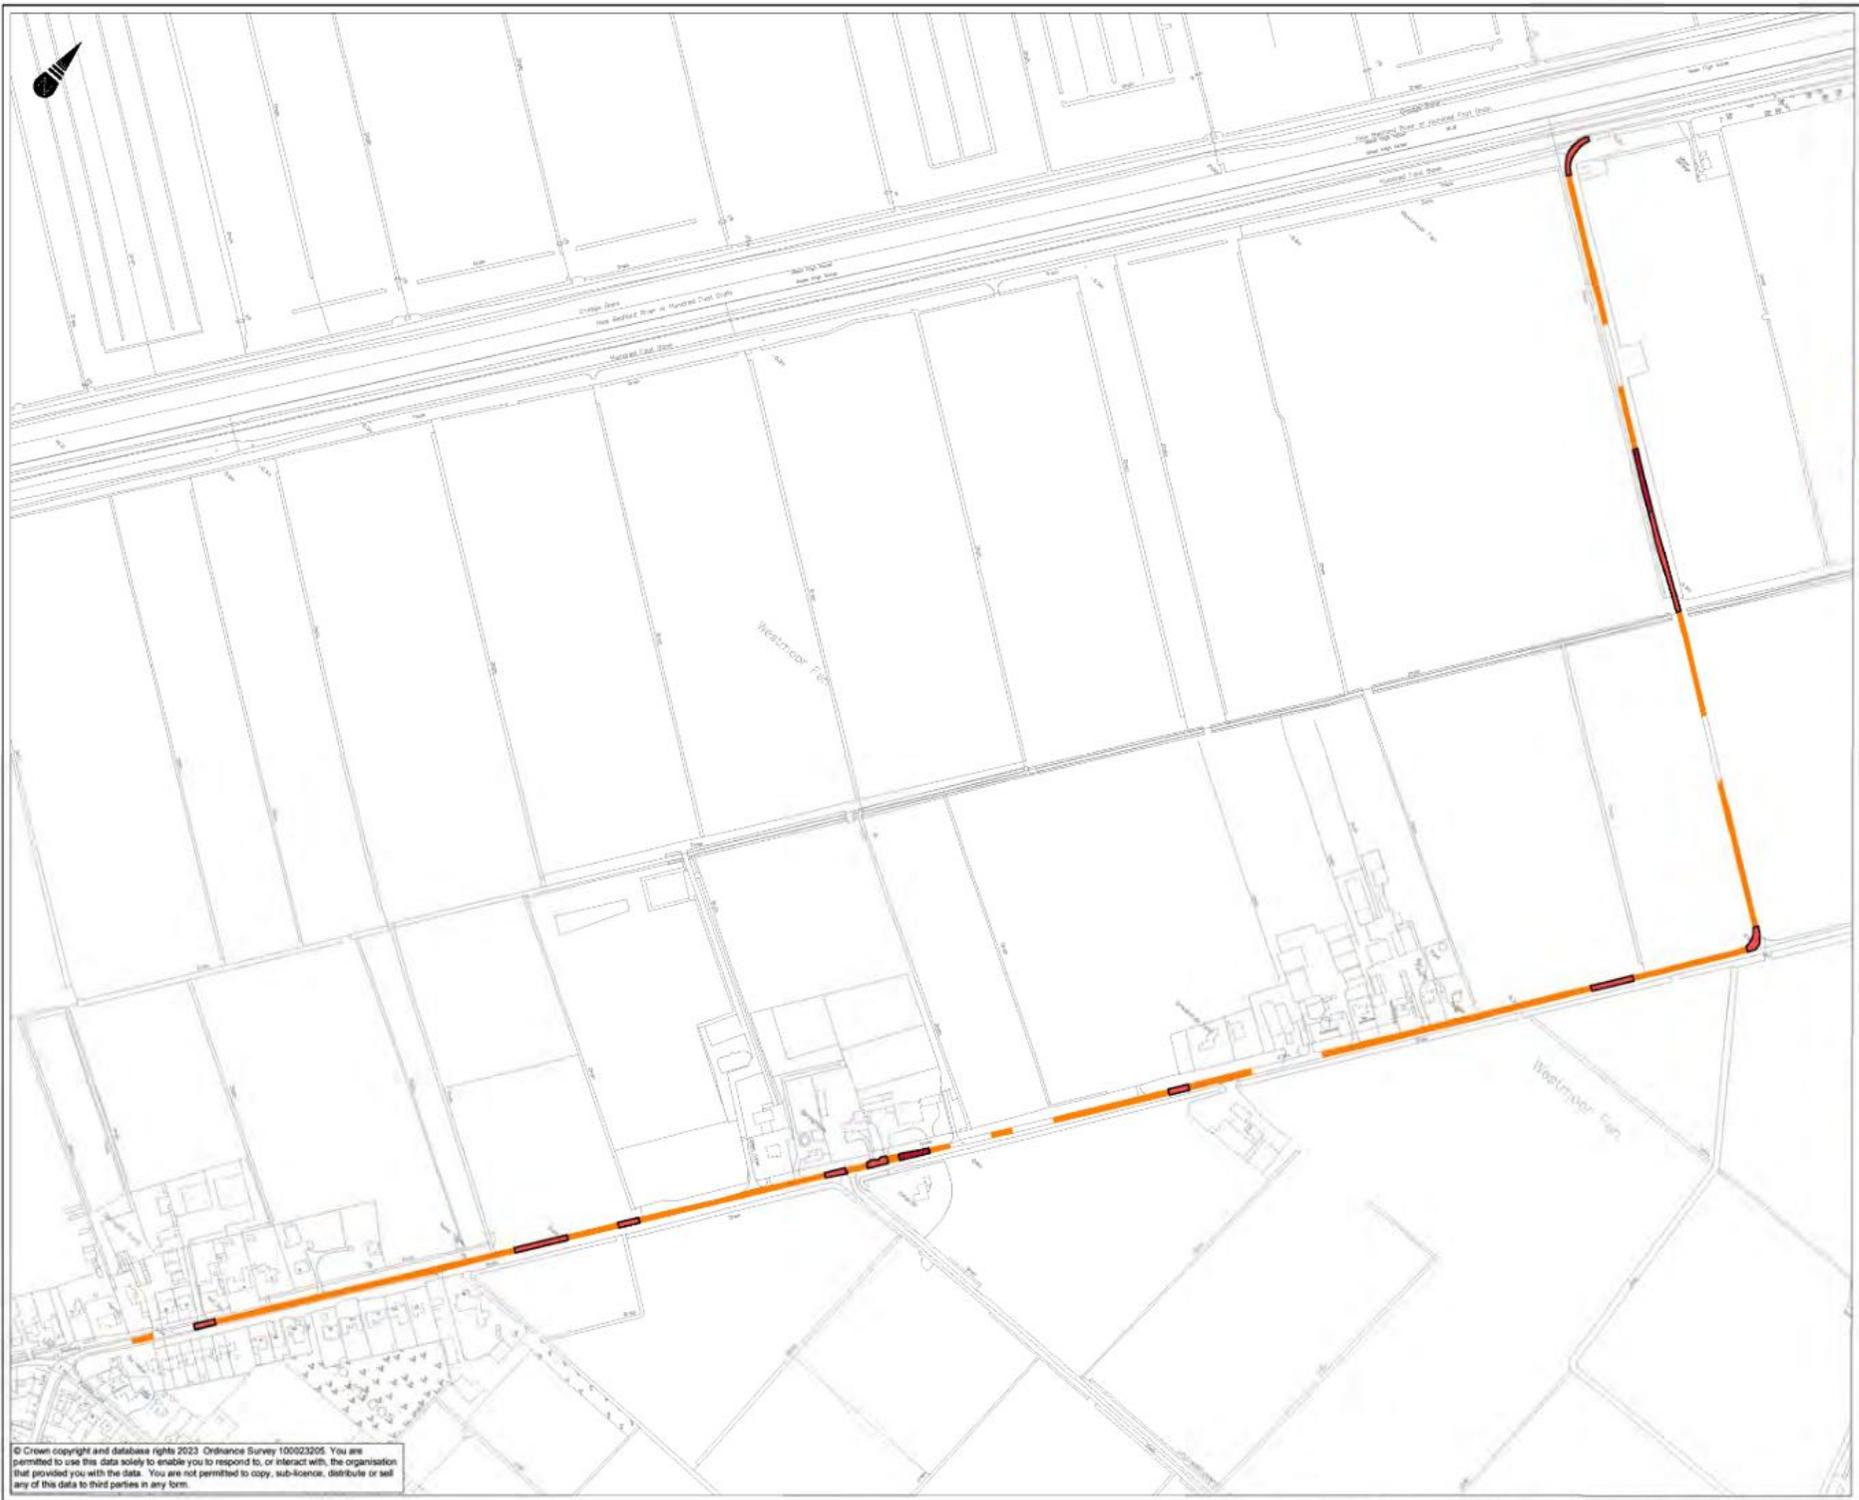
KEY:

International Roughness Index (IRI)
7+ is categorised as poor to very poor
requiring intervention.

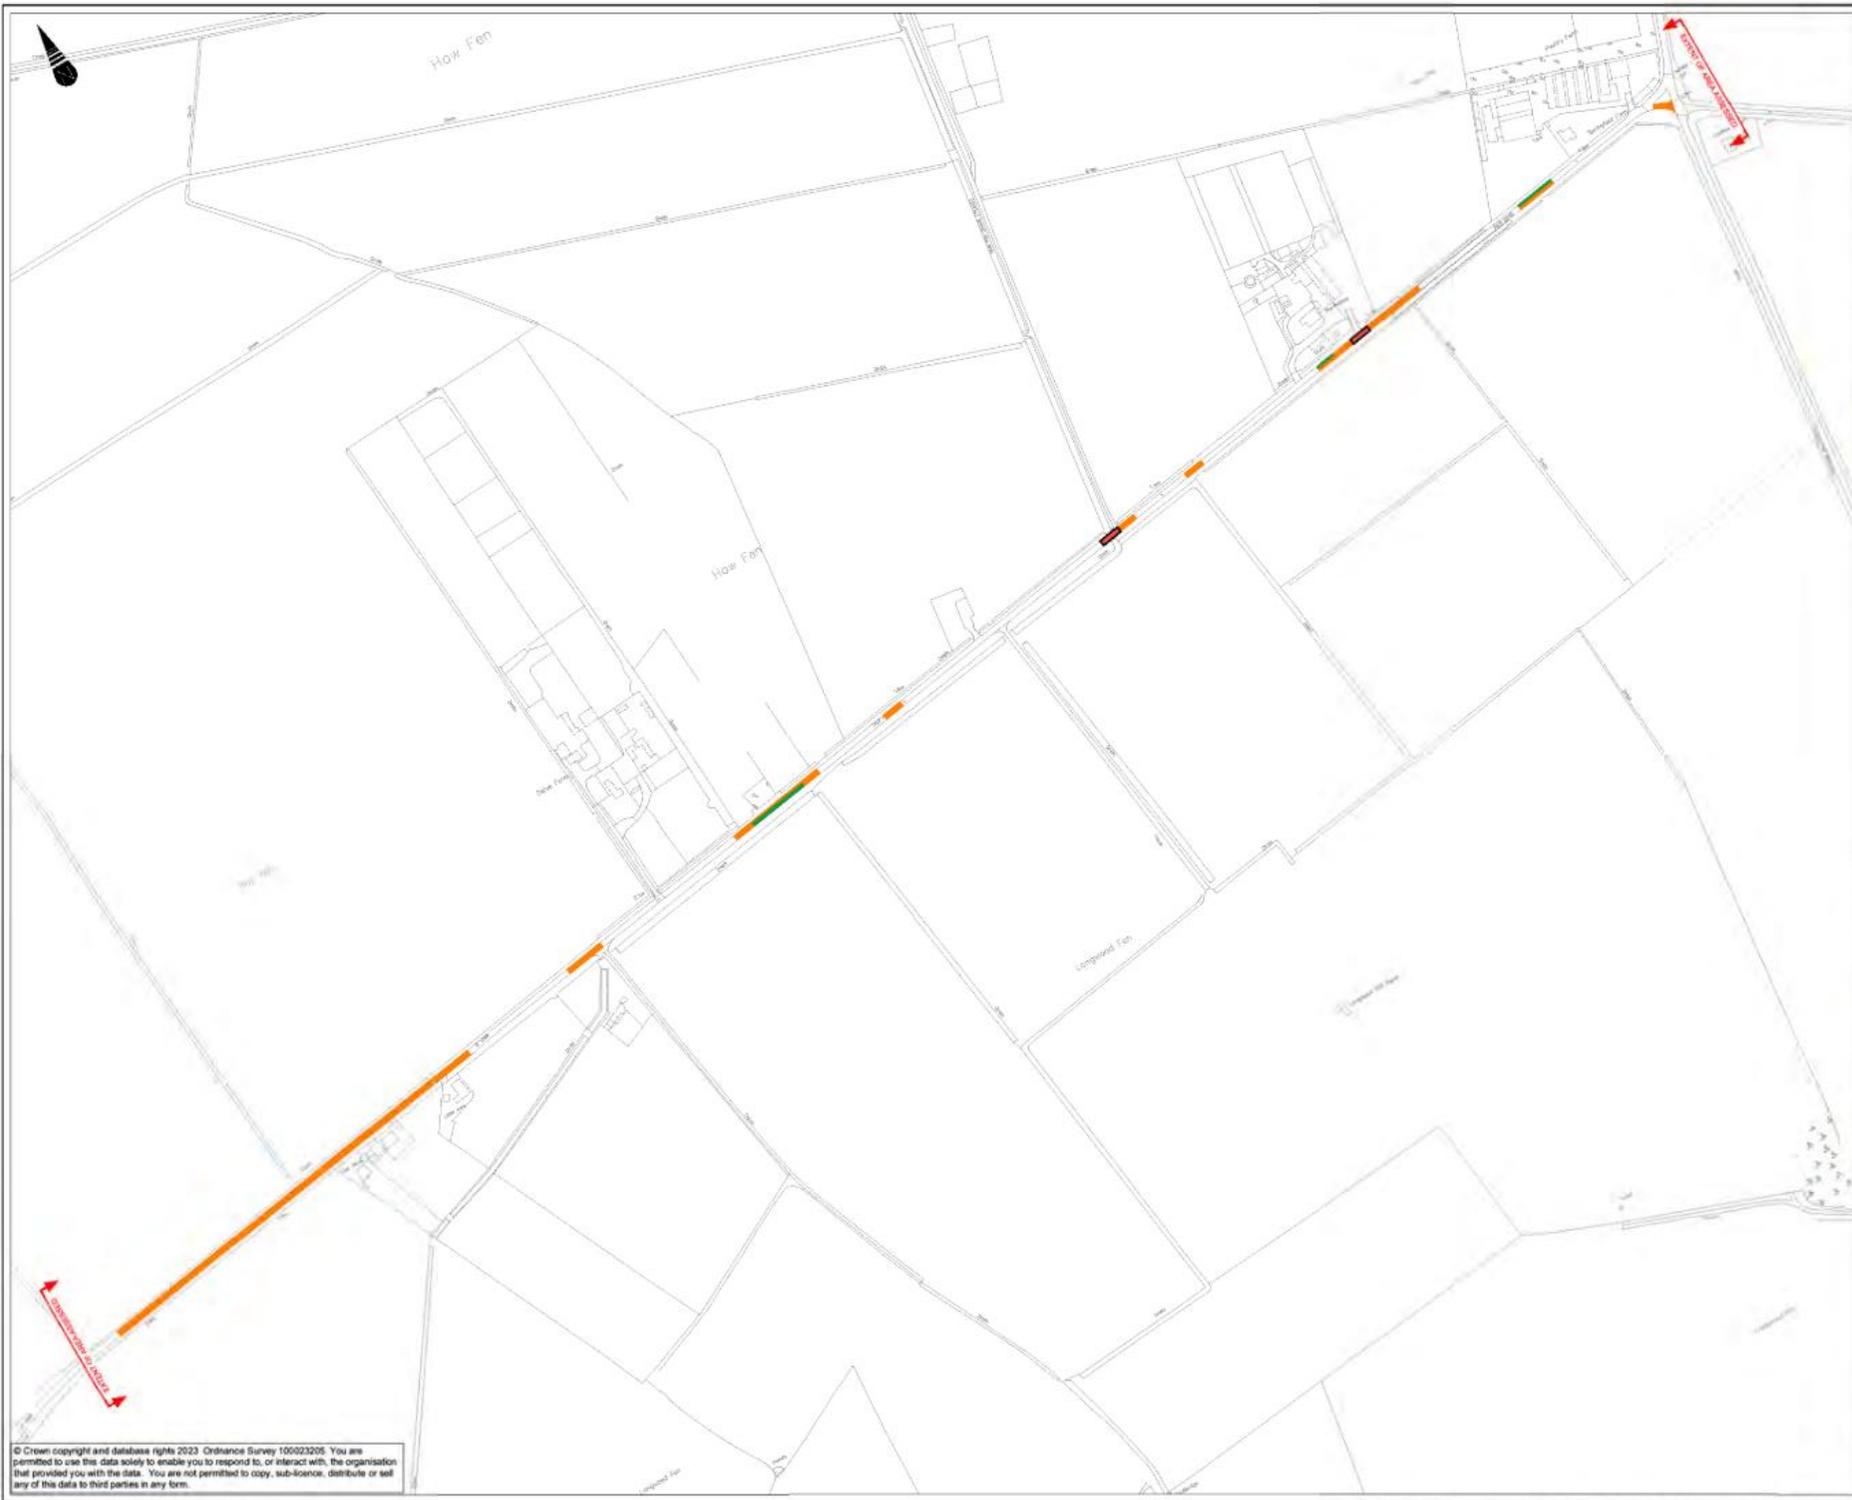
KEY:

International Roughness Index (IRI)
7+ is categorised as poor to very poor requiring intervention:

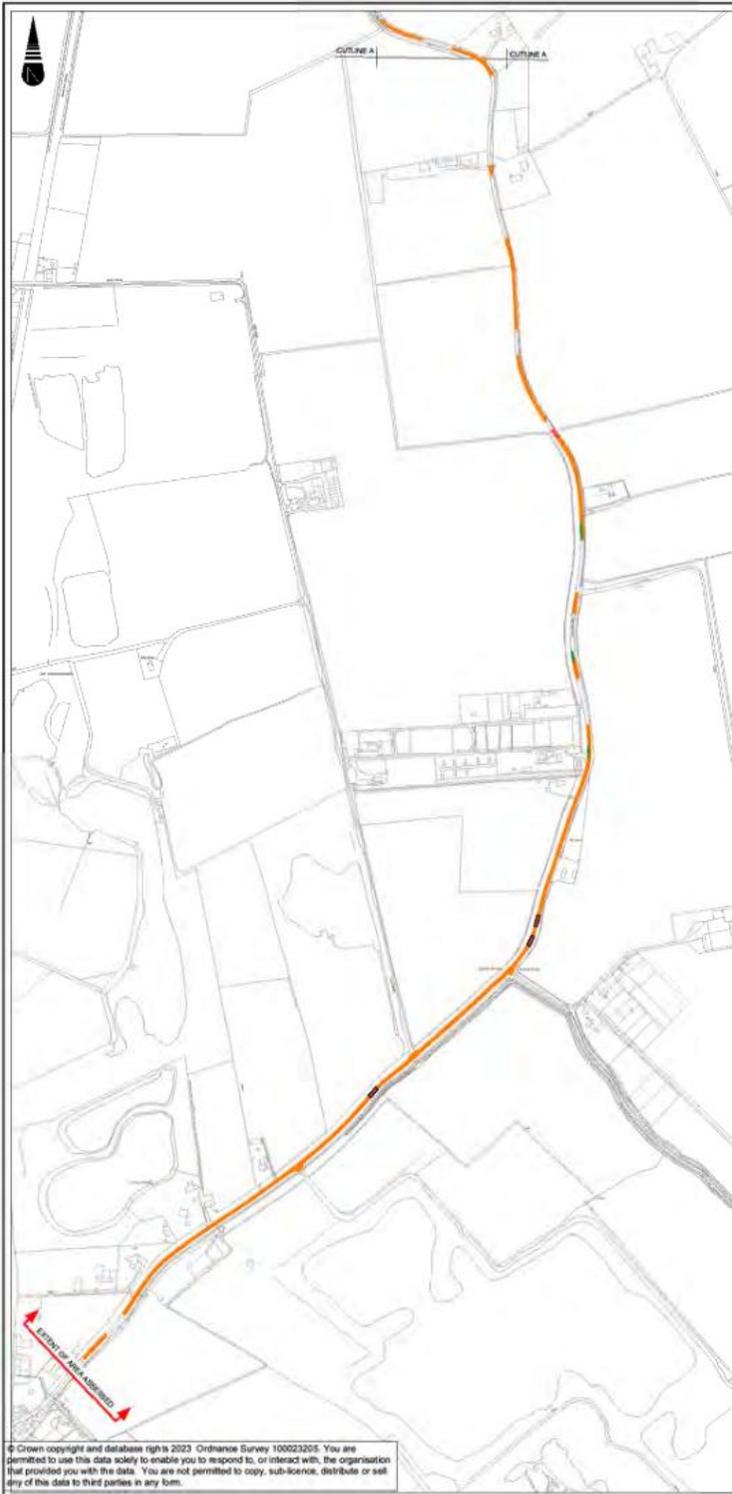
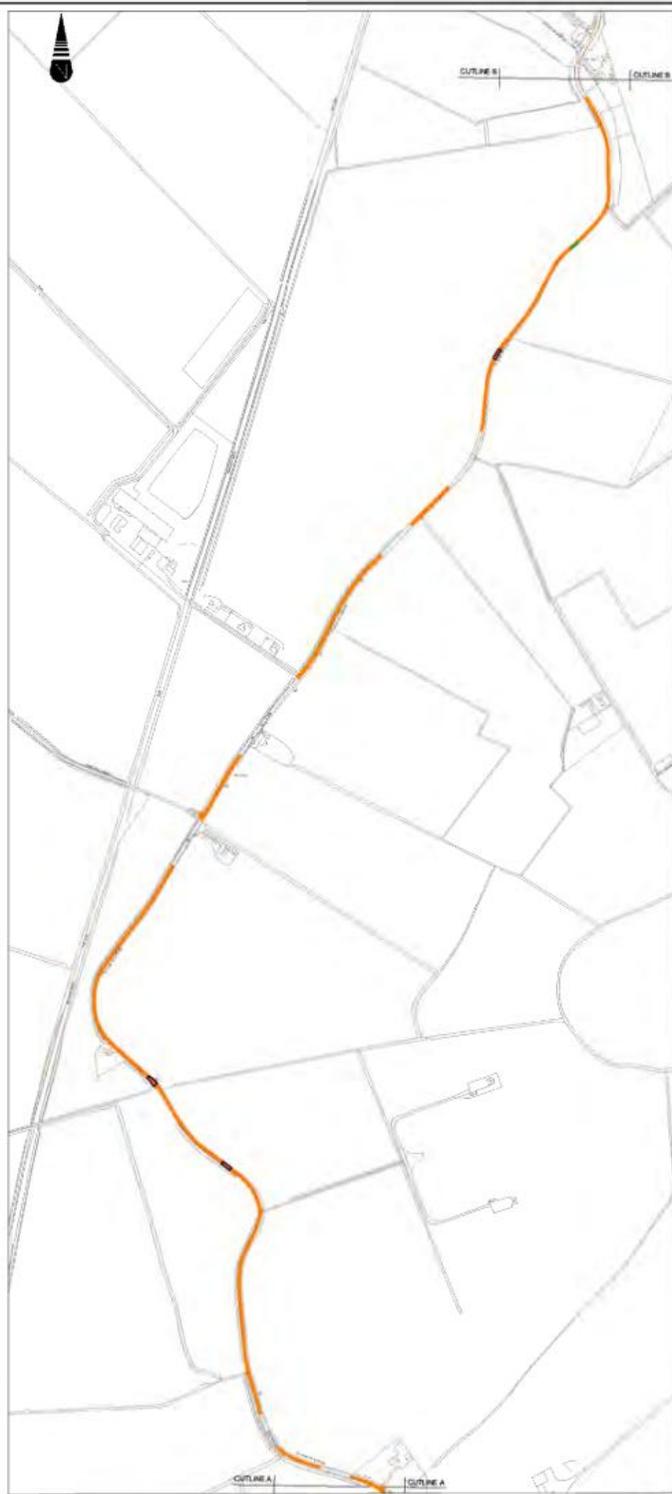
KEY:

International Roughness Index (IRI)
7+ is categorised as poor to very poor
requiring intervention:

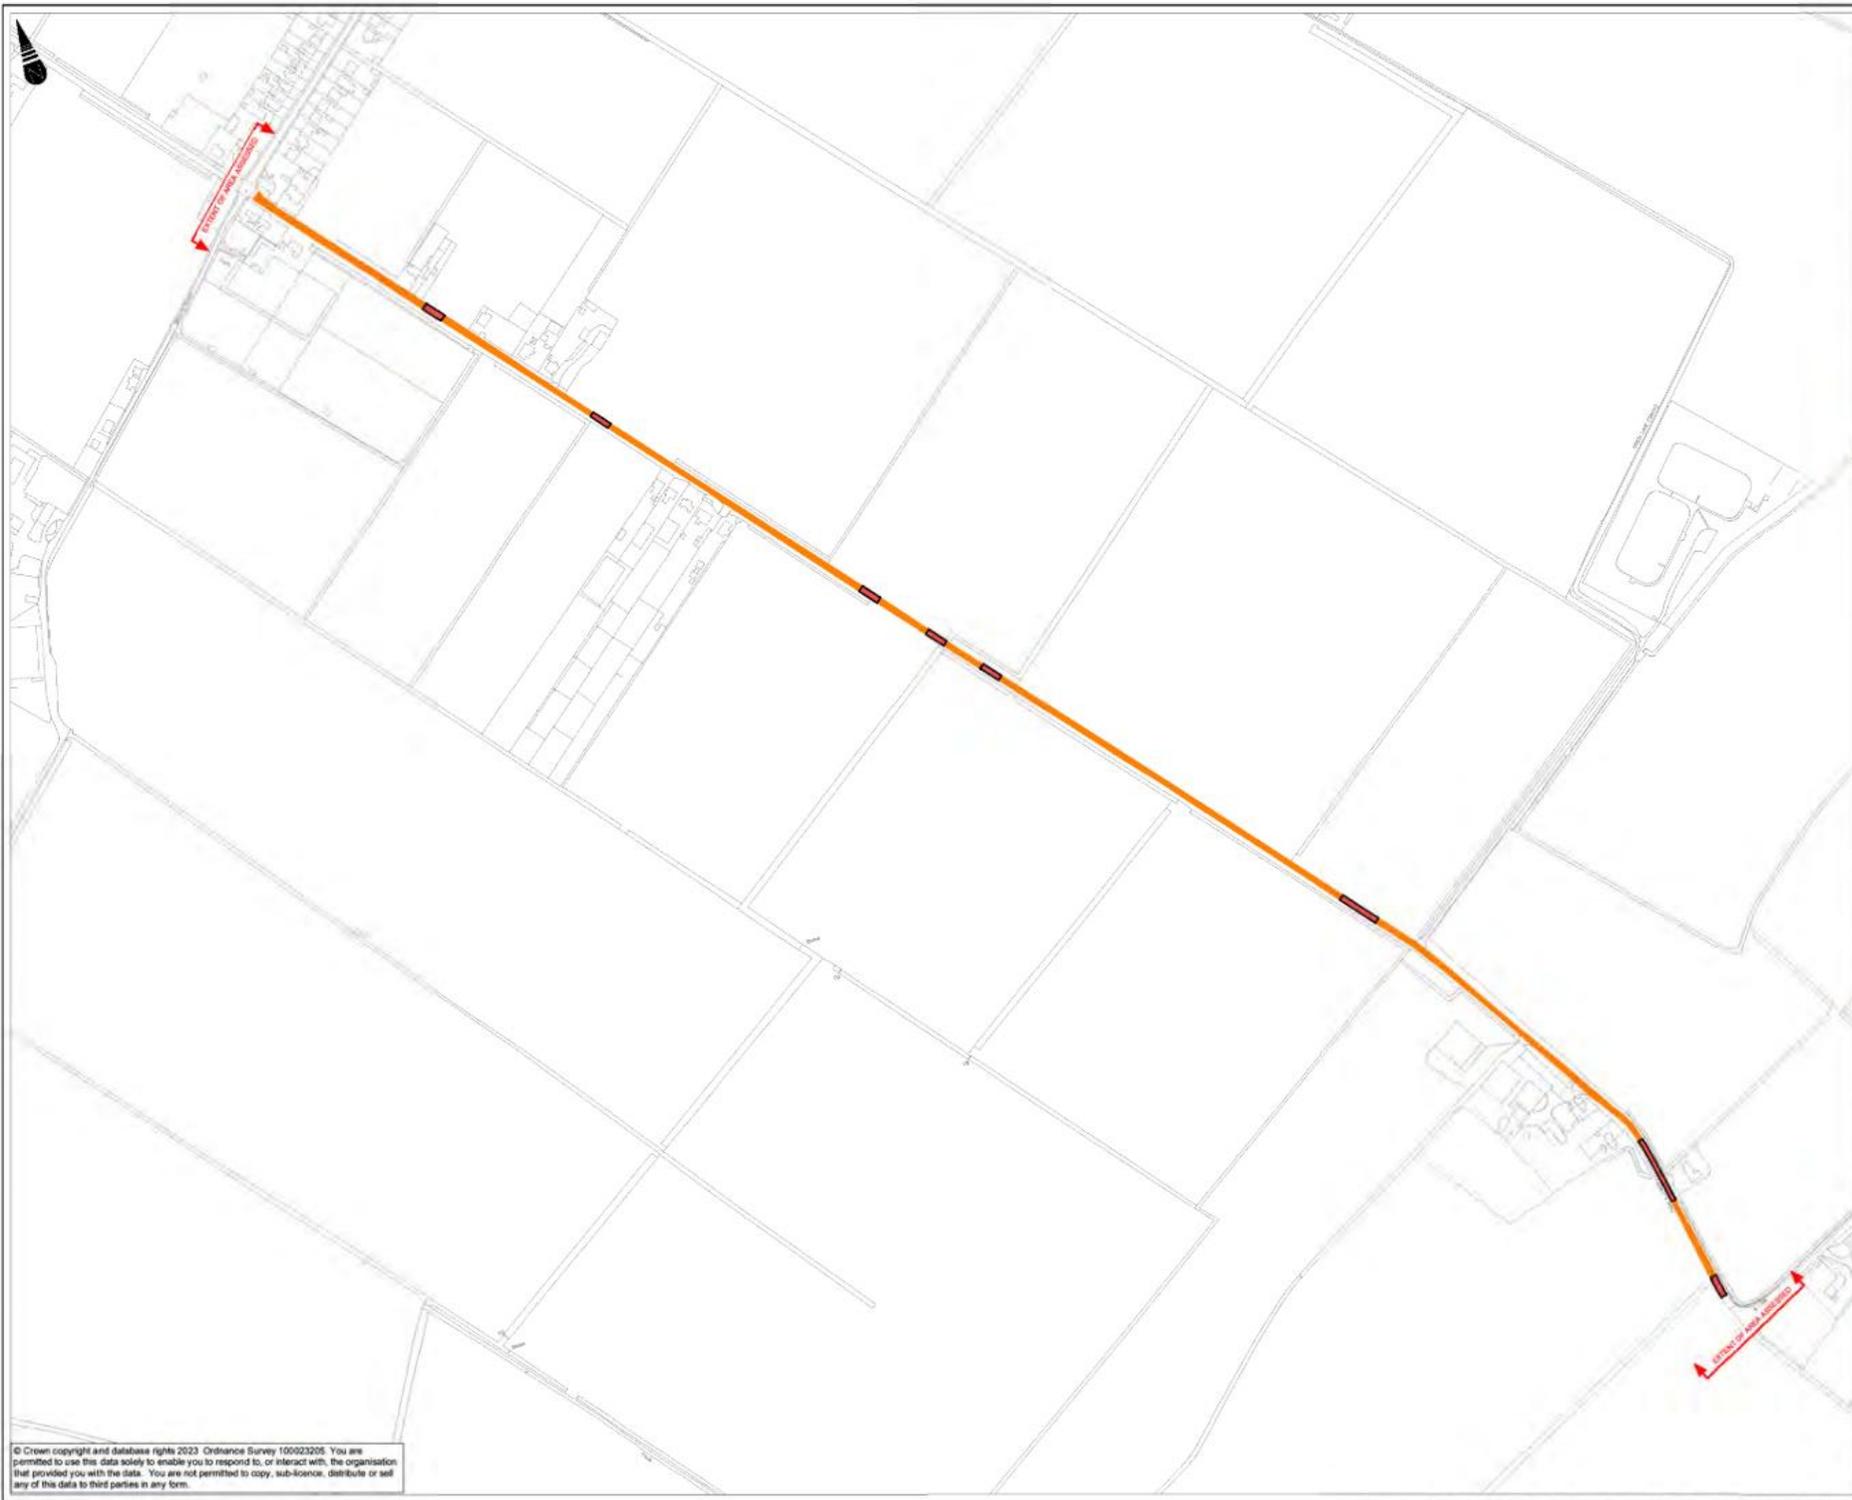
KEY:

International Roughness Index (IRI)
7+ is categorised as poor to very poor requiring intervention.

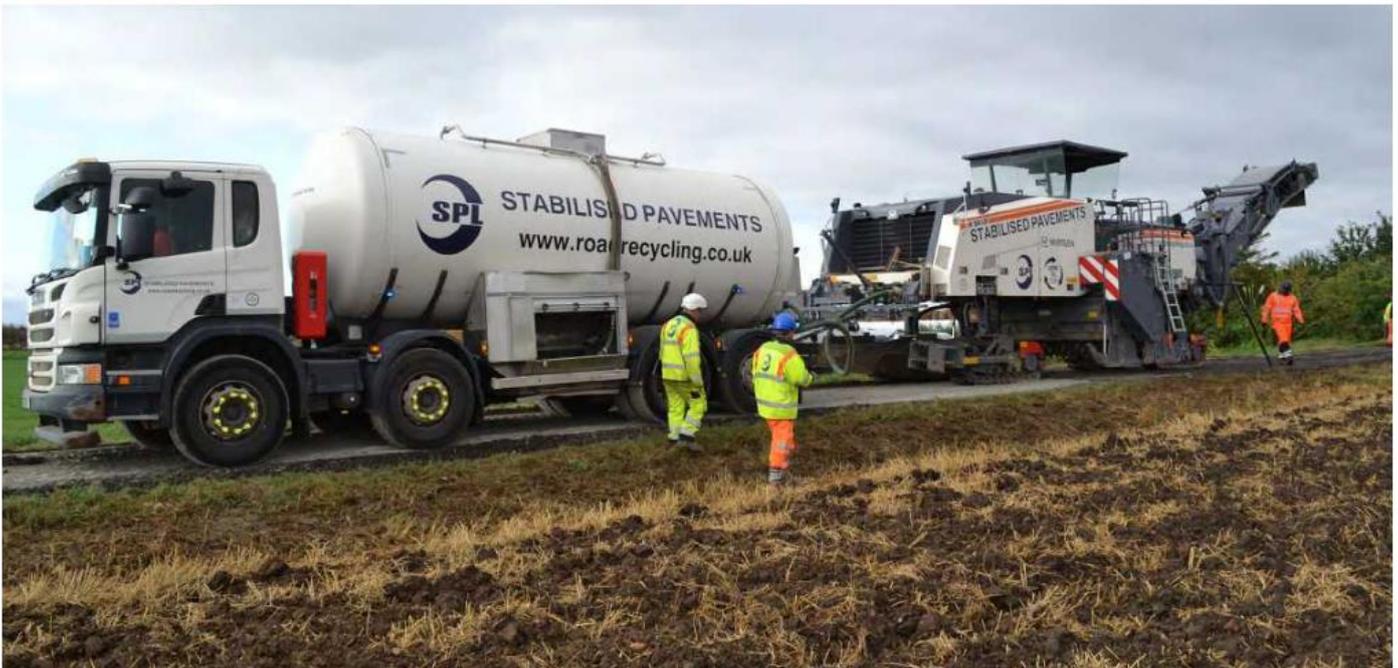
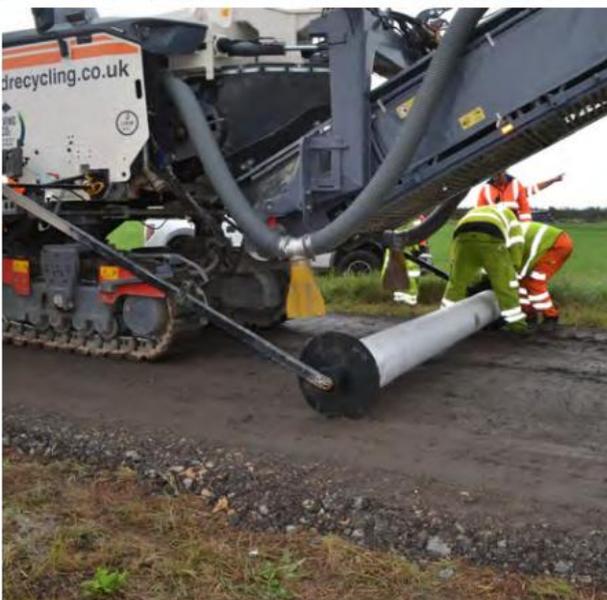
Due to a lack of formal, granular construction and the evolved nature of the road some 850 Tonnes of planings were imported to be recycled within the existing structural layers. Due to the presence of coal tar in the road, this allowed Cambridge to use tar bound arisings from elsewhere in the county which could be encapsulated within the Cant's Drove recycling. This structural benefit also helped to avoid any costly disposal of tar bound carriageway material.

Having imported the additional material, SPL's Wirtgen 380 would not only recycle and create a structural Hydraulically Bound Material to a depth of 150mm with the addition of 2% Cementitious Binder, but also would install simultaneously a layer of geotextile and a layer of geogrid – both would sit below the recycled layer with the grid providing more structural stability and the textile separation layer preventing any clay migration from below when re-opened to traffic.

In order to recycle and install grid and textile in one pass, the Blended Cement was spread and a planer gave an addition 1 metre width so that the 380 could pick up and mix all of the material, feed the paver, which in turn could be set to place the recycling to the required width of the carriageway.

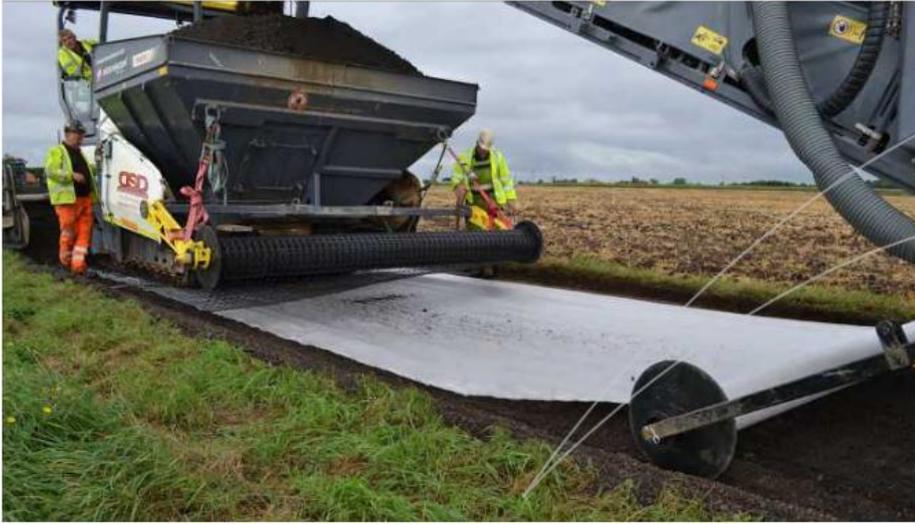
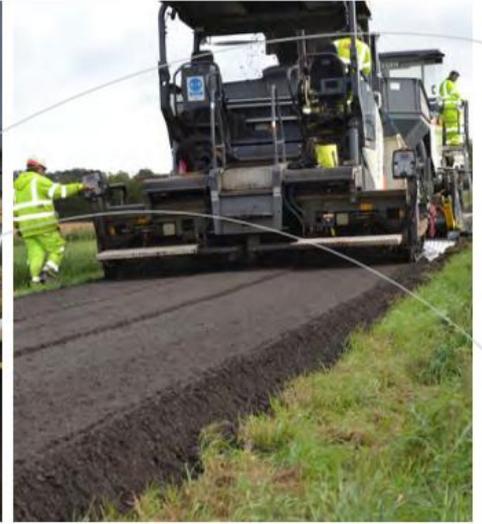
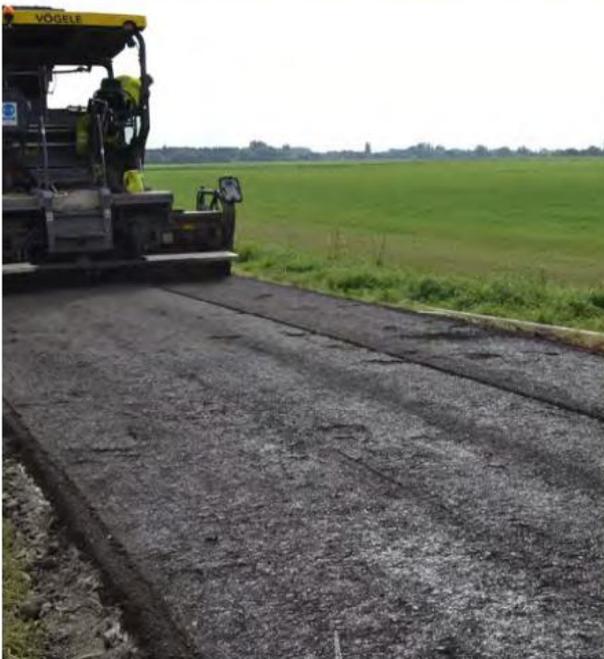
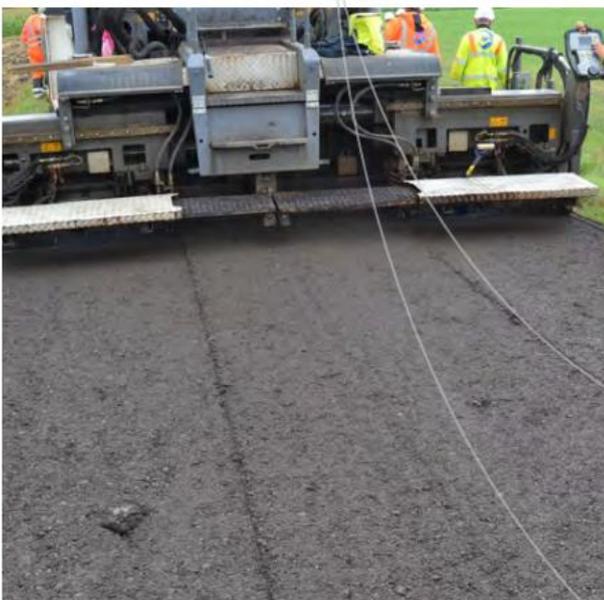
The recycled layer was completed with a K1-40 emulsion and sealing grit – applied to protect the recycled layer prior to surfacing and prevent the top of the HBM drying out too quickly to prevent any aggregate loss.

Following a light sweep of the carriageway Surfacing was carried out – unlike the usual Surface Dressing application for REGEN, due to the weight of traffic the recycling was capped off with a 60mm thick AC20 Binder course and a 50mm thick Cambridge Asphalt Surface Course. In turn providing a more robust construction over the enhanced recycling.

Due to the pace of installation the site preparation, including excavation of soft areas, the import and spread of planings and recycling complete with Geogrid and textile was complete within 3 days ready for surfacing thereby minimising disruption to the valuable work carried out by the Green Energy provider Adapt Biogas at Somerset Farm.

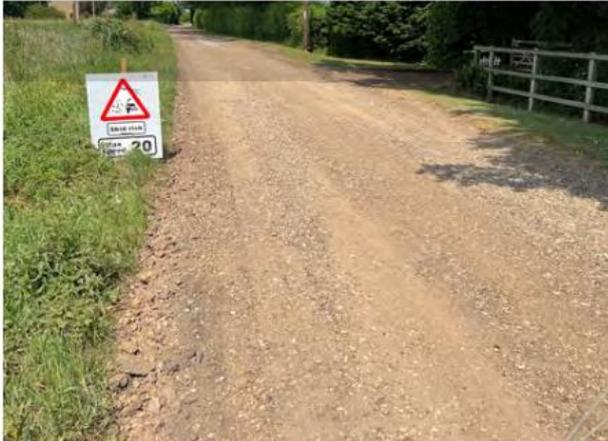
As an alternative to formal reconstruction or extensive patch repairs, the recycling of the existing carriageway material with a surface dressing represents a cost appropriate approach to highways maintenance.

Recycling to a depth of 150mm, the existing road layers were pulverised, compacted and re-shaped before the introduction of a cementitious binder (CEM 2 – a blend of 70% OPC and 30% PFA). The binder was spread at 2% by volume before the 150mm layer was mixed through with the blended cement and water to create our hydraulically bound material (HBM) which was once again compacted and shaped to ensure consistent depth of construction.

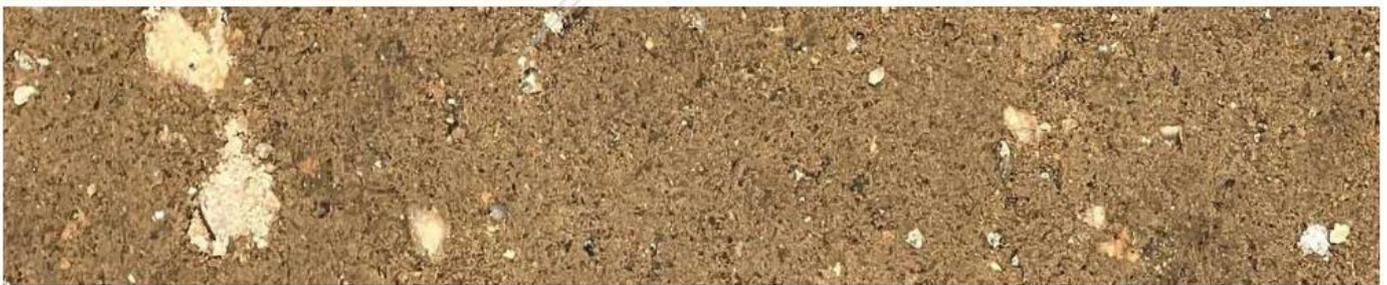
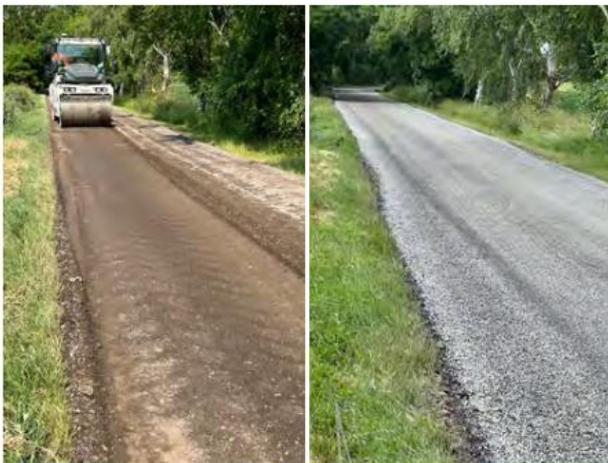
The profiling of the HBM also allows the smoothing out of high and low points in the existing carriageway, which cannot always be achieved through patch repairs alone. There are several benefits to this re-shaping:

- Road users experience a vastly improved ride quality.
- Falls are created to allow water to be vacated from the running surface.
- The removal of bumps and troughs reduces the impact of dynamic loadings thereby extending the durability and life of the road structure.

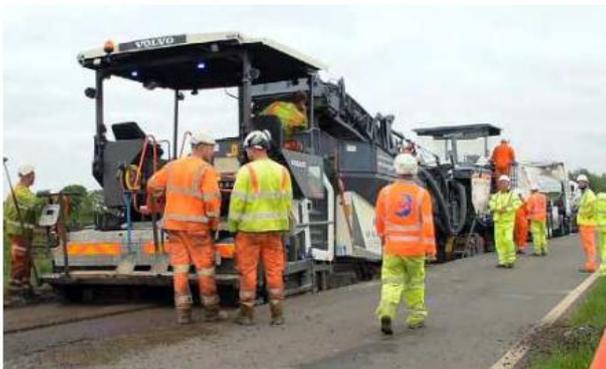
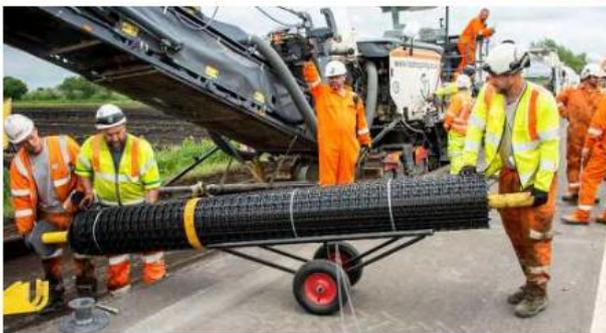
Wissington in Norfolk is the site of British Sugar’s largest refinery in the UK, indeed the largest in Europe, and the local highway network certainly takes the strain. Sitting on peat and soft ground, alongside deep drainage ditches, the client required a deeper solution than simple asphalt patching.

The reconstruction of this section of College Road involved in situ recycling the existing carriageway materials using cementitious binder placed onto the road prior to mixing, to create a Hydraulic Bound Material as well as a section of Foamed Bitumen binder injected into the mixing chamber of the recycler to create Bituminous bound cold recycled material.

The recycled layers in both sections received an Asphalt Binder course and an Asphalt Surface course.

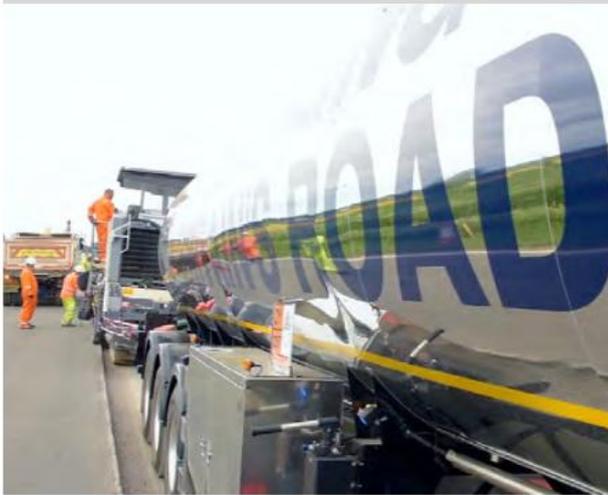
A polypropylene geogrid, incorporated into the reconstruction below the recycled layer and above the subgrade had been proposed, which historically would have meant excavation of the carriageway to lay the grid before covering and recycling.

SPL have now developed a pioneering “one pass” technique by using the Wirtgen 380CRi. As the recycling takes place, this state-of-the-art recycler exposes a section of subgrade below the material conveyor for a brief period, presenting the opportunity to roll out the grid before the recycled layer is placed back onto this grid in the road through the following paver.

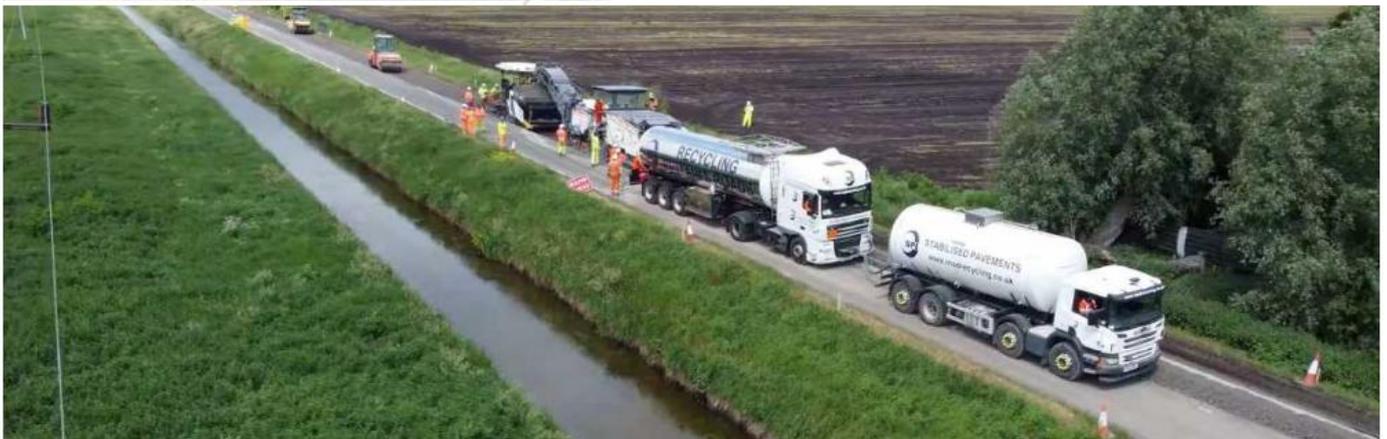
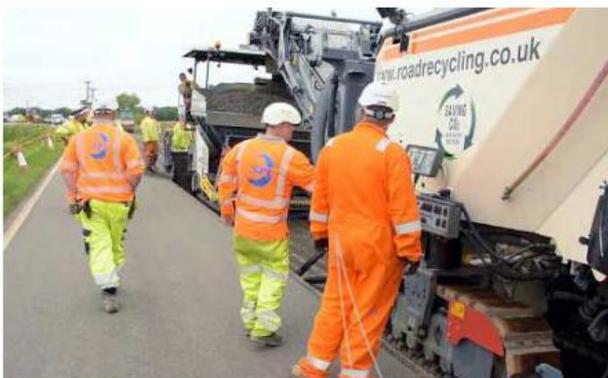
This installation technique has minimal impact on the delivery of the recycling in terms of productivity yet benefits the construction by acting as a spring constraint preventing the development of micro cracks through crack recovery when loads are applied within the grid layer. This mitigation of the development of cracking preserves the structural benefits and life of the hydraulically and bitumen bound recycled layers therefore preserving the integrity as a supporting layer to the Asphalt above.

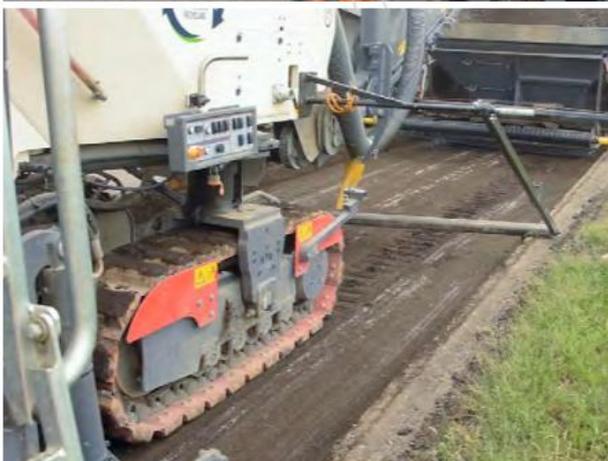
In addition to the successful trial of this installation technique, a trial section using Foamed Bitumen to create a Bituminous bound cold recycled material was also carried out as an alternative to the cementitious Hydraulically Bound Material. Creation of the product in Phase 2 of the works (B1160 East West) was achieved utilising the Wirtgen 380CRi, recycling the existing carriageway aggregate using bitumen with good foaming characteristics and additions of cement and Pulverised Fuel Ash (PFA). This section will be monitored closely to evaluate the impact of moisture and sub-grade to establish performance compared to the HBM.
