Examples of Highway Maintenance Treatments

Carriageway recycling on peat soil affected road – before and after photographs

Footpath improvements - Queens Walk

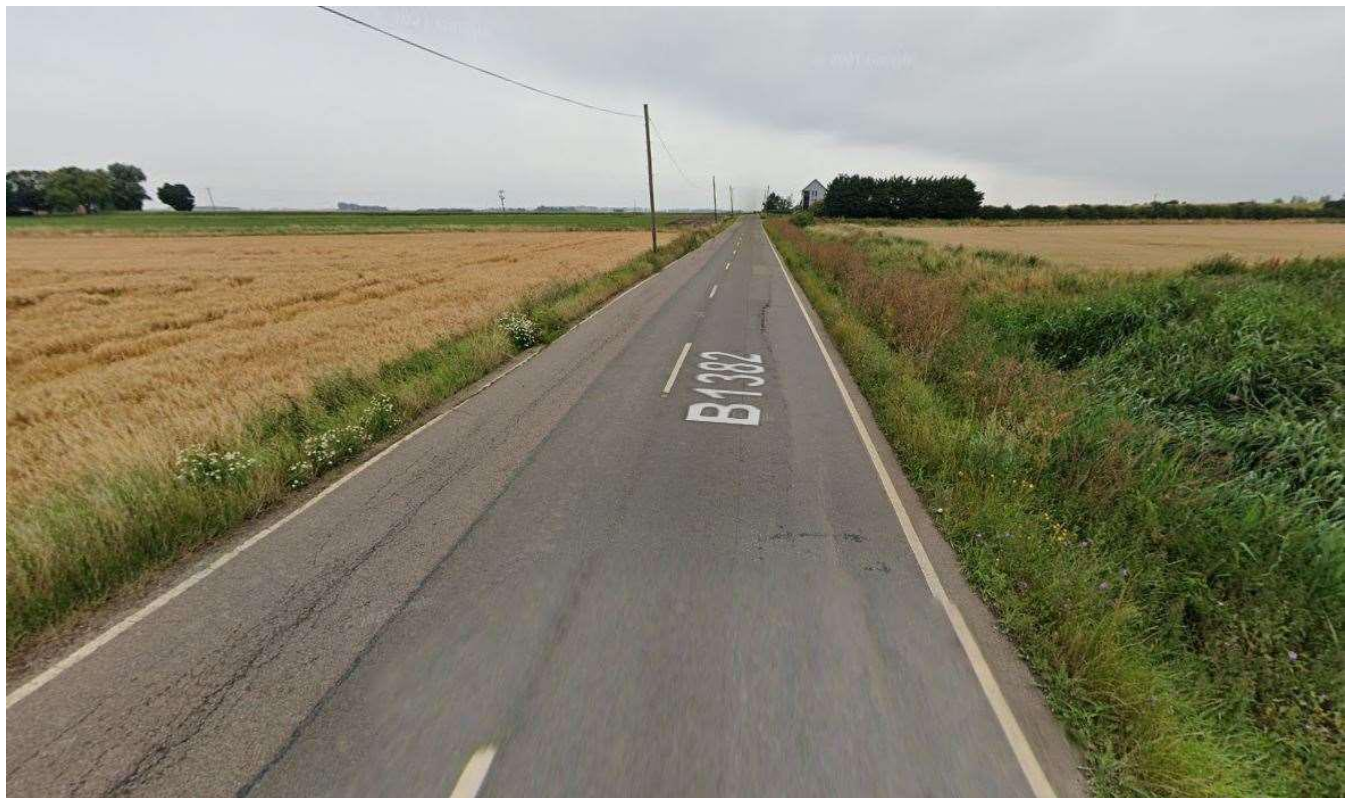
Before

B1382, Queen Adelaide/Littleport in 2022/23– see detailed case study attached at the end of this appendix.

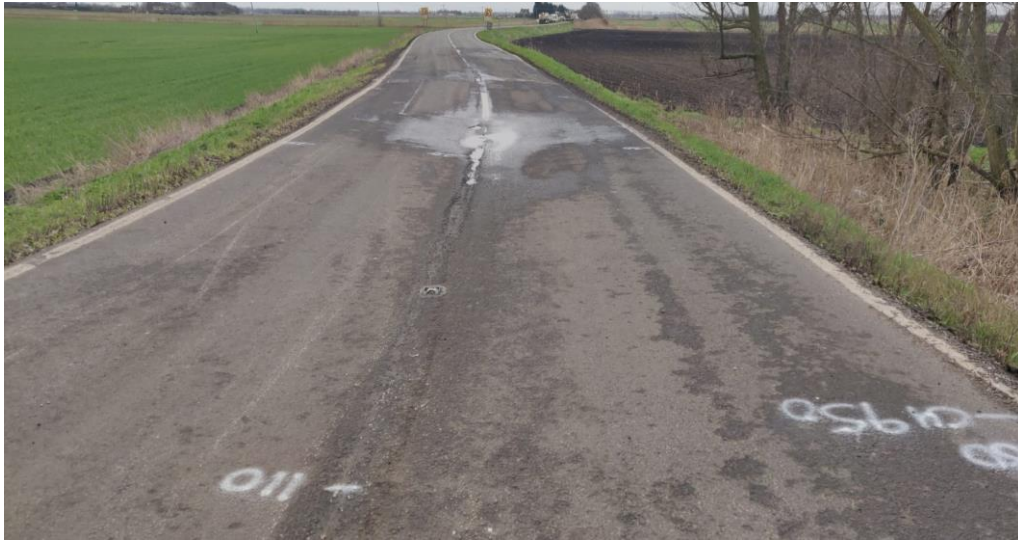
Before

A1101 Mildenhall Road, Littleport – 2022/23 to 23/24

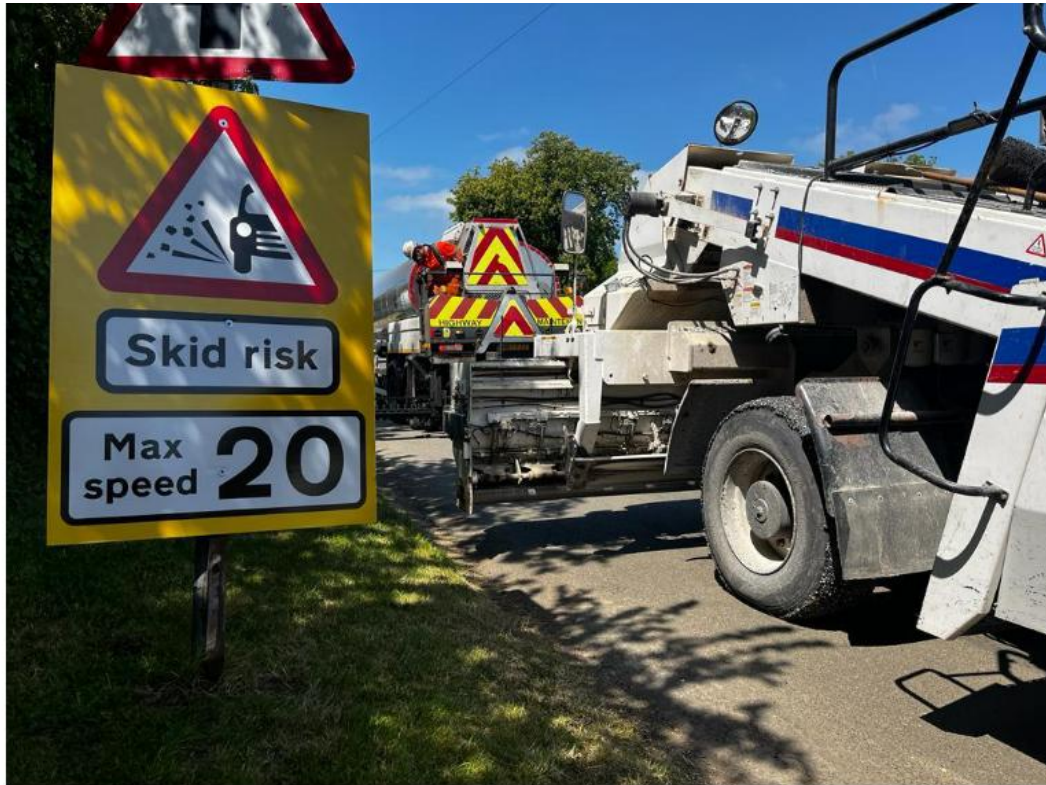
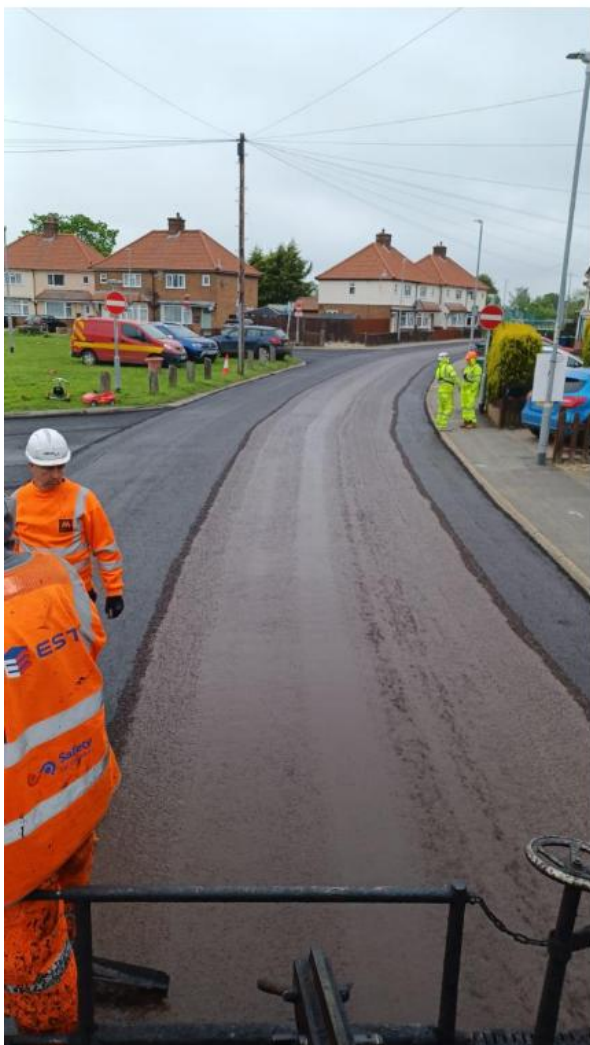
Surface treatments – surface dressing and micro asphalt surfacing

The photographs below are of work carried out in Cambridgeshire, showing the two treatments being undertaken, and the results following completion of works.

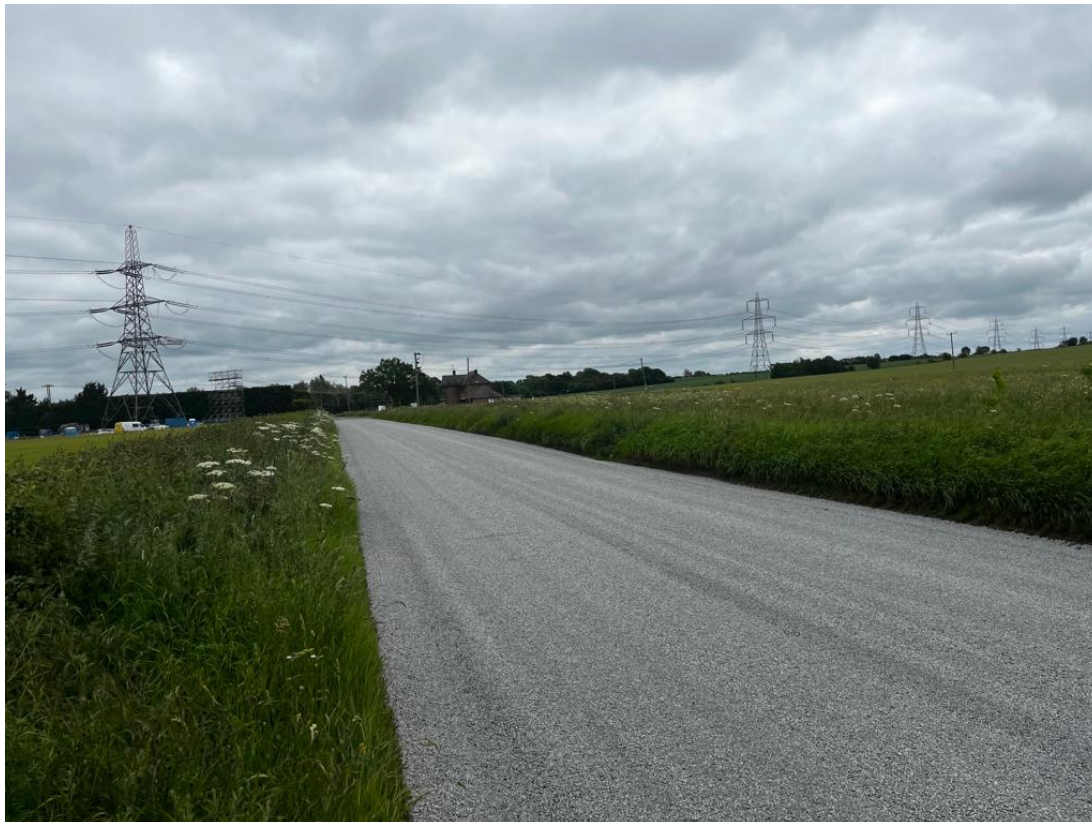
Completed Surface Dressing – B645 Hail Weston Road, Great Staunton – summer 2023

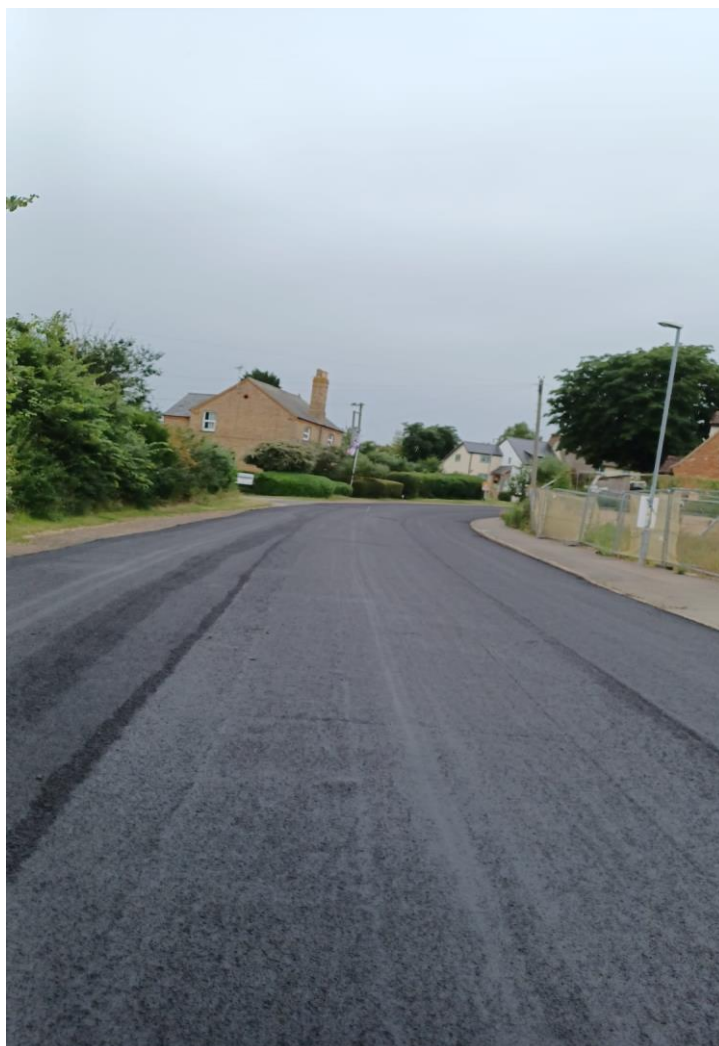
Completed Micro Surfacing – High Street, Landbeach – 2023/24

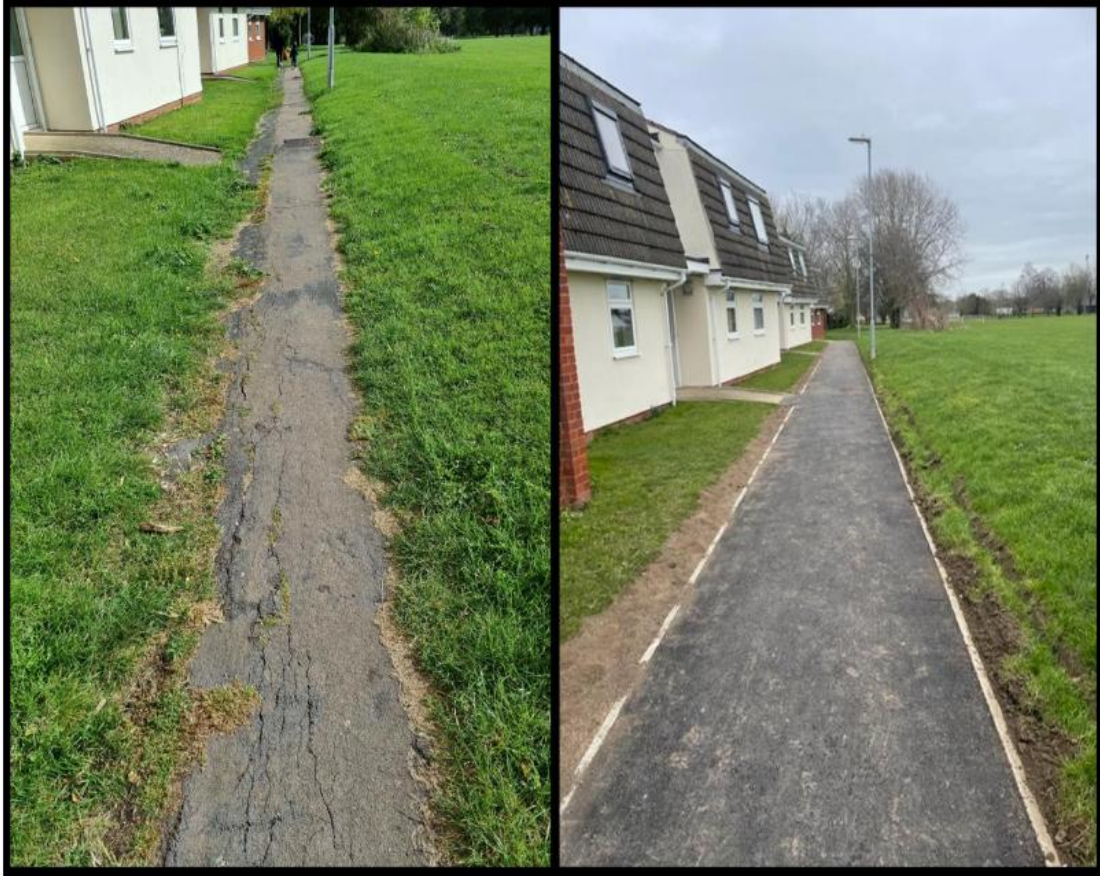
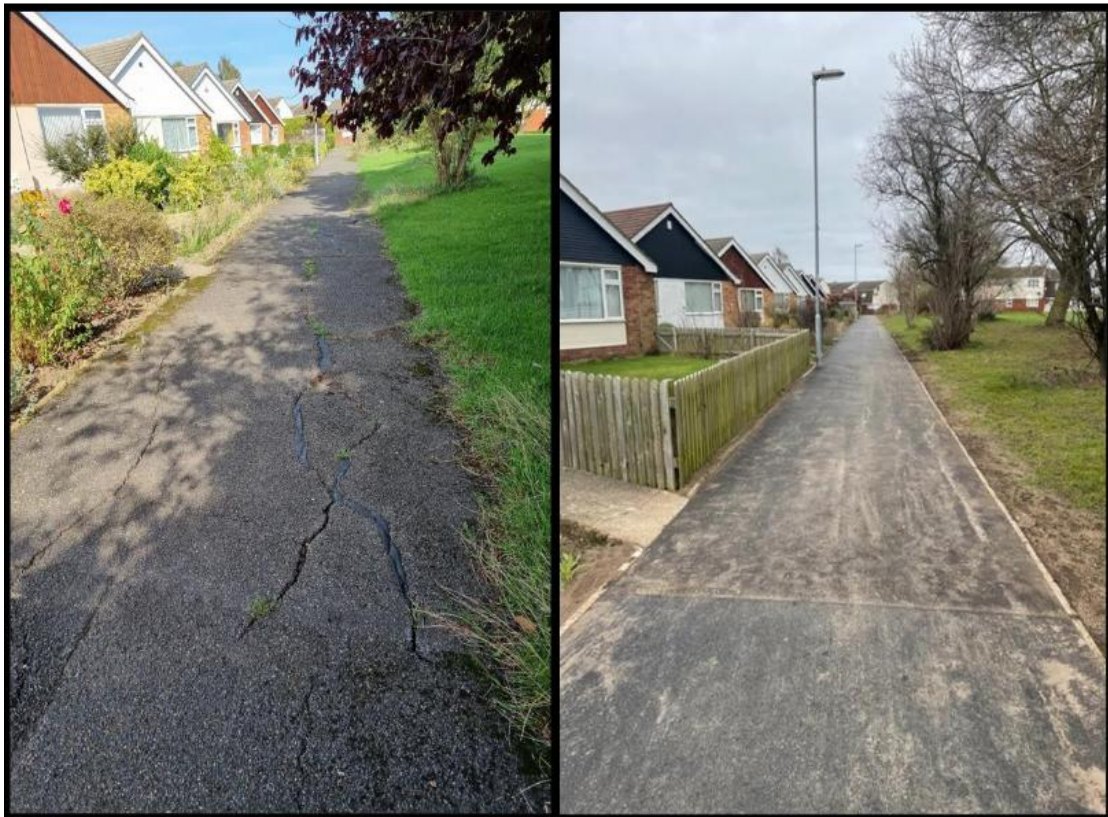
Queens Walk, Ramsey – 2023/24 - Resurfacing of a bituminous footway and replacement of an uneven concrete overlaid footway – see detailed case study attached at the end of this appendix.

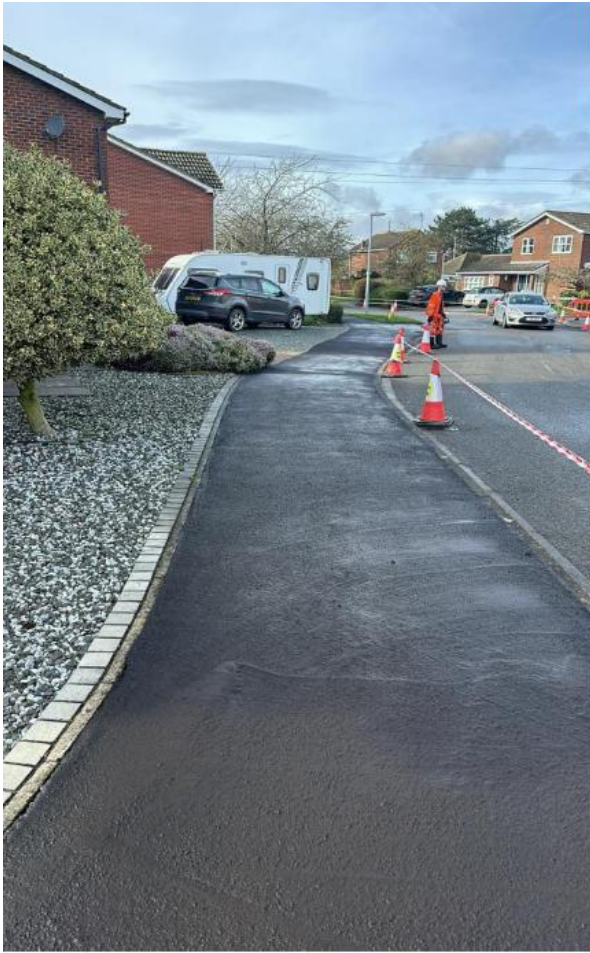
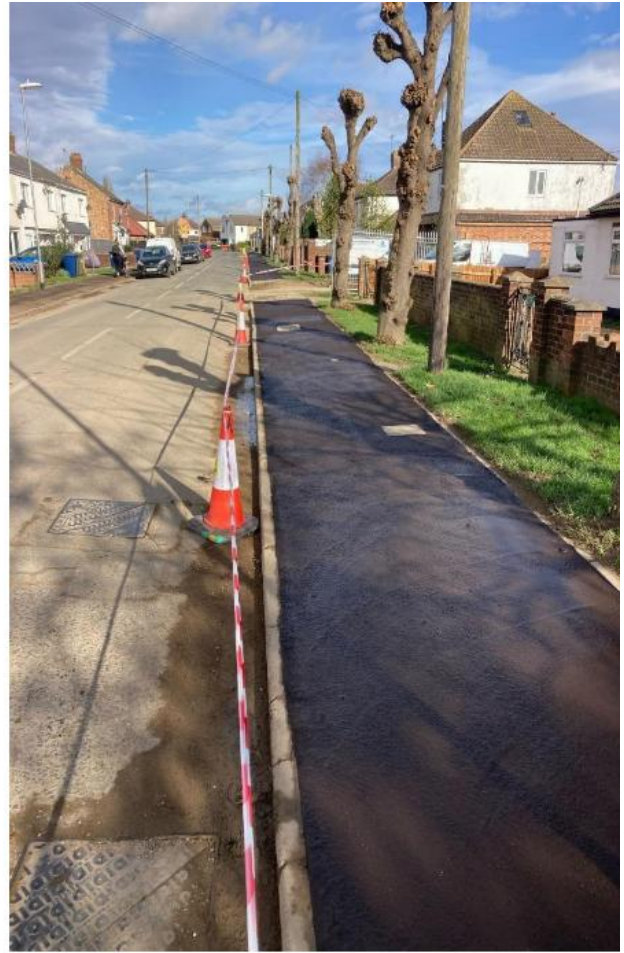
Footway slurry sealing works – 2023/24 – Gresley Way and Norwood Road, March

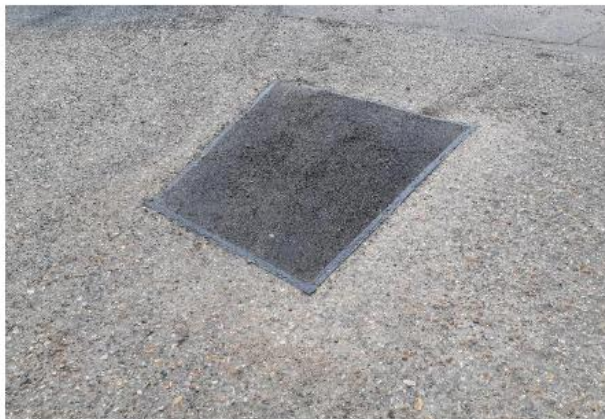
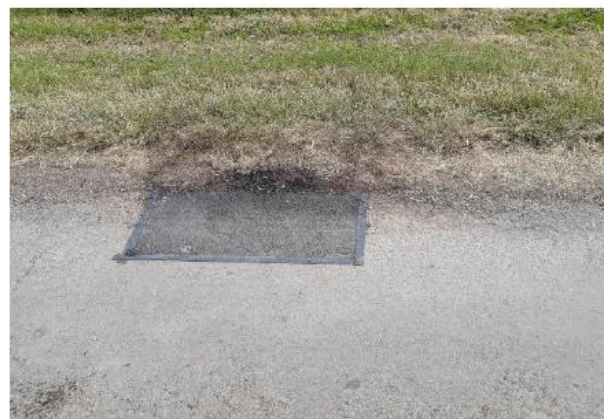
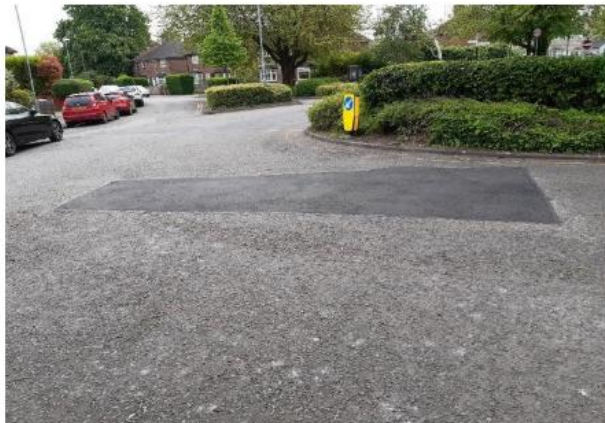
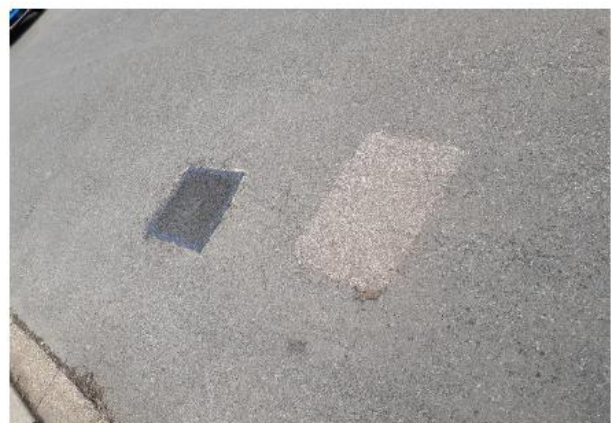
Capitalised Road Patching 2023/24 – locations include: Station Road, Whittlesford / Lode Way, Haddenham / Cromwell Road, Cambridge / Russell Avenue, March

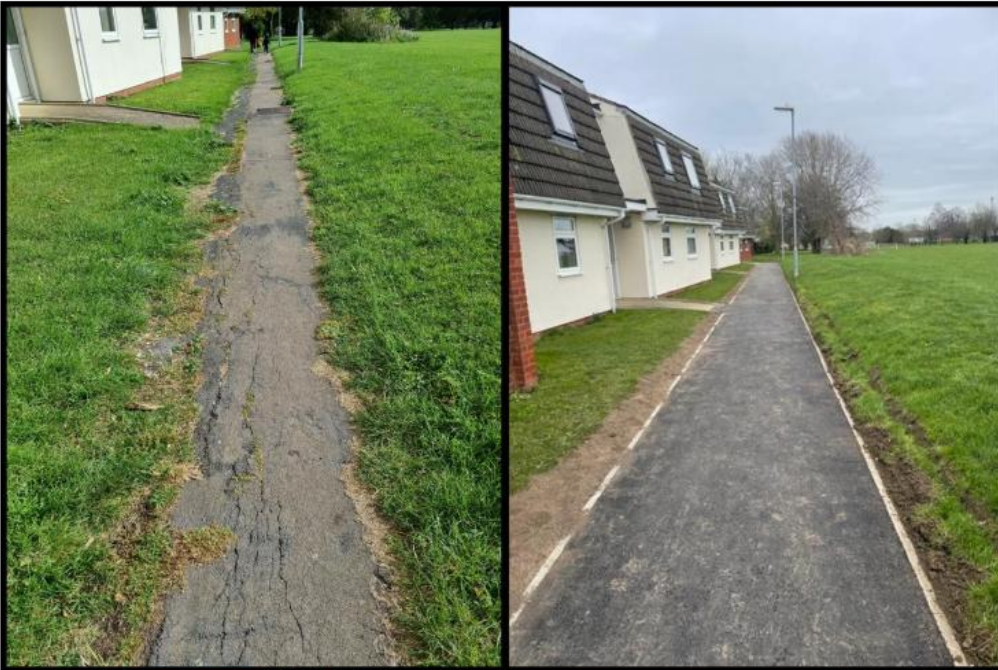
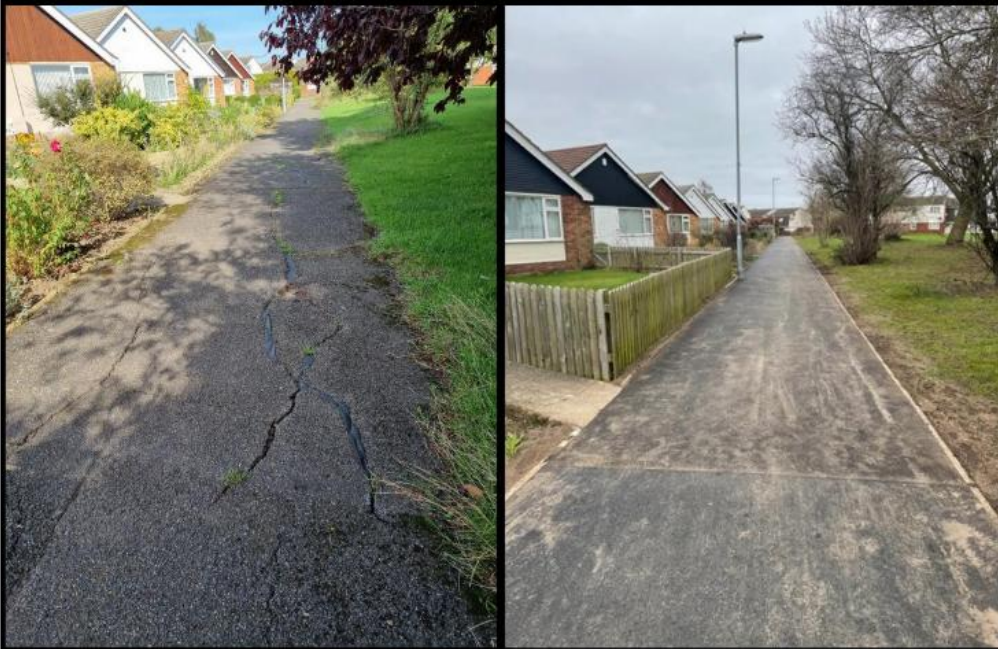
- The existing construction consisted of a concrete slabbed base, with various asphalt surfaces added in recent years.
- The underlying construction consisted of concrete slabs; previous efforts had been made to patch the impacts of the slabs which had been lifted by buried the tree roots.
- This resulted in significant level changes which needed to be addressed urgently due to the risks the existing profile posed to walkers.
- The area in question has a large elderly population who were unable to use the footpath in its current condition.

- Surface / binder course.
- Concrete edging.
- Subbase levelling.
- Footway widening.
- Reprofilng.
