# TECHNICAL NOTE 1

**SUBJECT:** A14 NMU Routes BN18 and BN22 Safety Reviews

**PROJECT:** A14 NMU Bridges

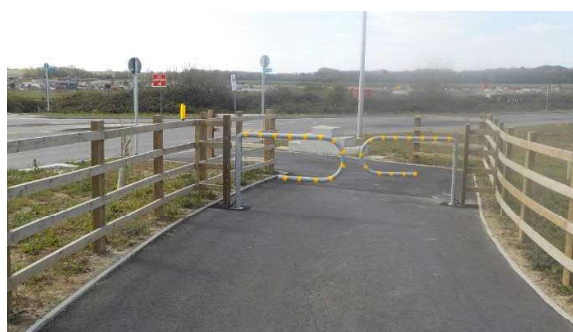
Figure 7- View looking towards uncontrolled crossing

On the Swavesey south route, the gradients are more gentle and the route leads to an uncontrolled crossing via a 90-degree bend. At the tie in to Boxworth Road, there are wayfinding signs for pedestrians, cyclists and horse riders, but the shared signs leading to the NMU bridge is only signed for pedestrians and cyclists. It is therefore unclear whether horse riders are expected to use the bridge.

Cyclists descending the ramp at Swavesey south have good visibility to approaching cyclists/ pedestrians and will be slowing down to the crossing due to the 90-degree bend. The risk of collision with other pedestrians/cyclists and vehicles at this location is low.

It is recommended that the chicane barrier arrangement at this location is removed. It is also recommended that a form of vehicle access control is provided to prevent unauthorised vehicles from accessing the NMU route.

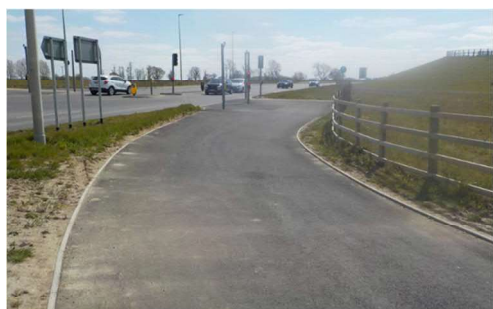
Figure 10 – View looking at controlled crossing

The NMU route over the A14 at its northern end joins the existing road (A1307) parallel to the A14 via a controlled crossing.

The slope on the northern approach ramp is gentle and unlikely to encourage higher cyclist speeds. The visibility to other approaching cyclists/ pedestrians is generally good. There is a wide verge serving as a buffer zone between the NMU route and the carriageway. The risk of speed and collisions with other pedestrians/cyclists or vehicles at this location is low.

It is recommended that the chicane barrier arrangement at this location is removed. It is also recommended that a form of vehicle access control is provided to prevent unauthorised vehicles from accessing the NMU route.

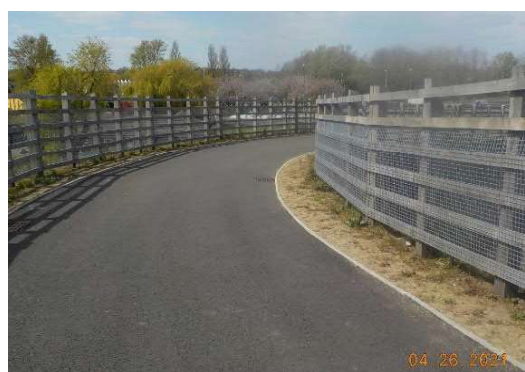
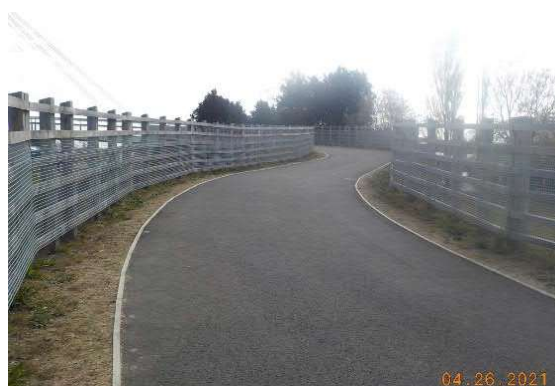
South of the NMU bridge, the alignment of the route follows a series of horizontal curves and gradients along this section appear to be steep (LTN 1/20 recommends a desirable maximum length of 30m for a 5% gradient). The edge of the NMU route is protected by a high fence infilled with mesh. Visibility along this section of the route is restricted by the horizontal curvature and fence. There is no visibility to other approaching cyclists/pedestrians or horse riders and there is an increased of conflict between cyclists and pedestrians/other cyclists and horse riders. Any conflicts between cyclists/pedestrians/horse riders is likely to occur within this section.

Figure 9: View of obstructed visibility

Figure 10: View of obstructed visibility

- The chicane barrier arrangement is removed.
- A form of vehicle access control is provided to prevent unauthorised vehicles from accessing the NMU route.
- The hotel sign in the northern verge of The Willows is set further back and overgrown vegetation cut back to improve visibility to vehicles exiting The Cambridge Bar Hotel.
- Cycle logos are installed on the outside of the bend on the downward grade where visibility is poor to encourage cyclists to keep to the edge of the NMU route thereby minimising conflict with other users.

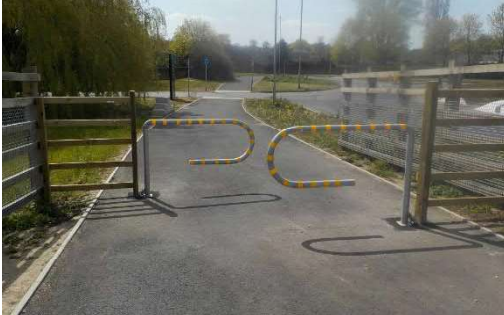
Figure 11 – View from route looking towards The Willows.

Visibility as the route approaches the Willows is generally good although it is partially obstructed by a large sign and overgrown vegetation in the northern verge of The Willows.

At the location of the southern barrier, cyclists will generally have good forward visibility to traffic however visibility to vehicles exiting The Willows is obstructed by the hotel sign and overgrown vegetation. Risk of collision with vehicles or other cyclists/pedestrians is low.
