## Cambridgeshire Guided Busway

### Advisory Report on Guideway Investigations, Defects and Corrective Measures

Advisory Report on Guideway Investigations, Defects and  
Corrective Measures

| Date | : | 1 November 2016 |

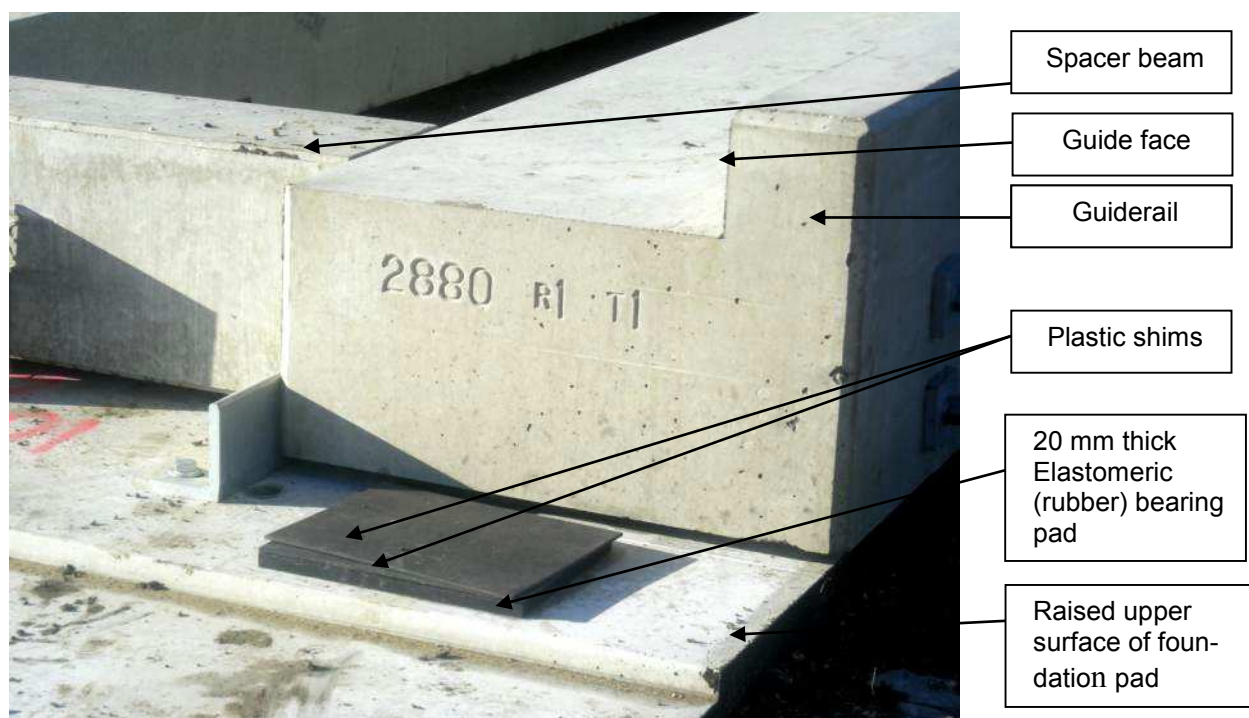
**Figure 2. Photograph of a part of the guideway during construction, showing a spacer beam, guiderail, shims, bearing pad, and foundation pad.**

12. The shims are the only part of the guideway structure that are designed to be removed or added to allow limited vertical movement between the foundations and guideway ladders. The individual shims are of 2mm and 5mm thickness so that small, millimetre scale adjustments can be made to ensure the continuity of bearing between the guideway ladders and the foundations.

13. The elastomeric (rubber) bearing pads are present to provide uniform seating of the beams and to permit the ends of the guiderails to rotate without damage occurring to the concrete. Such rotation occurs when buses pass along the guiderails causing them to move downwards slightly, and also when one foundation of a guiderail moves vertically relative to the next foundation – the design was supposed to allow for 25mm of such differential movement of the supports.

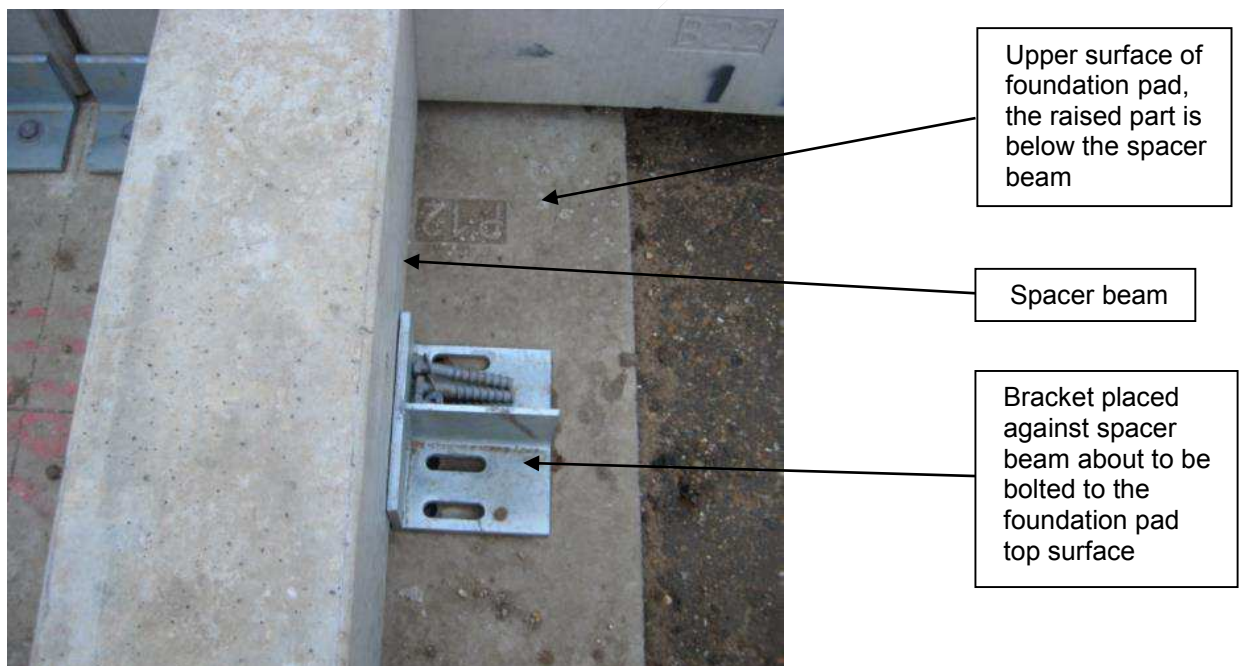
**Figure 4. Photograph of a 'fixed' joint longitudinal restraint bracket.**

15. Alternate joints in the ladders are designated as 'fixed' and the guideways at these locations are designed as touching end-to-end. At these locations both ladders were 'fixed' by brackets positioned against the spacer beams and bolted to the foundation pads or pile caps. These brackets are intended, according to DDG Rev 6, to provide restraint to longitudinal movement of the ladder units under a longitudinal force of about 24 tonnes.

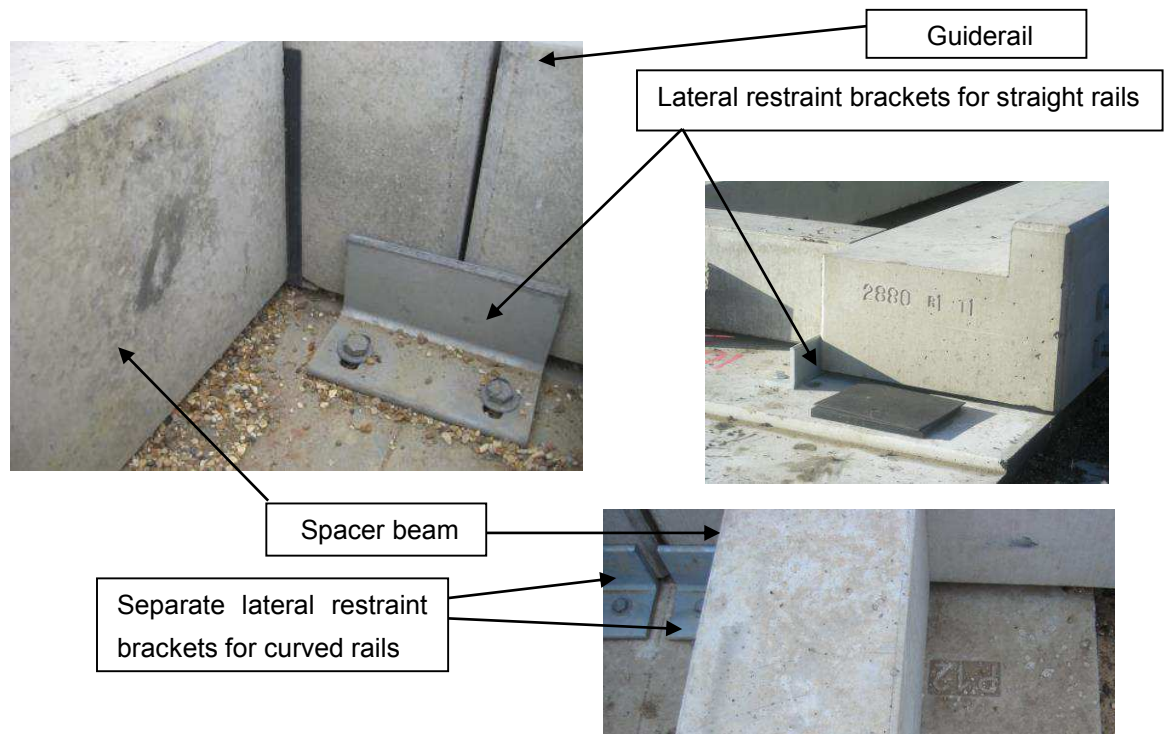
**Figure 5. Photographs of lateral restraint brackets.**

17. The beams are designed to be restrained laterally (across the direction of bus travel) by brackets that are placed against the inside of the guiderails at every joint.

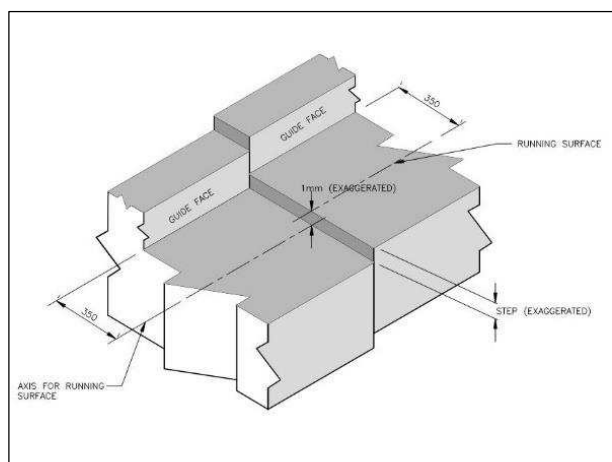
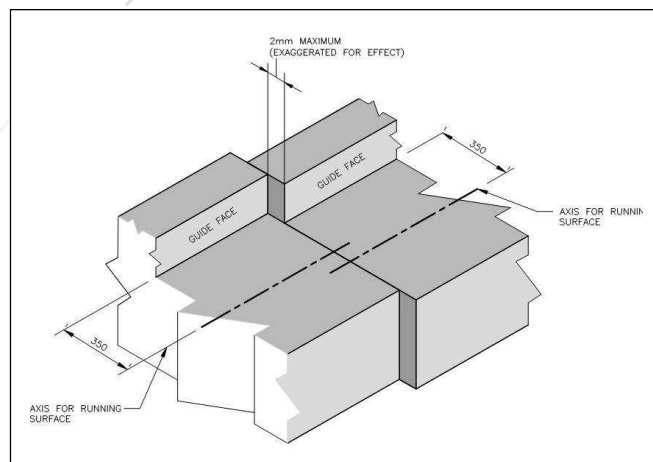
81. Investigation C records, inter alia, vertical and horizontal steps at joints. Figures 13 and 14 above show the limits of these steps required by the Works Information. We include in Appendix D, summaries prepared by Atkins of the extent of vertical and horizontal joint displacement before the investigations, surveyed from September to November 2015 and since Investigation C (based on a survey by Atkins on 16 May 2016). . Atkins has carried out an assessment of the Investigation results and compared these with the step dimensions in Defect Notice 287 and 288. This led Atkins to carry out a re-survey in May 2016 to resolve certain anomalies in the results. This showed that in some 13 instances the Defect Notice dimensions were incorrect and that in several locations the steps had increased in height. Atkins has reported (see letter to BAMN dated 26 July 2016 included in Appendix D) that there are 343 instances (i.e. 6.1%) of vertical steps at joints greater than 2mm.

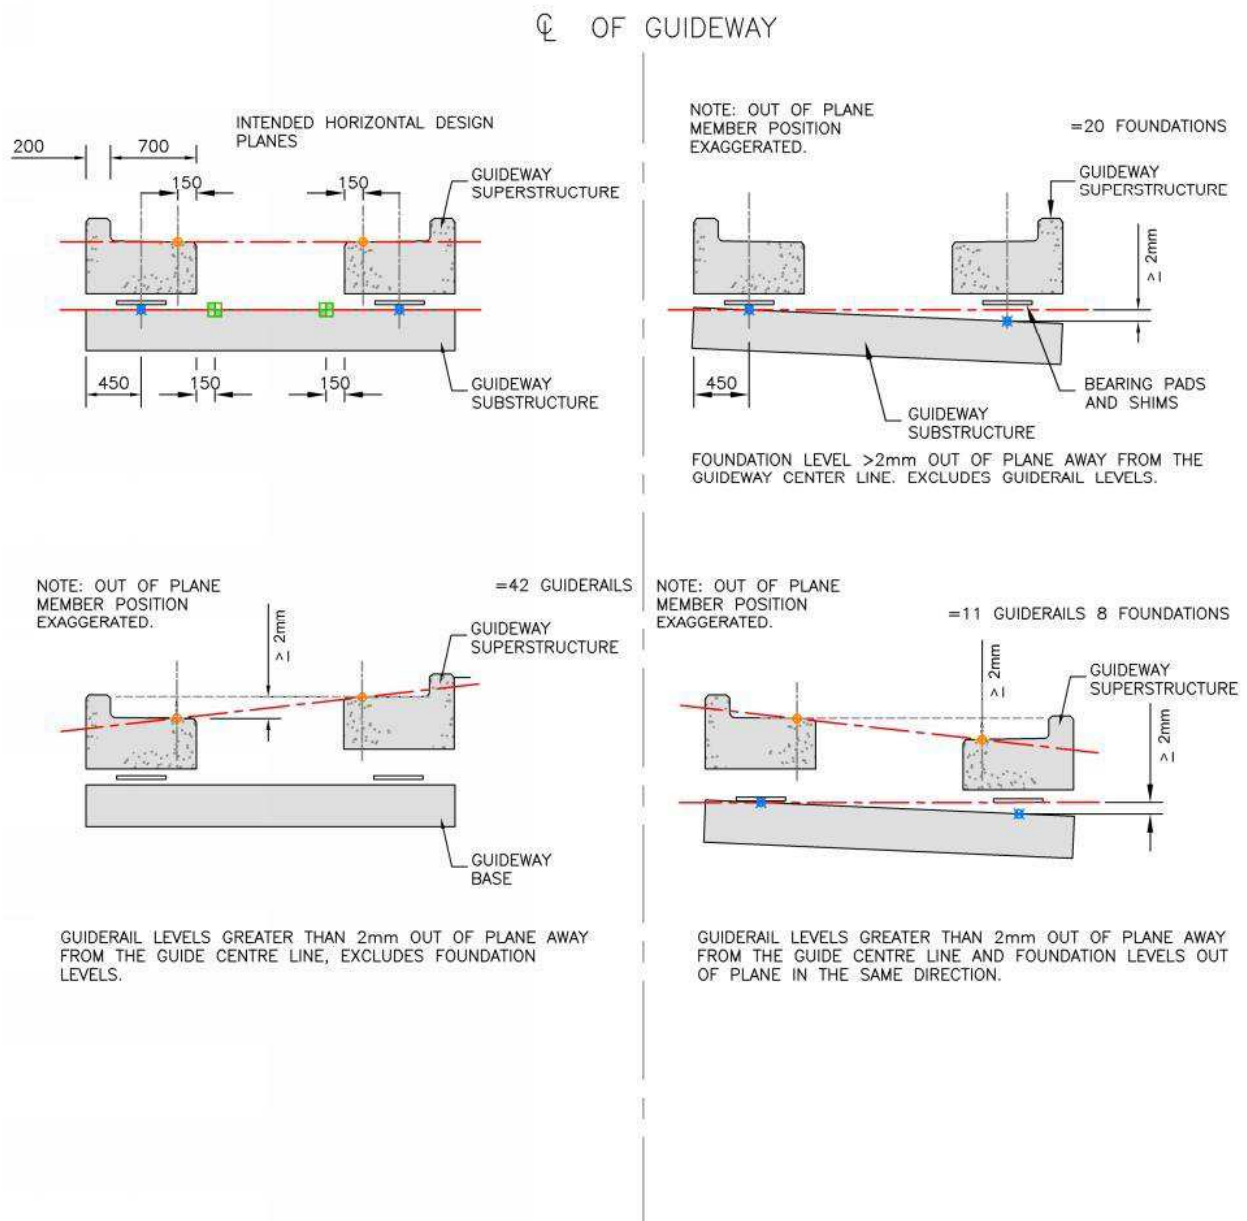
Figure 15. Diagrams to accompany Table 3.

91. Figure 15 below presents diagrams to explain the descriptions in Table 2 above.
92. Of the 26 supports where the guiderails and foundations are out of plane in the same direction with vertical differences of greater than 2mm, 10 of the supports are adjacent to each other on the same foundation which relates to movement of five foundations.

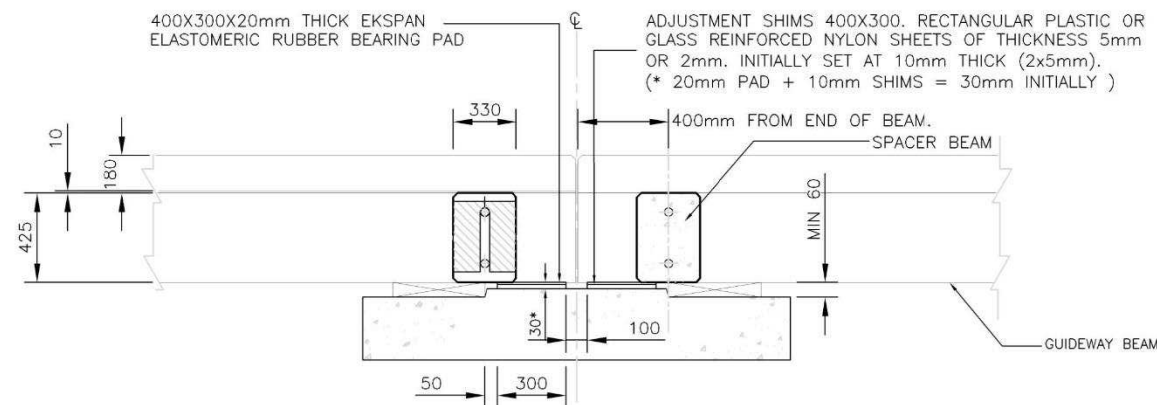
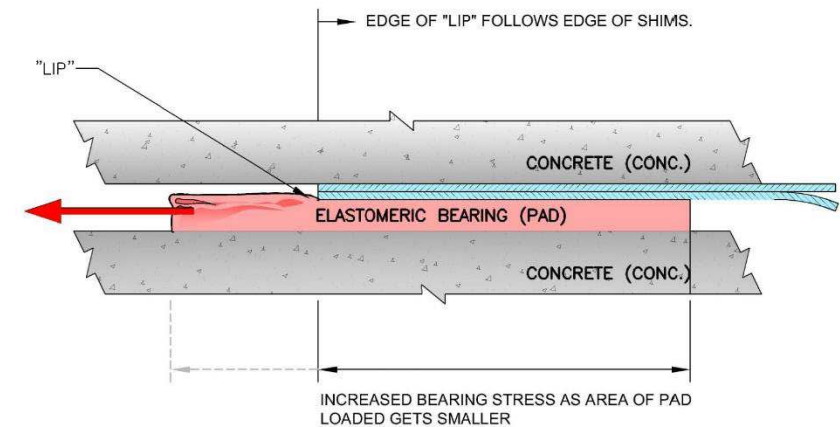
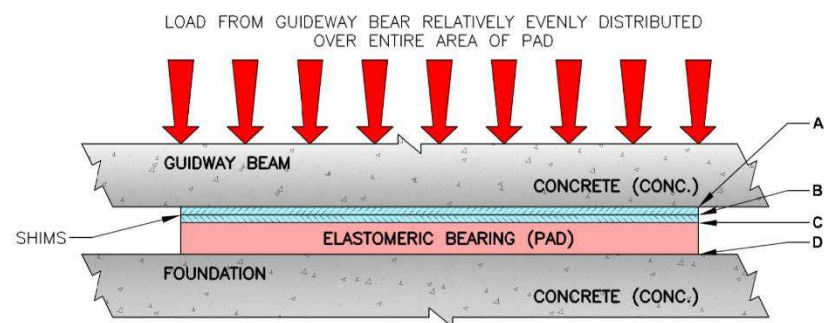
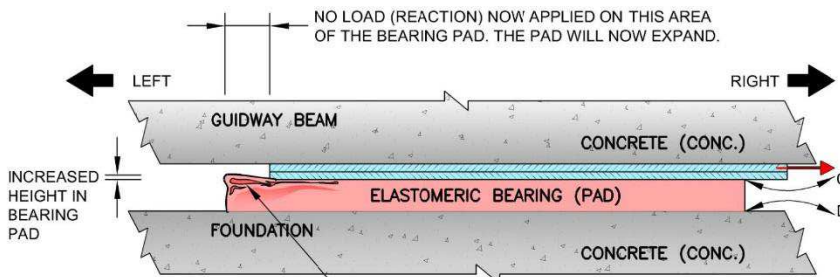
## **APPENDIX F – PROBABLE MECHANISM FOR ‘WALKING’ OF BEARINGS**

3. THERMAL MOVEMENT CAUSES BEARING PAD TO MOVE TO LEFT.

NOTE:  
AS THE SHIMS PROGRESSIVELY MOVE OUT THE "LIP" WILL FOLLOW. HEIGHT OF LIP WILL PROBABLY INCREASE AS THE AREA OF SHIM TO BEARING PAD CONTACT BECOMES LESS AND THE BEARING PAD STRESS IS INCREASED. THE LARGER STRESS WOULD TYPICALLY CAUSE A GREATER COMPRESSION (SQUASHING) OF THE PAD.

1. INITIALLY, AS INTENDED, BEARING PAD AND SHIMS ALL ALIGNED

2. THERMAL MOVEMENT CAUSES SHIMS TO MOVE TO THE RIGHT.

THIS EXAMPLE ASSUMES THAT THE COEFFICIENT OF FRICTION AT THE SHIM TO PAD INTERFACE (C) IS LESS THAN THAT AT PAD TO FOUNDATION CONCRETE (D). SLIPPING COULD THEN OCCUR AT THIS INTERFACE IF THIS GUIDEWAY BEAM EXPANDS (OR CONTRACTS ) SUFFICIENTLY TO THE RIGHT. IF THE RESISTANCE OF THE SAME INTERFACE (C + LIP) IS THEN GREATER THAN THE RESISTANCE AT INTERFACE D , THEN SLIPPING WILL THEN OCCUR AT THIS LOWER INTERFACE OF PAD TO FOUNDATION CONCRETE AS THE BEAM CONTRACTS (OR EXPANDS) TO THE LEFT. THUS THERMAL MOVEMENTS RESULT, BECAUSE OF THE RESISTANCE OF A LIP , IN WALKING OF THE BEARING PAD IN ONE DIRECTION ONLY.

NOTE:  
AS A RESULT OF EXTERNAL INFLUENCES (THERMAL EFFECTS , BUS TRAFFICKING, FOUNDATION / GROUND MOVEMENTS FOR EXAMPLE ) THE SHIMS AND BEARING BECOME DISPLACED RELATIVE TO EACH OTHER.
