# TECHNICAL NOTE 1

| <b>SUBJECT:</b> | A14 NMU Routes BN18 and BN22 Safety Reviews | | |
| <b>PROJECT:</b> | A14 NMU Bridges | <b>AUTHOR:</b> | [REDACTED] |

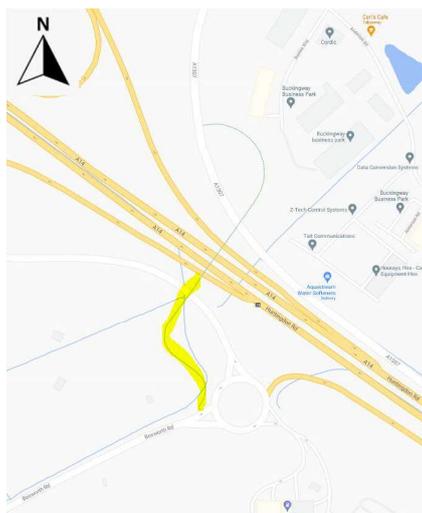
Figure 6- Swavesey South Location Plan

On the Swavesey south route, the gradients are more gentle and the route leads to an uncontrolled crossing via a 90-degree bend. At the tie in to Boxworth Road, there are wayfinding signs for pedestrians, cyclists and horse riders, but the shared signs leading to the NMU bridge is only signed for pedestrians and cyclists. It is therefore unclear whether horse riders are expected to use the bridge.

Cyclists descending the ramp at Swavesey south have good visibility to approaching cyclists/ pedestrians and will be slowing down to the crossing due to the 90-degree bend. The risk of collision with other pedestrians/cyclists and vehicles at this location is low.

It is recommended that the chicane barrier arrangement at this location is removed. It is also recommended that a form of vehicle access control is provided to prevent unauthorised vehicles from accessing the NMU route.

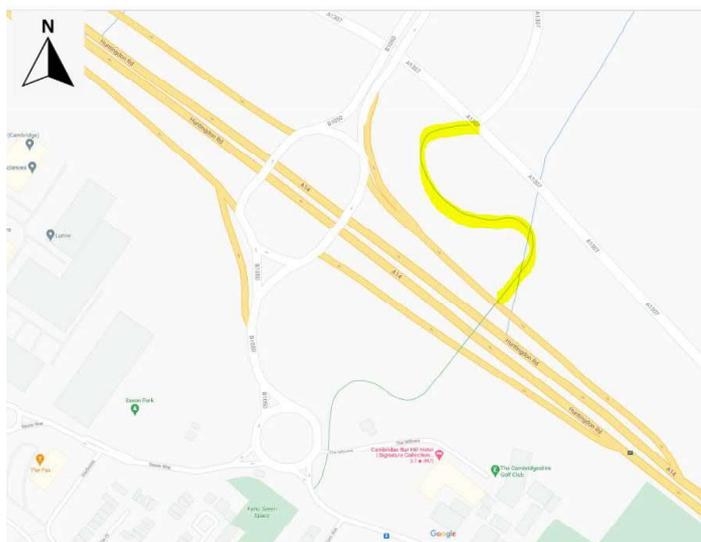
Figure 9 – Bar Hill North Location Plan

The NMU route over the A14 at its northern end joins the existing road (A1307) parallel to the A14 via a controlled crossing.
