# Review of the the Imperial War Museums' report to Cambridgeshire County Council

Produced by:  
Biomass Power Projects Ltd.

10<sup>th</sup> July 2016

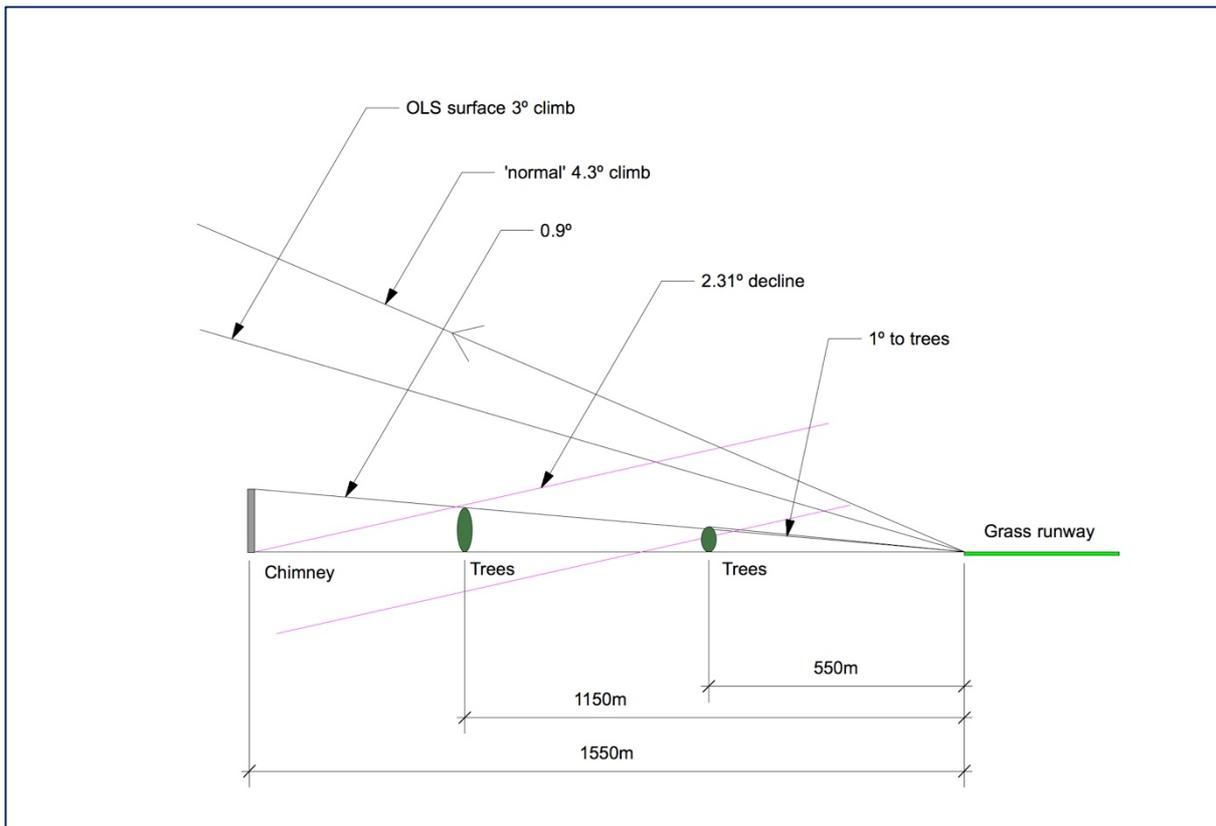
Figure showing relationship between various climb rates and clearance over existing trees.

If on take-off from grass Rwy 24 the aircraft had achieved 36m height above the extreme end of the licenced run - which would be typical - and one engine then failed, and the aircraft continued straight ahead, the aircraft would descend on a gradient 2.31% downward to impact the Vetspeed site at ground level.

In case B of engine failure it is unclear when this would happen, if it was immediately after take-off, within say 250m then the aircraft would either land or hit the trees on the IWM site. If the engines fail after having cleared the trees at 550m from the end of the runway then it would make a slow descent, (with clear view of what is ahead), it may just clear the second line of trees before coming down at approximately 1500m away at the Vetspeed site or if it had drifted north on A505 or drifted south onto the memorial garden or neighbouring field.

This scenario makes two things very clear, if this plane or any other that cannot maintain an increase in its climb rate will come down at some point resulting in a forced landing and result in a major incident. If engine failure happens at a distance of 550m then the plane will crash land at the Vetspeed site, it will have hit the ground and not the chimney. So this statement and calculation by the IWM confirm that the proposed chimney is not the hazard as it will hit the ground. *The hazard seems to be flying planes that cannot maintain an increase in climb rate and the risk is not just to Vetspeed but the drivers on A505 which are also potentially on the crash line of the plane.*
