Cambridgeshire Guided Busway

Report on Guideway Defects and Corrective Measures

Cambridgeshire Guided Busway
Cambridgeshire County Council v BAM Nuttall Ltd.

| Date | : | 11 September 2014 |

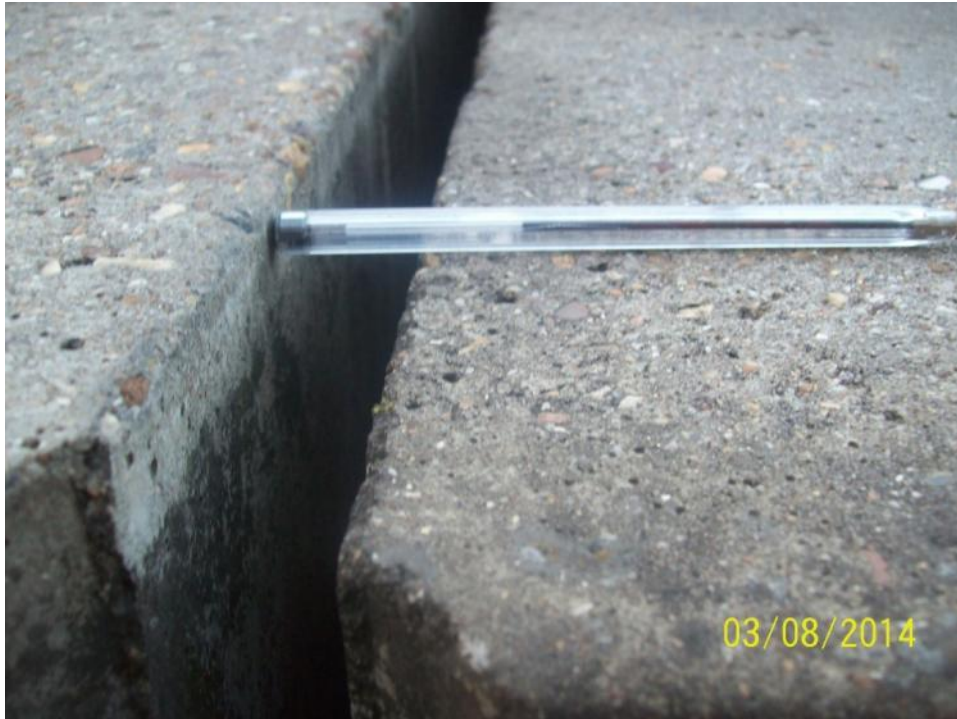
CH17811 C/B – Dropped beam (offside)

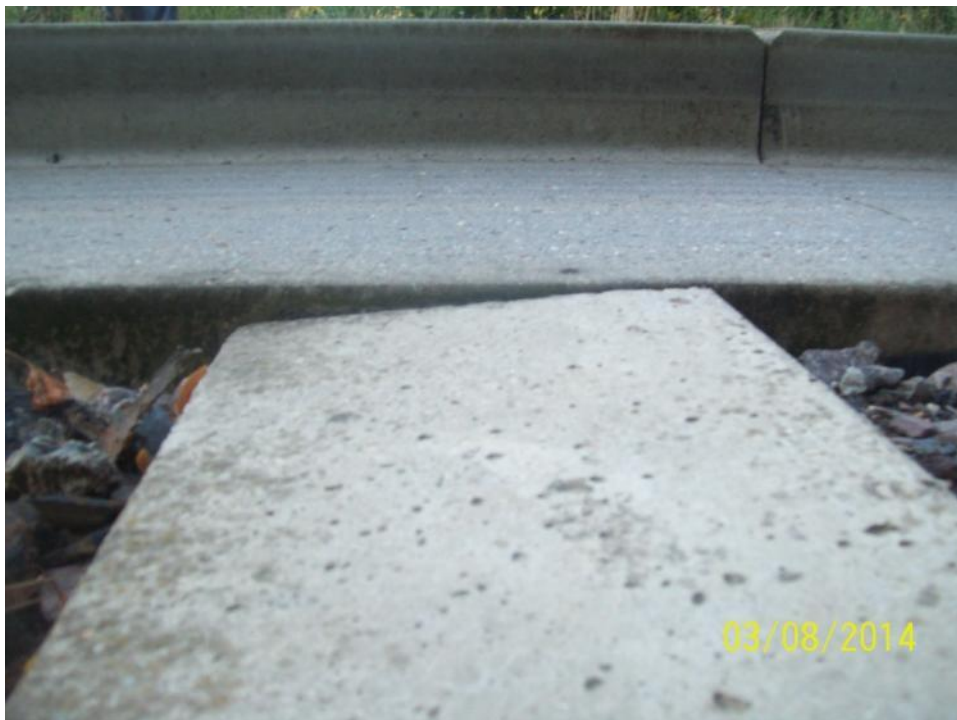
CH17796 C/B – Twisting spacer beam

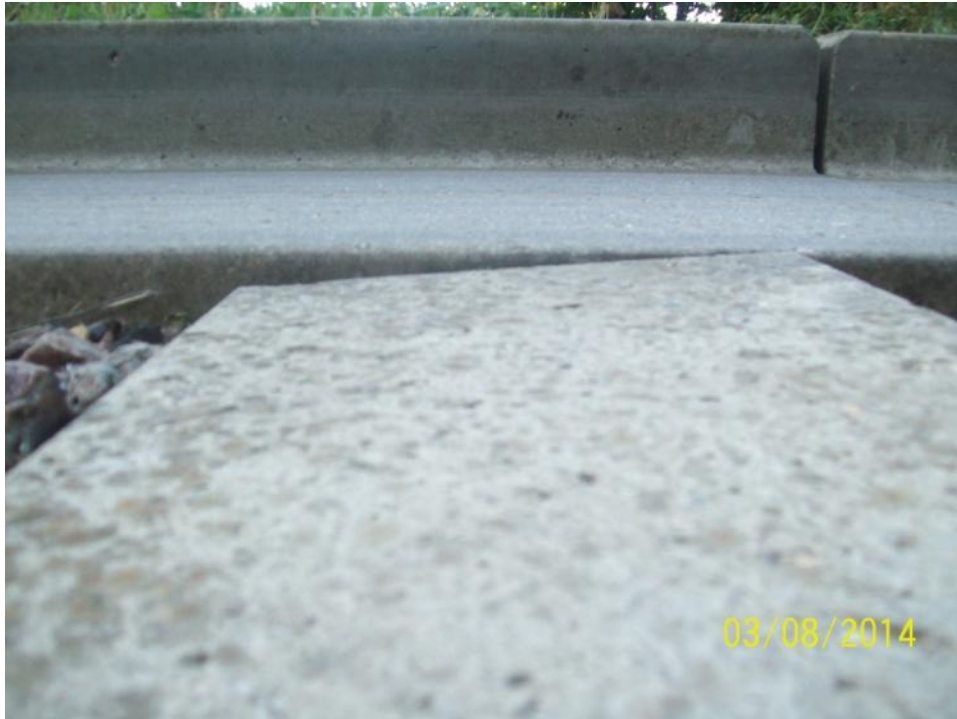
CH177796 SI/B – Twisting spacer beam

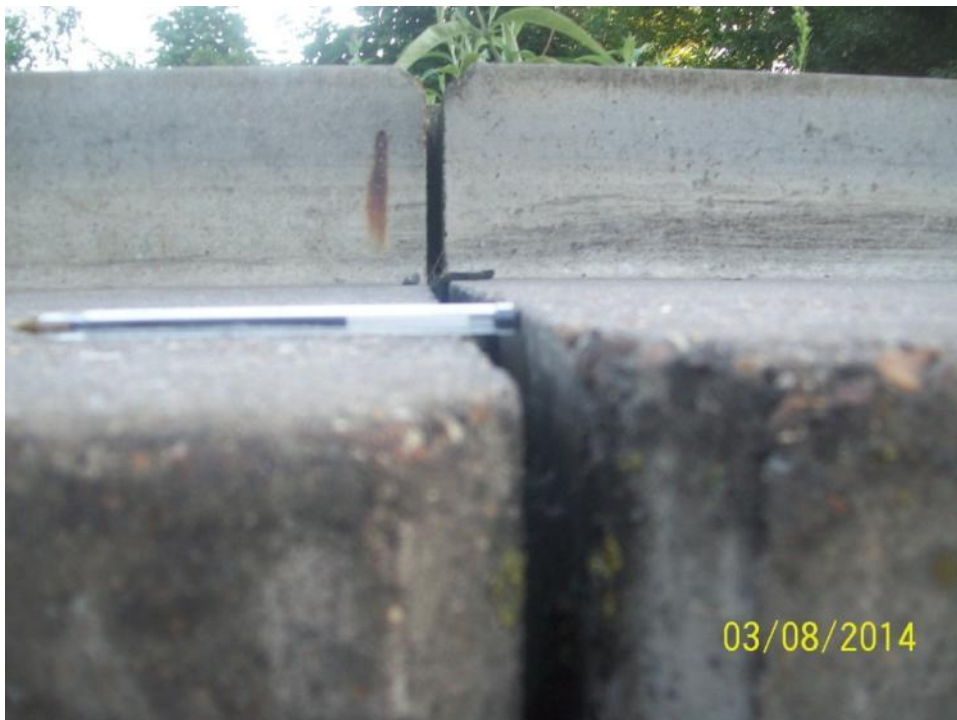
CH17751 C/B –beam dropped (nearside)

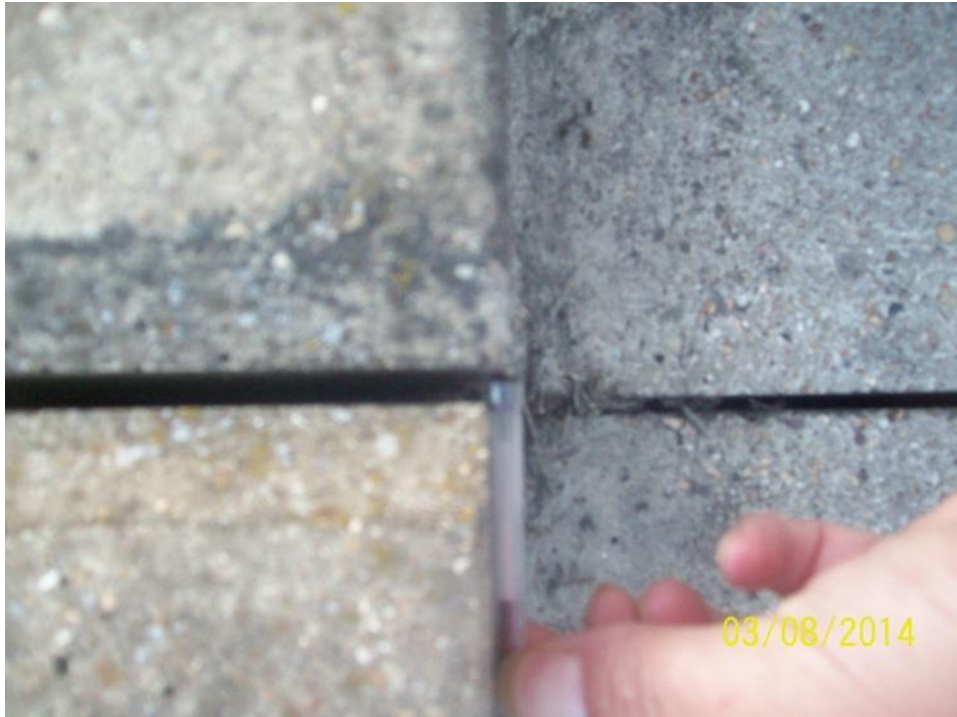
CH17736 C/B – Laterally displaced (nearside)

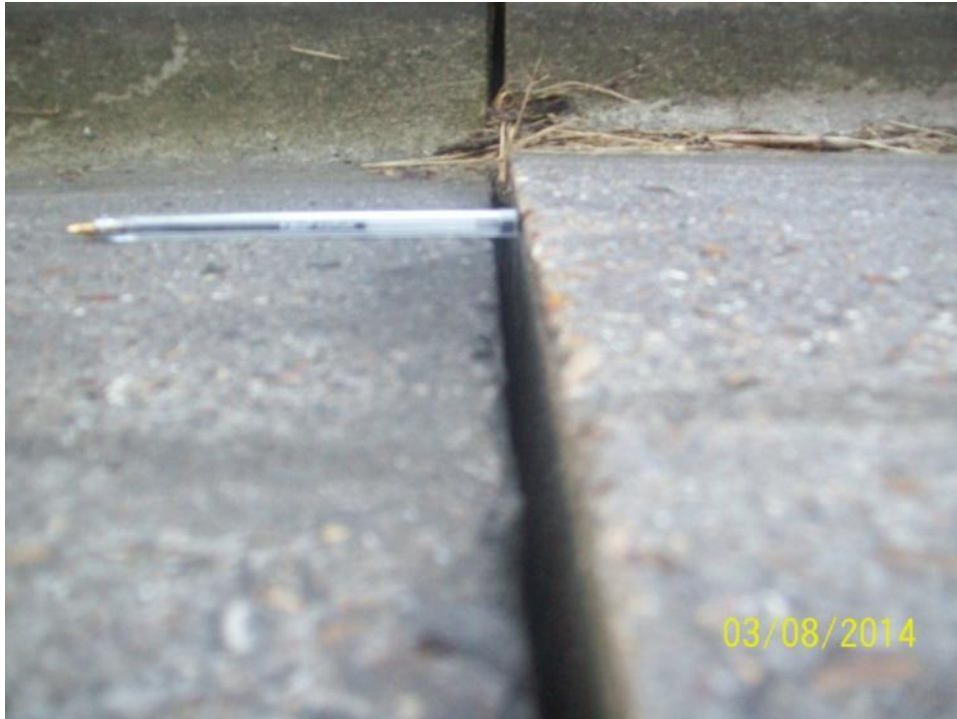
CH17586 SI/B – beam dropped (nearside)

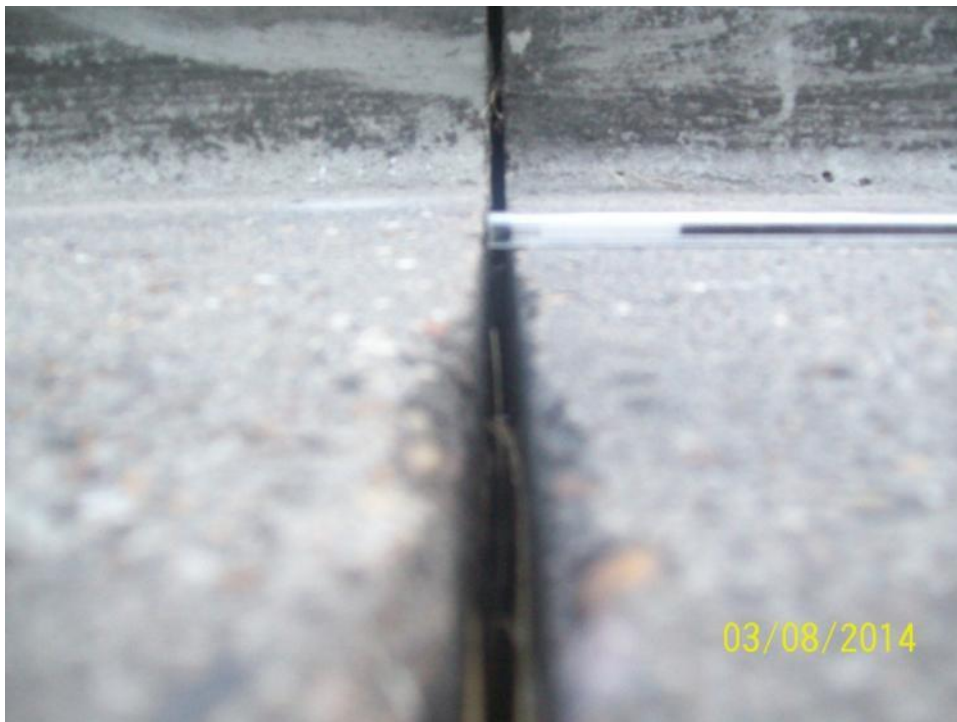
CH17586 C/B – beam dropped

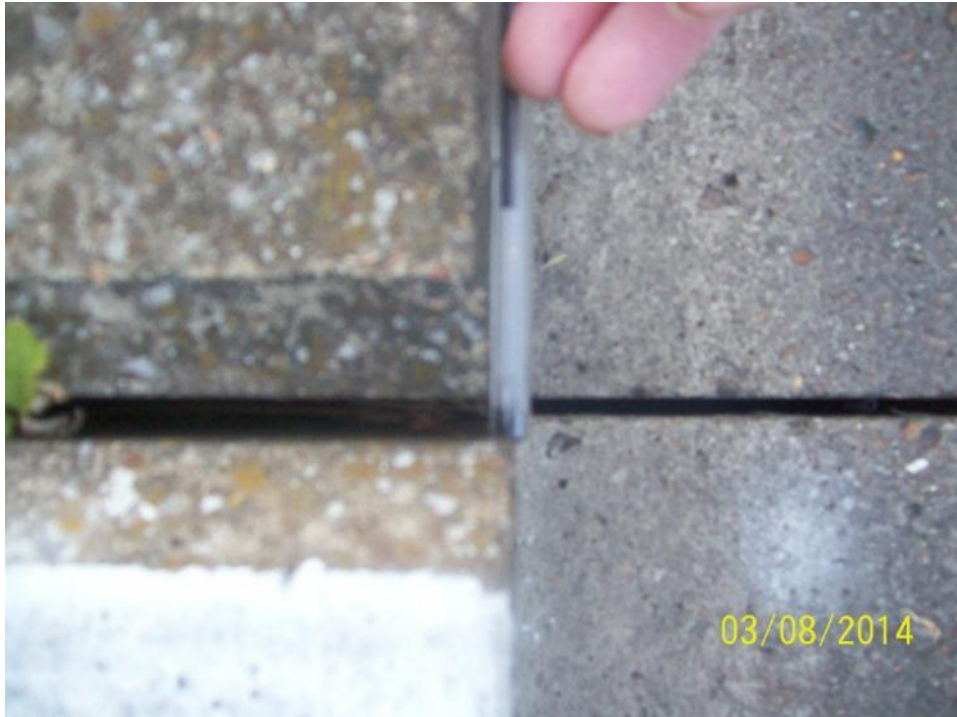
CH17586 C/B – Laterally displaced

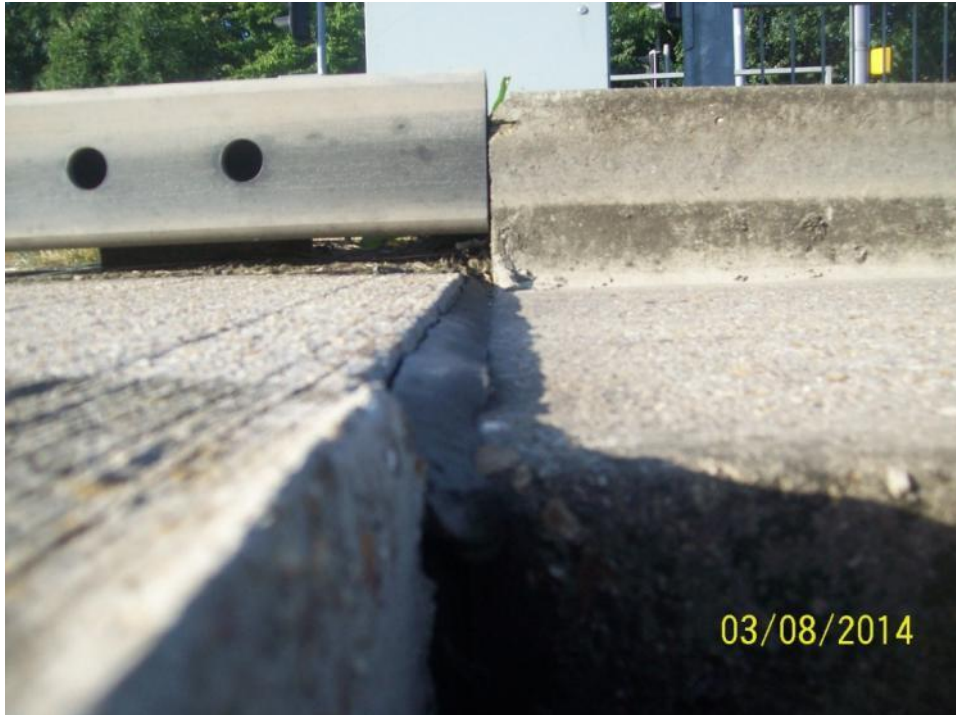
Beam 1 - beam dropped

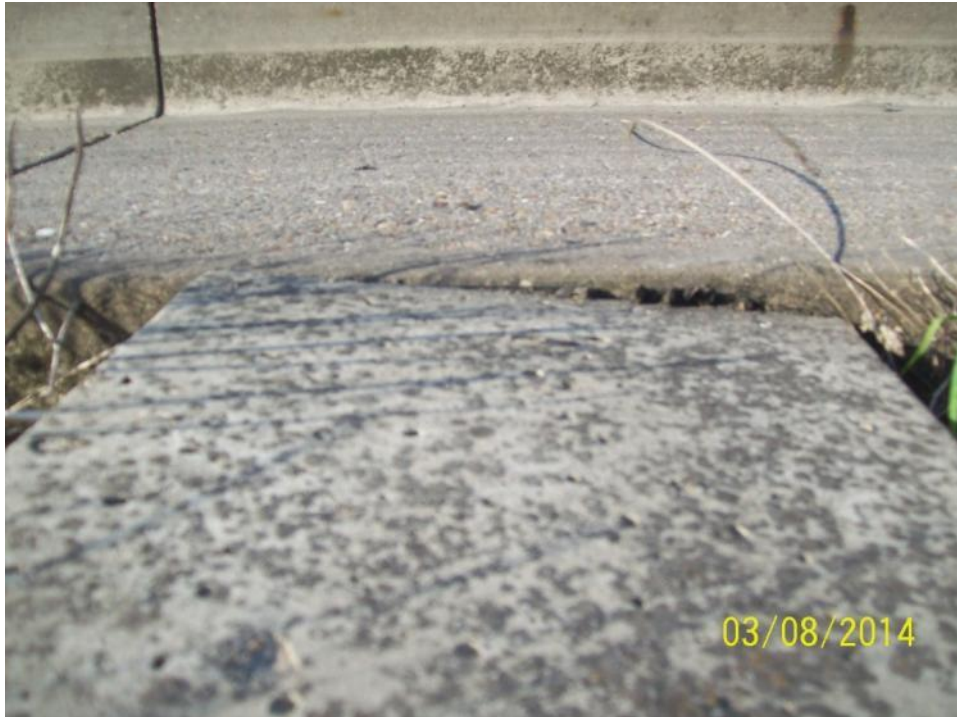
Beam 10 – Twisting spacer beam
